PROFESSIONAL HOME
INSEPTION REPORT

Inspector: **Shane Zimmerman**

License#: **24563**

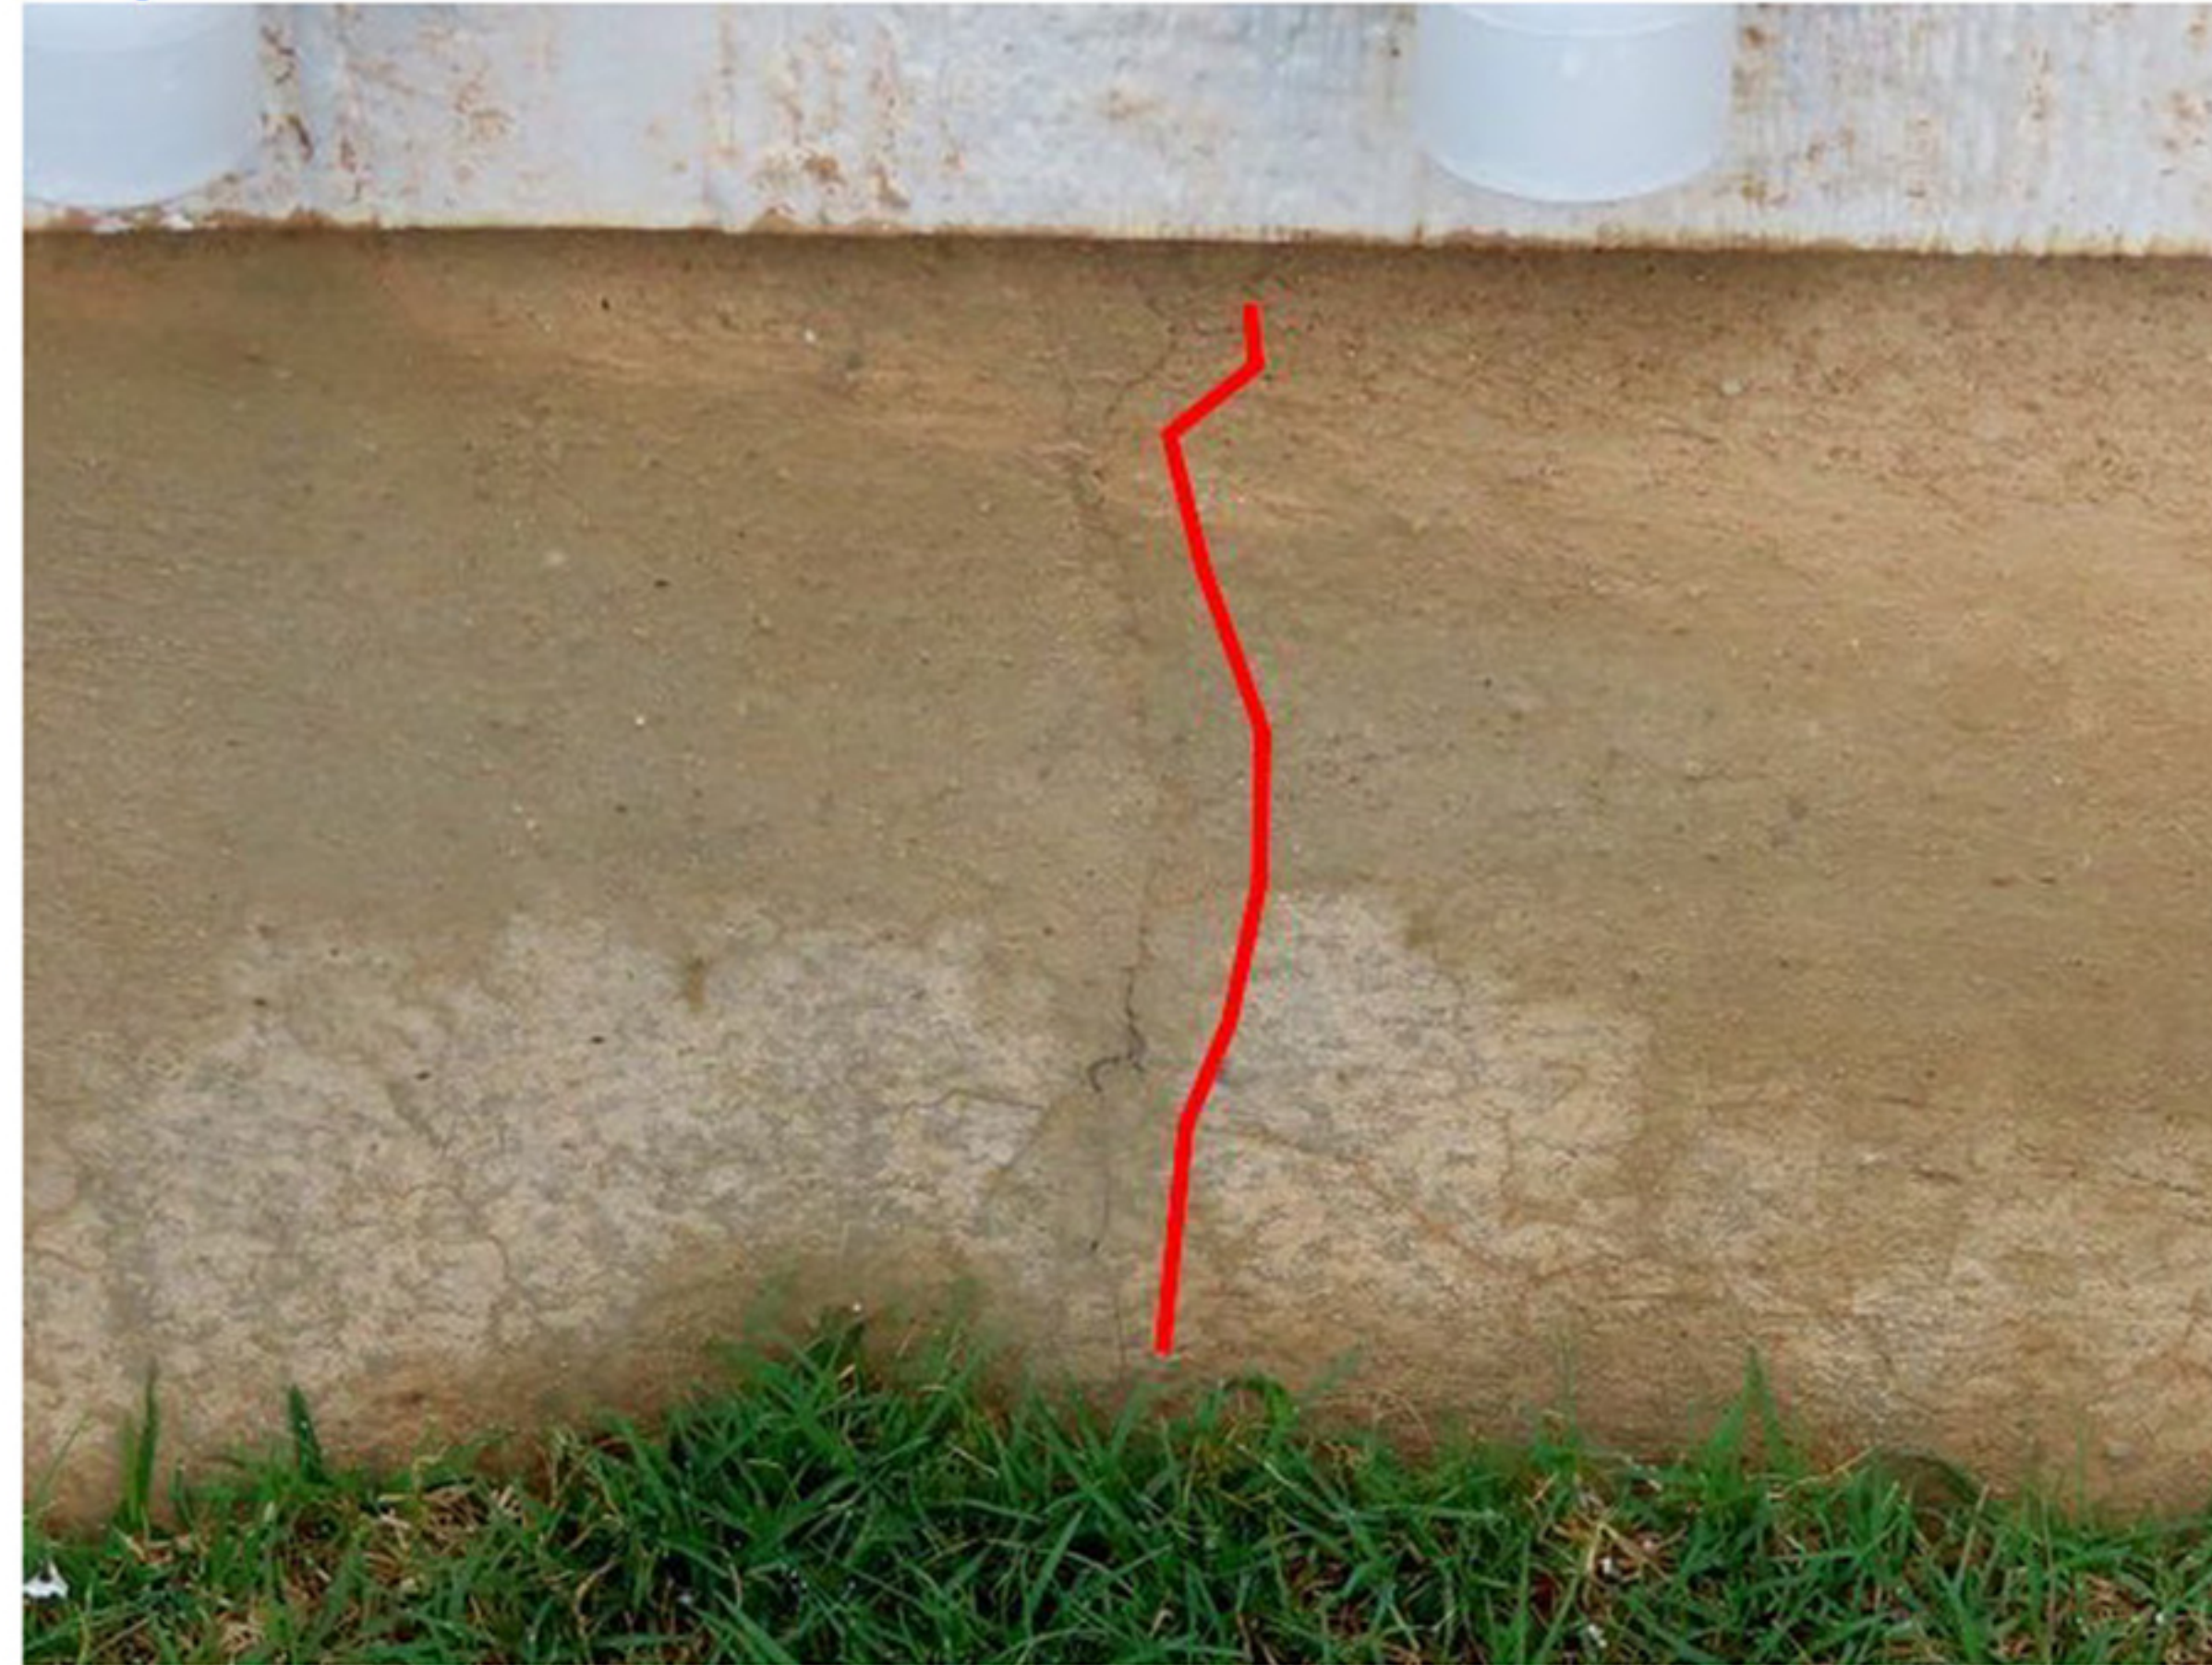
There is a hairline vertical crack in the parge coat on the right side of the house, directly under the water heater drain lines. There is a sprinkler head at this location that is spraying the wall, so this is likely due to over-saturation. It appears to be cosmetic, but it should be monitored for future expansion.

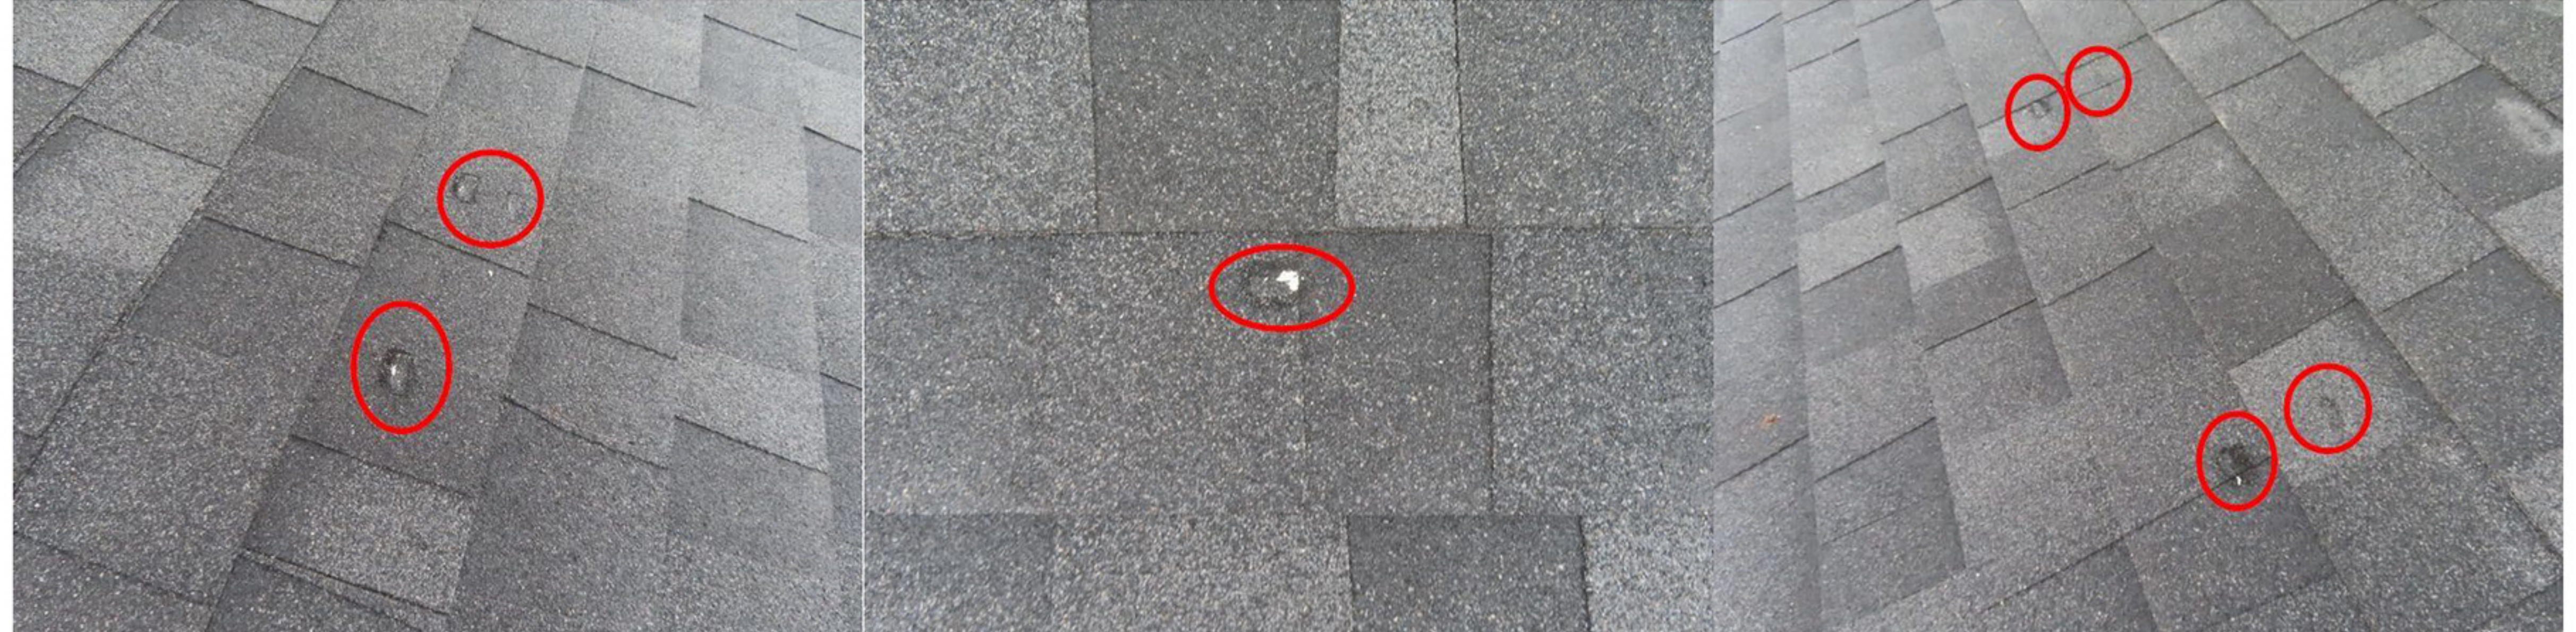
There are a few shingles on the front side of the house that have been damaged and need to be replaced. There are 7 spots in total that I was able to see. I have marked them below.

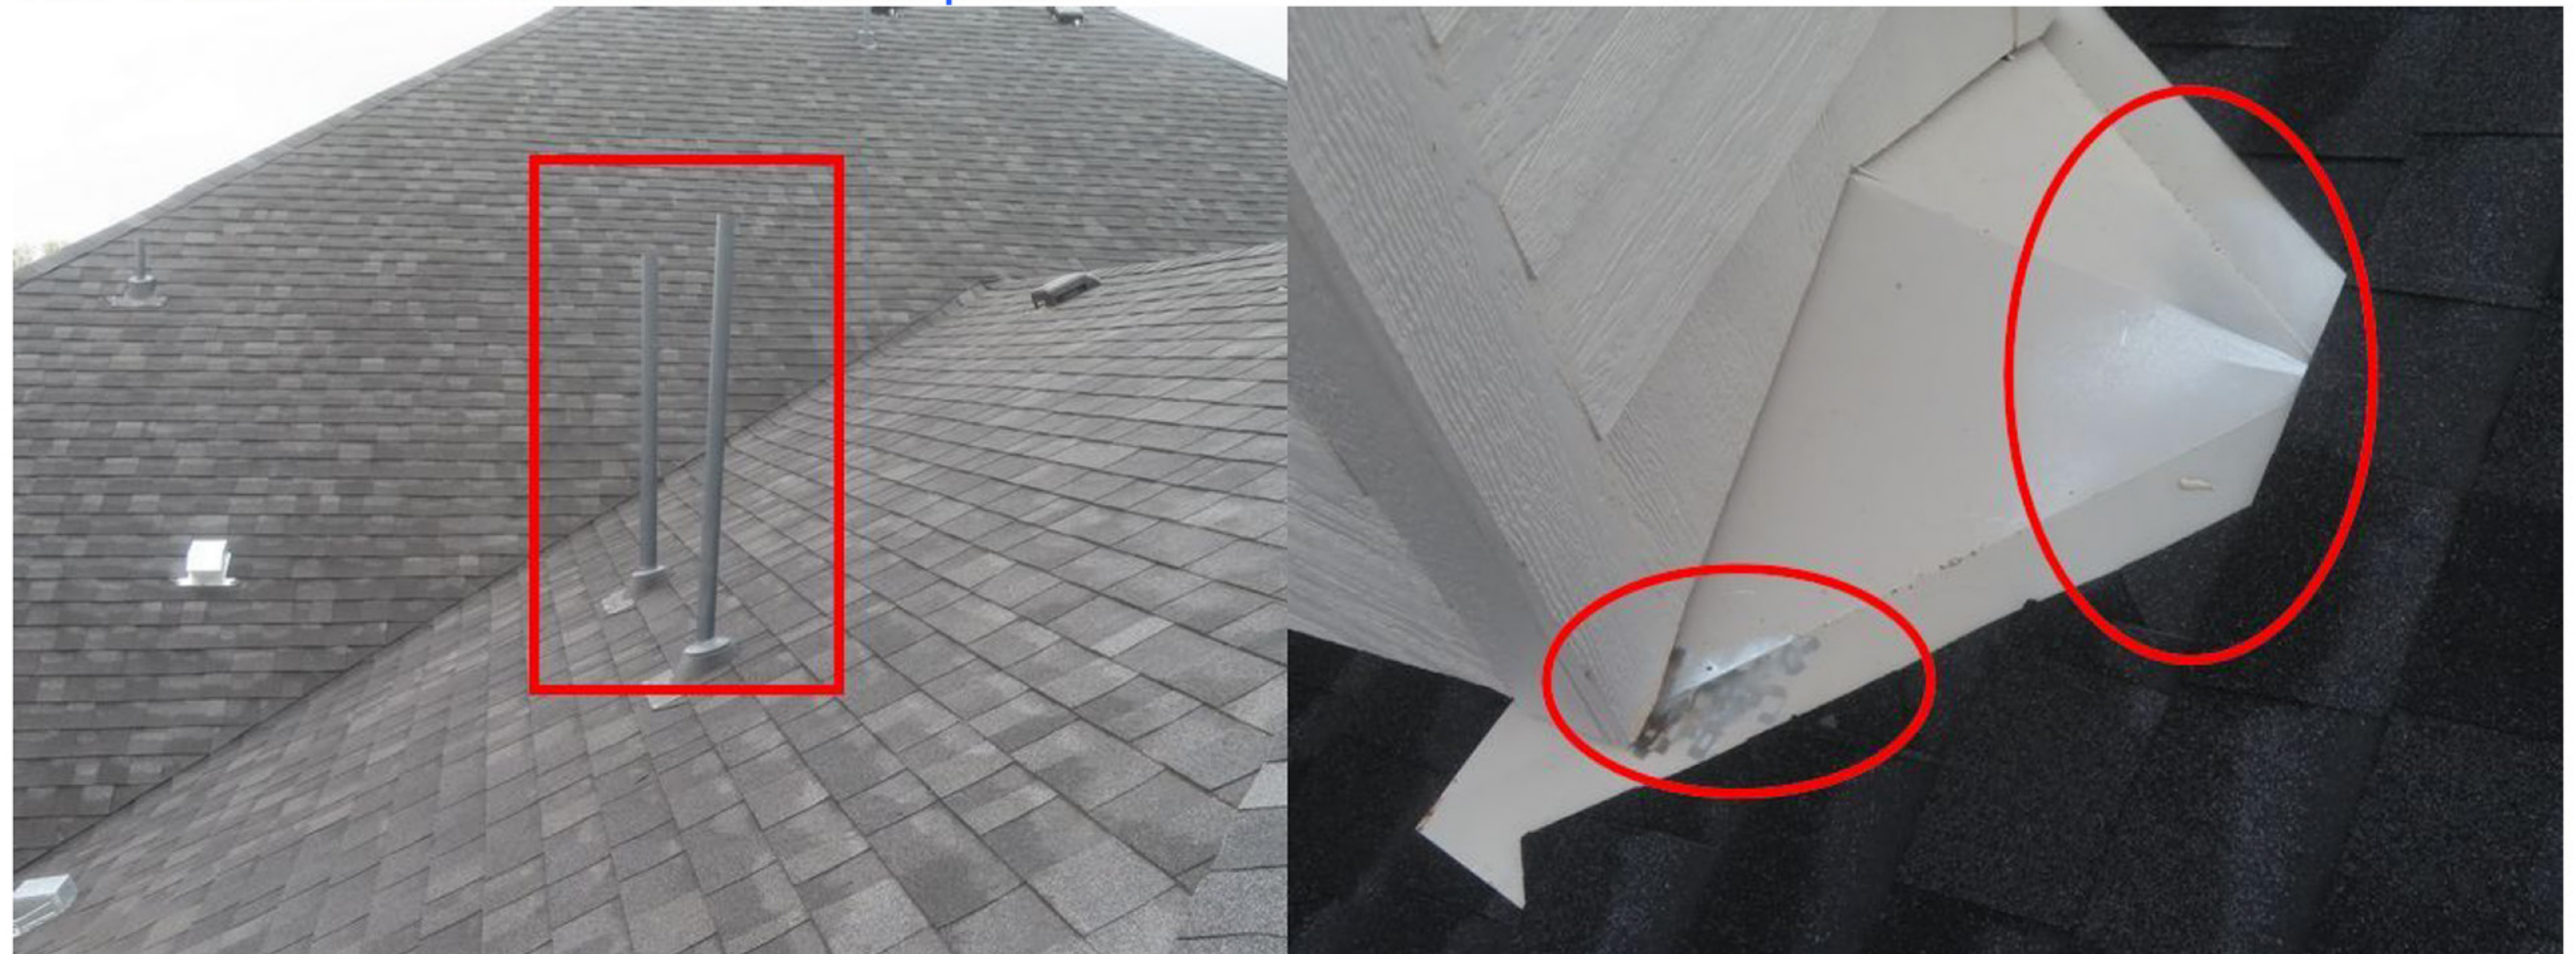
There are two vent pipes above the master bathroom that have not been trimmed. The cricket needs a second coat of paint.

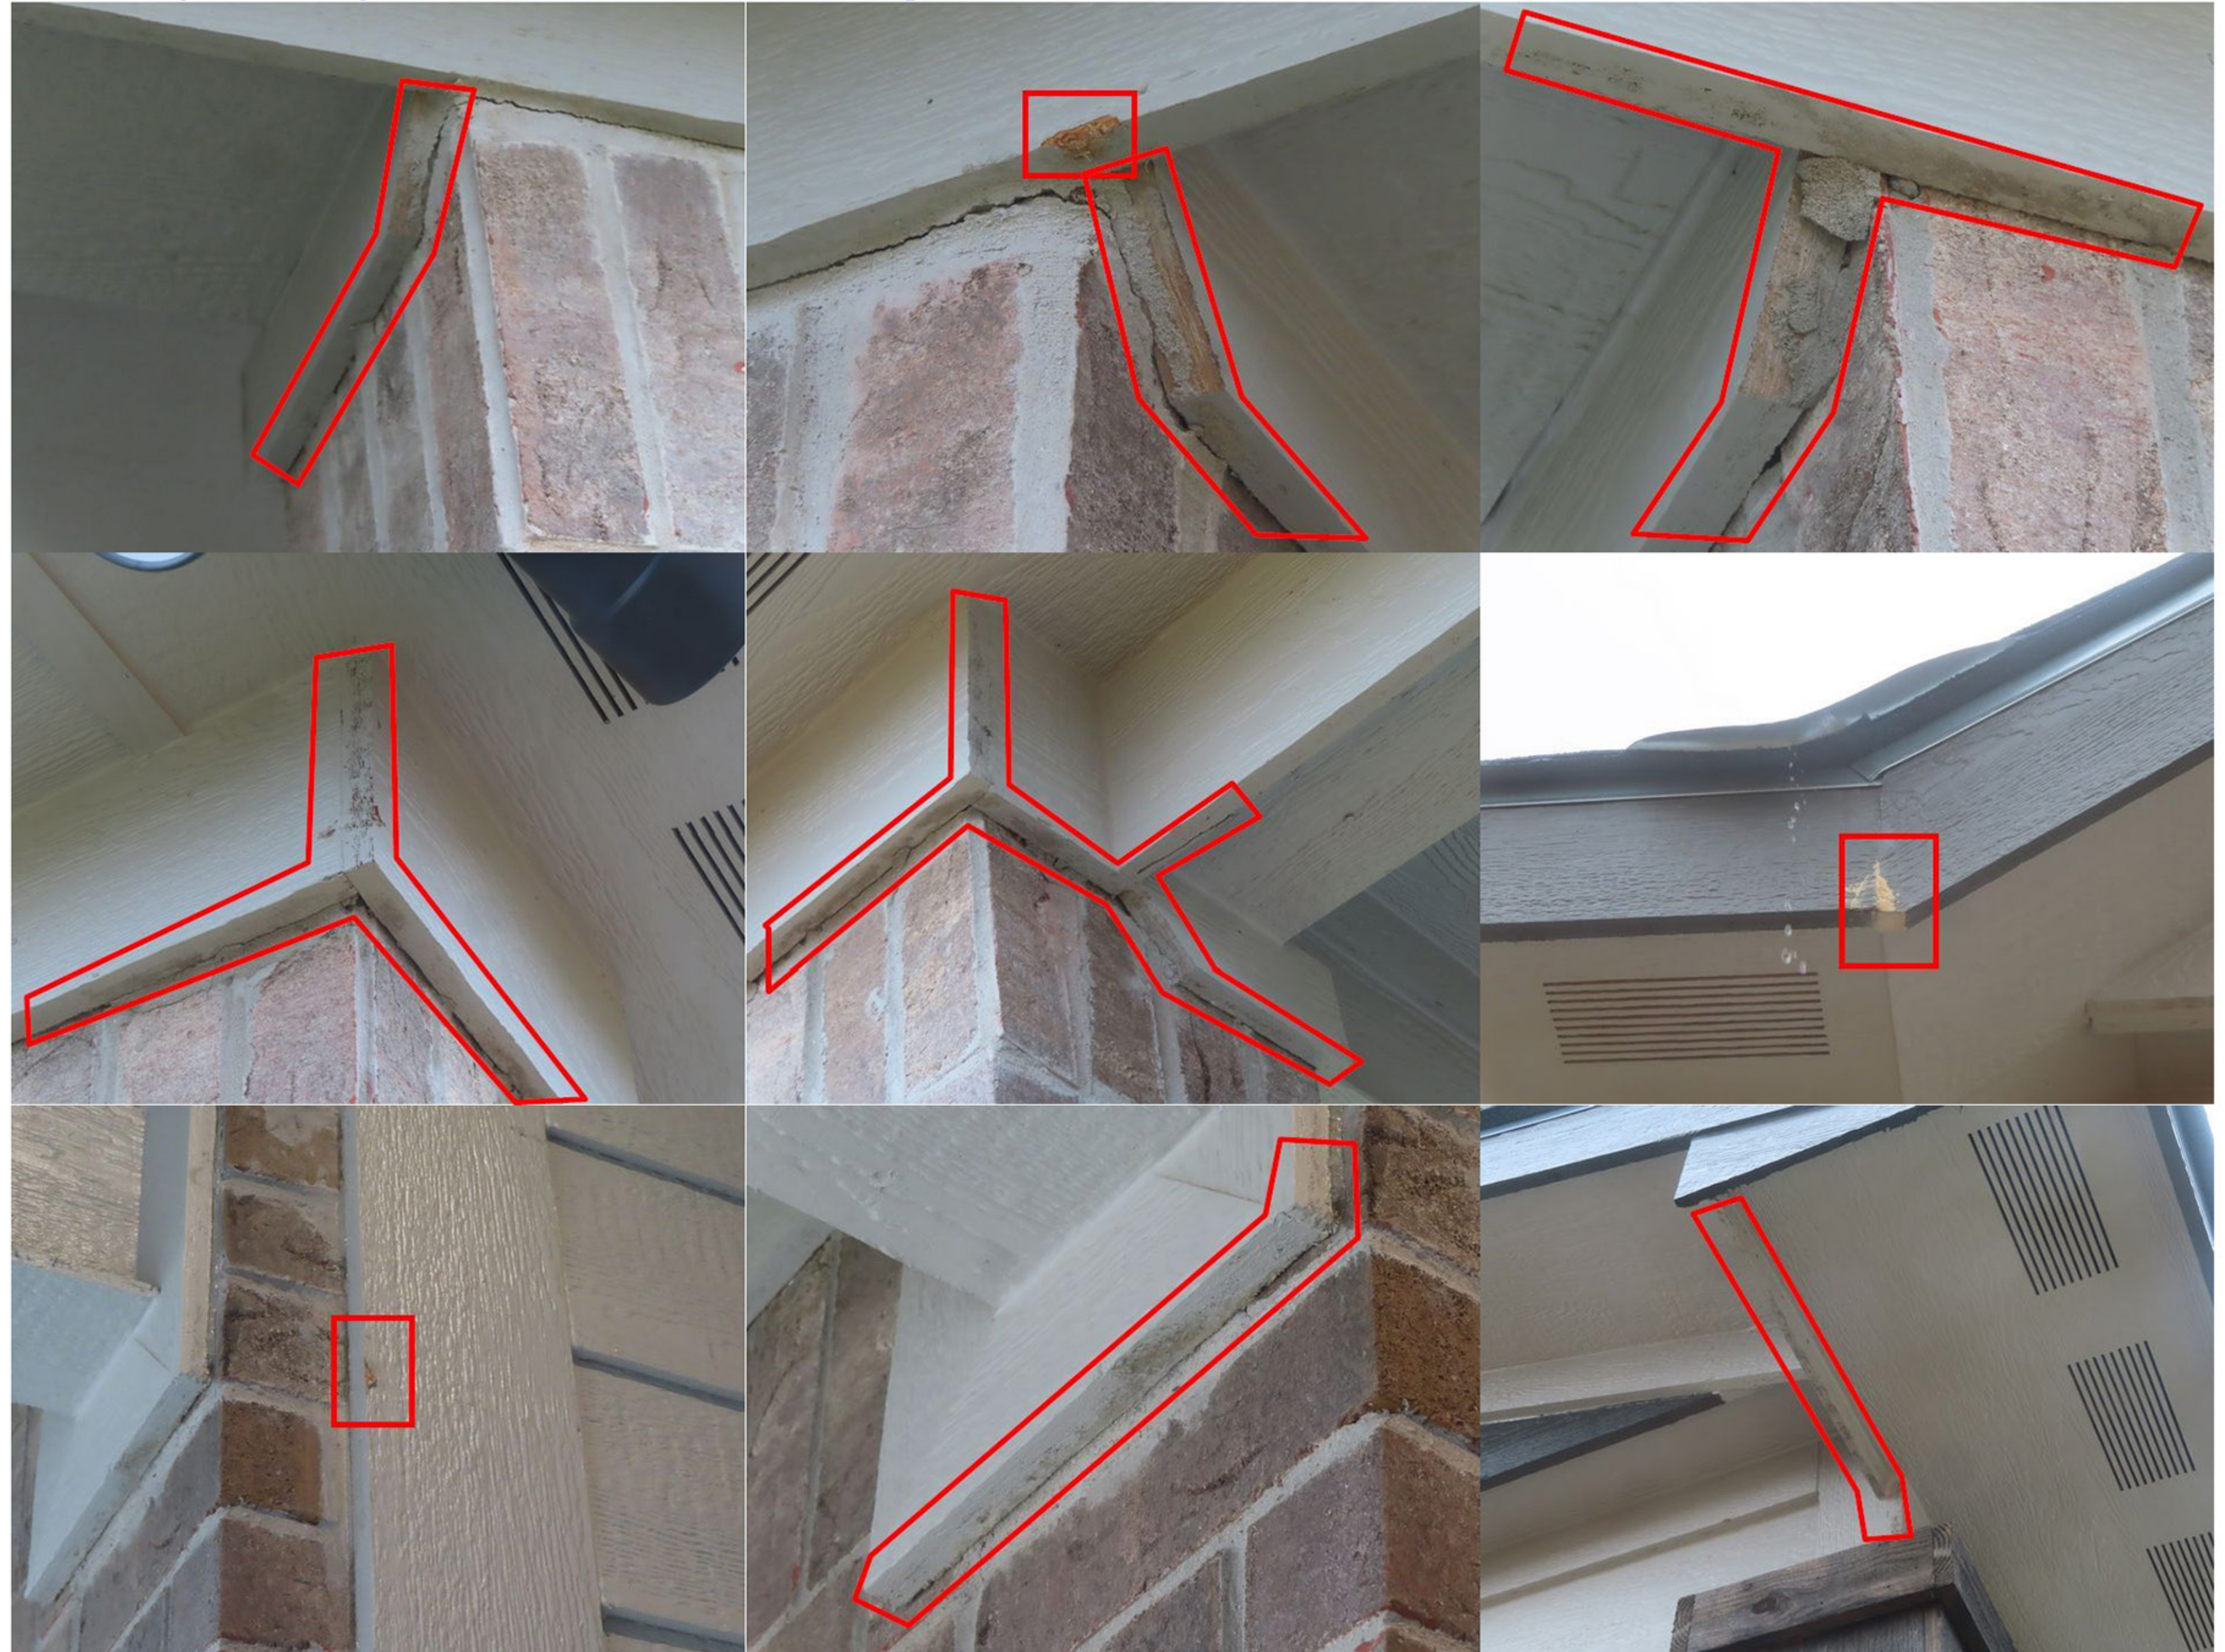
The osb wood trim, especially at the rear and front porches, really absorbed the first coat of paint, and several areas of the wood have not been covered/sealed. These trim boards need a second coat of paint to prevent them from rotting.

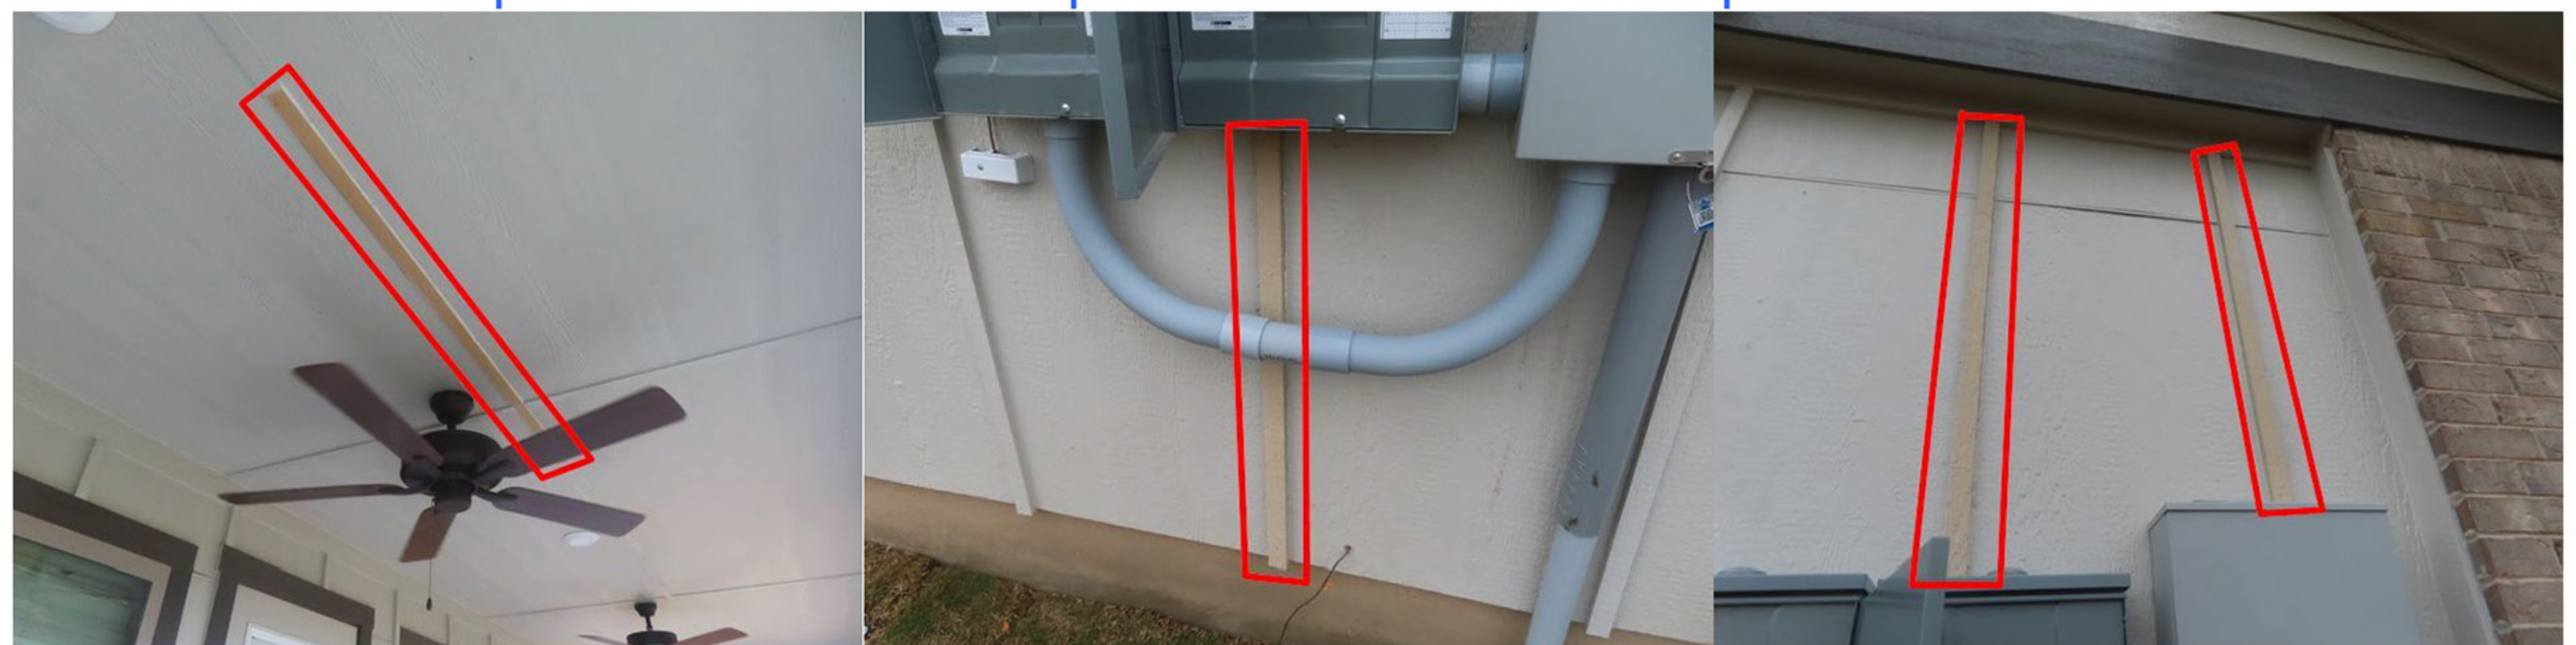
Several new trim boards have not been painted. They are located on the left side of the house, near the electrical panel and on the rear porch. These need to be painted.

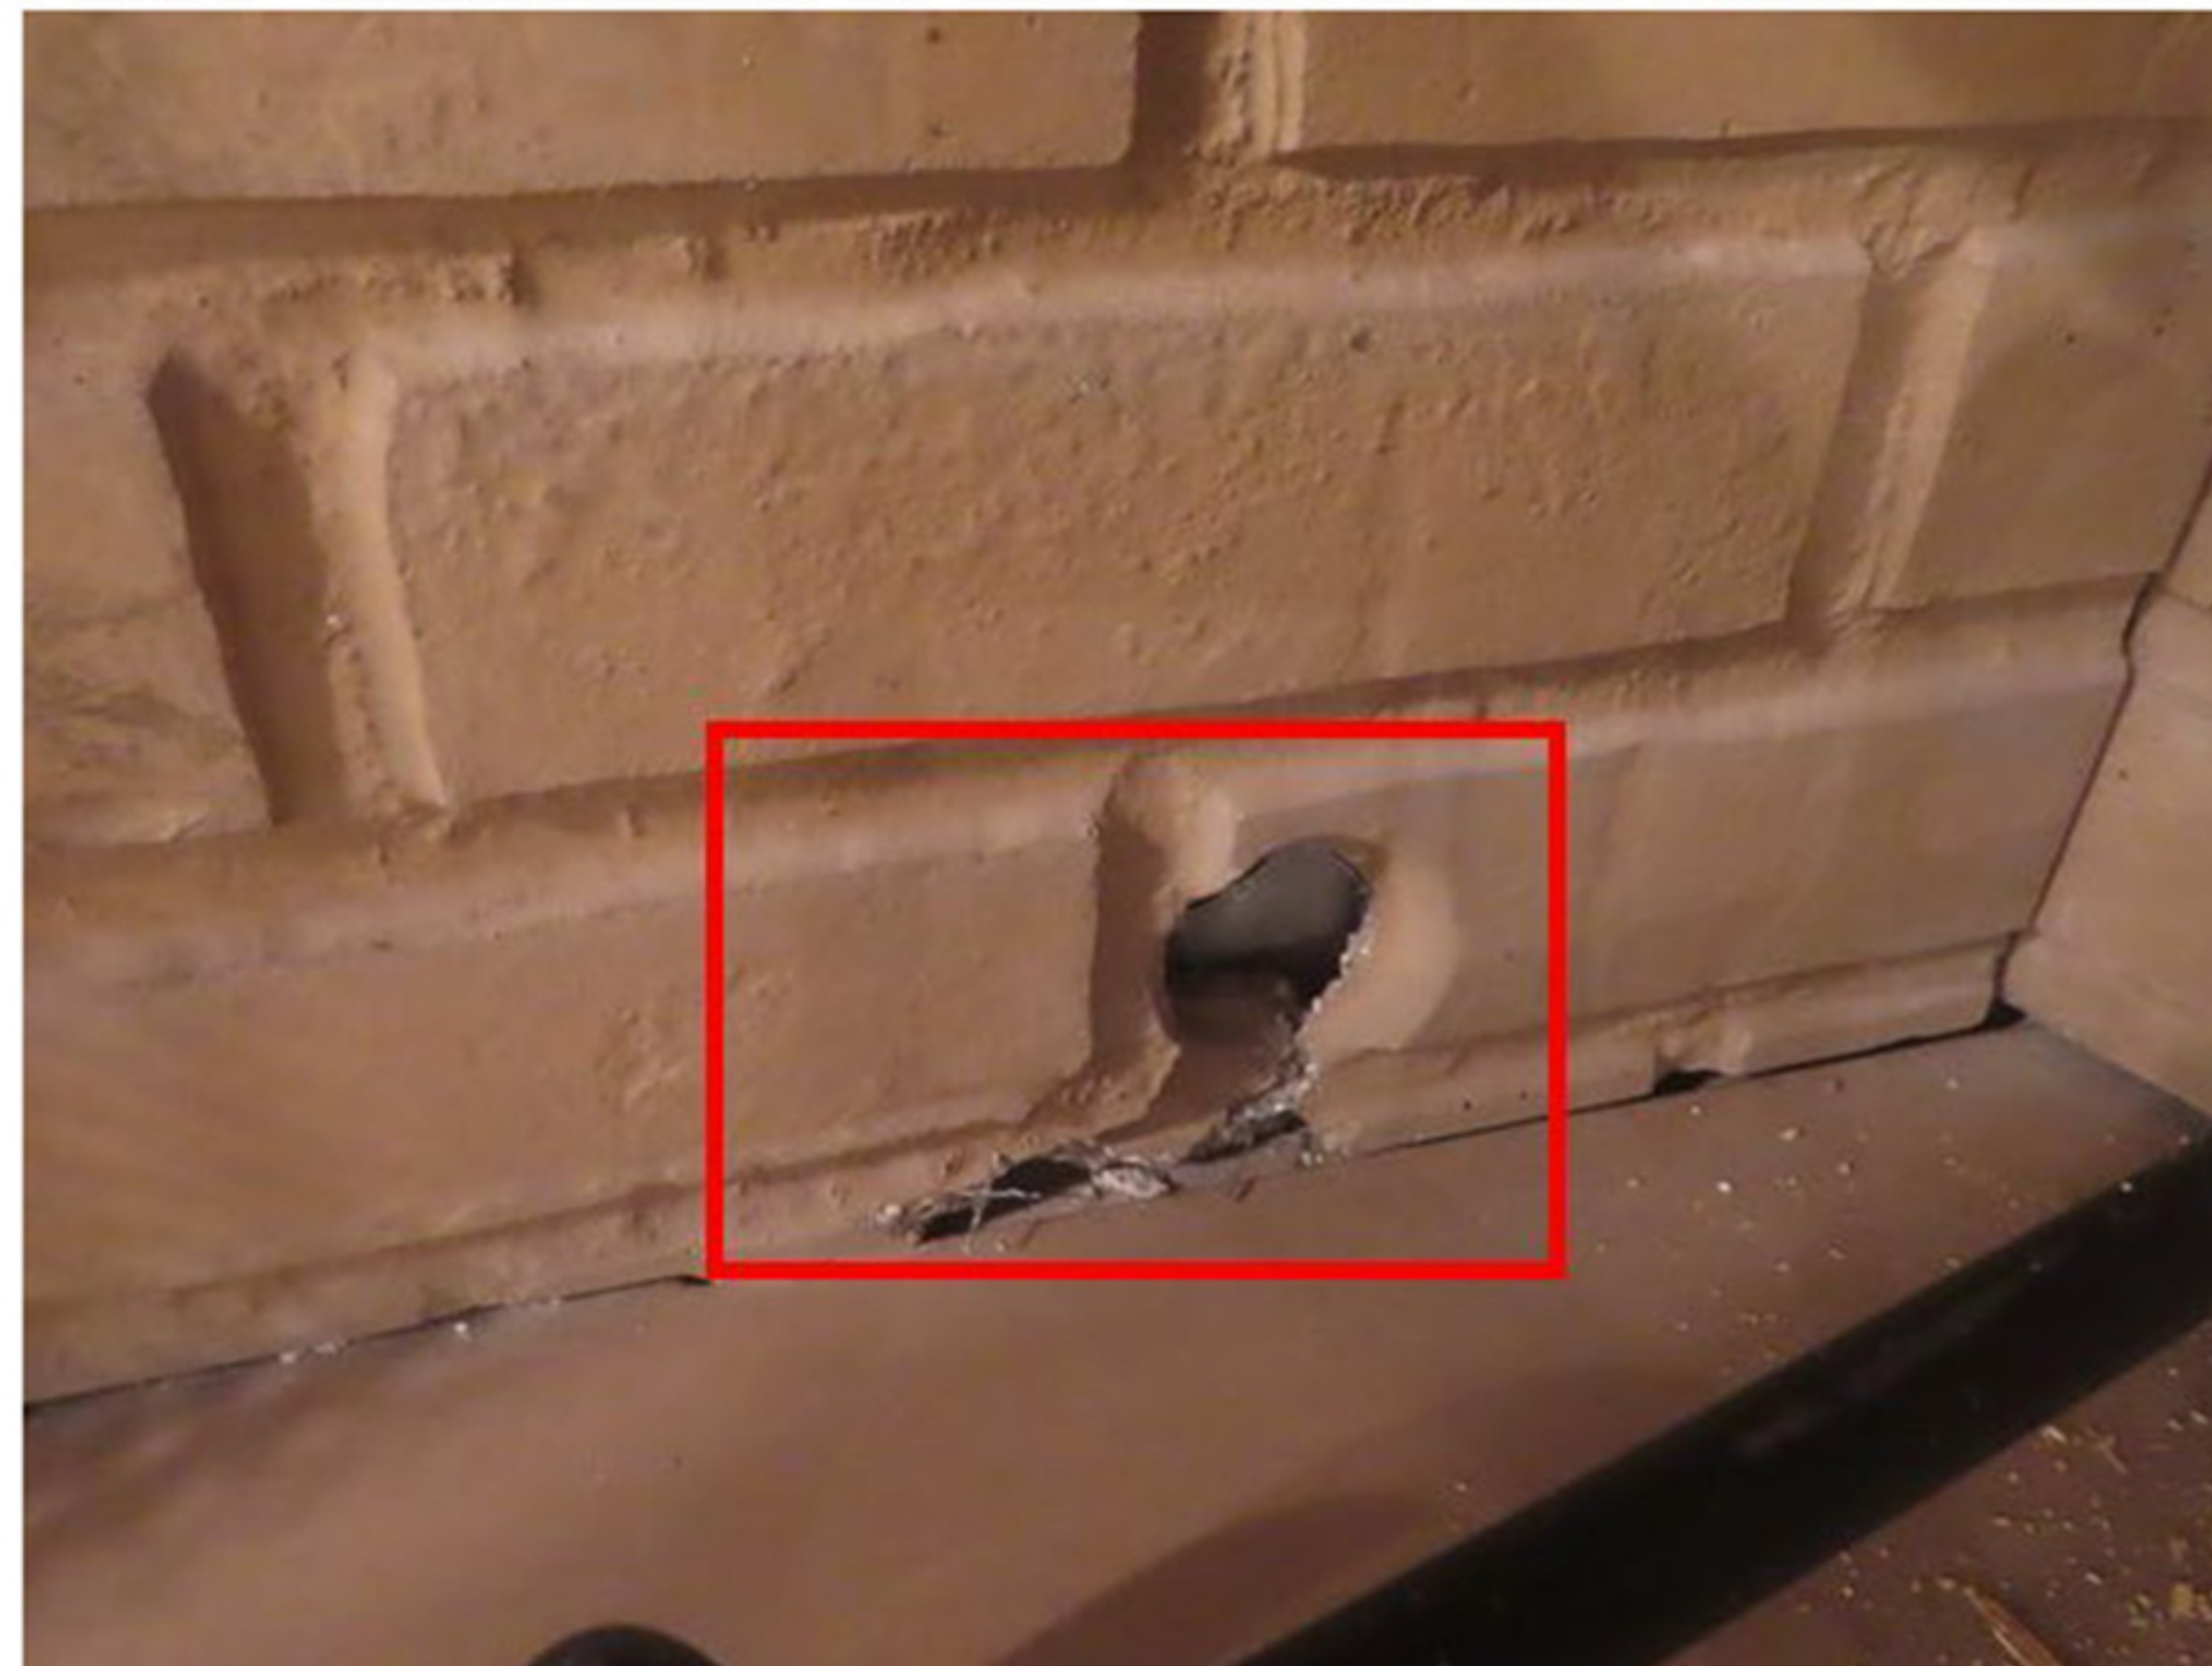
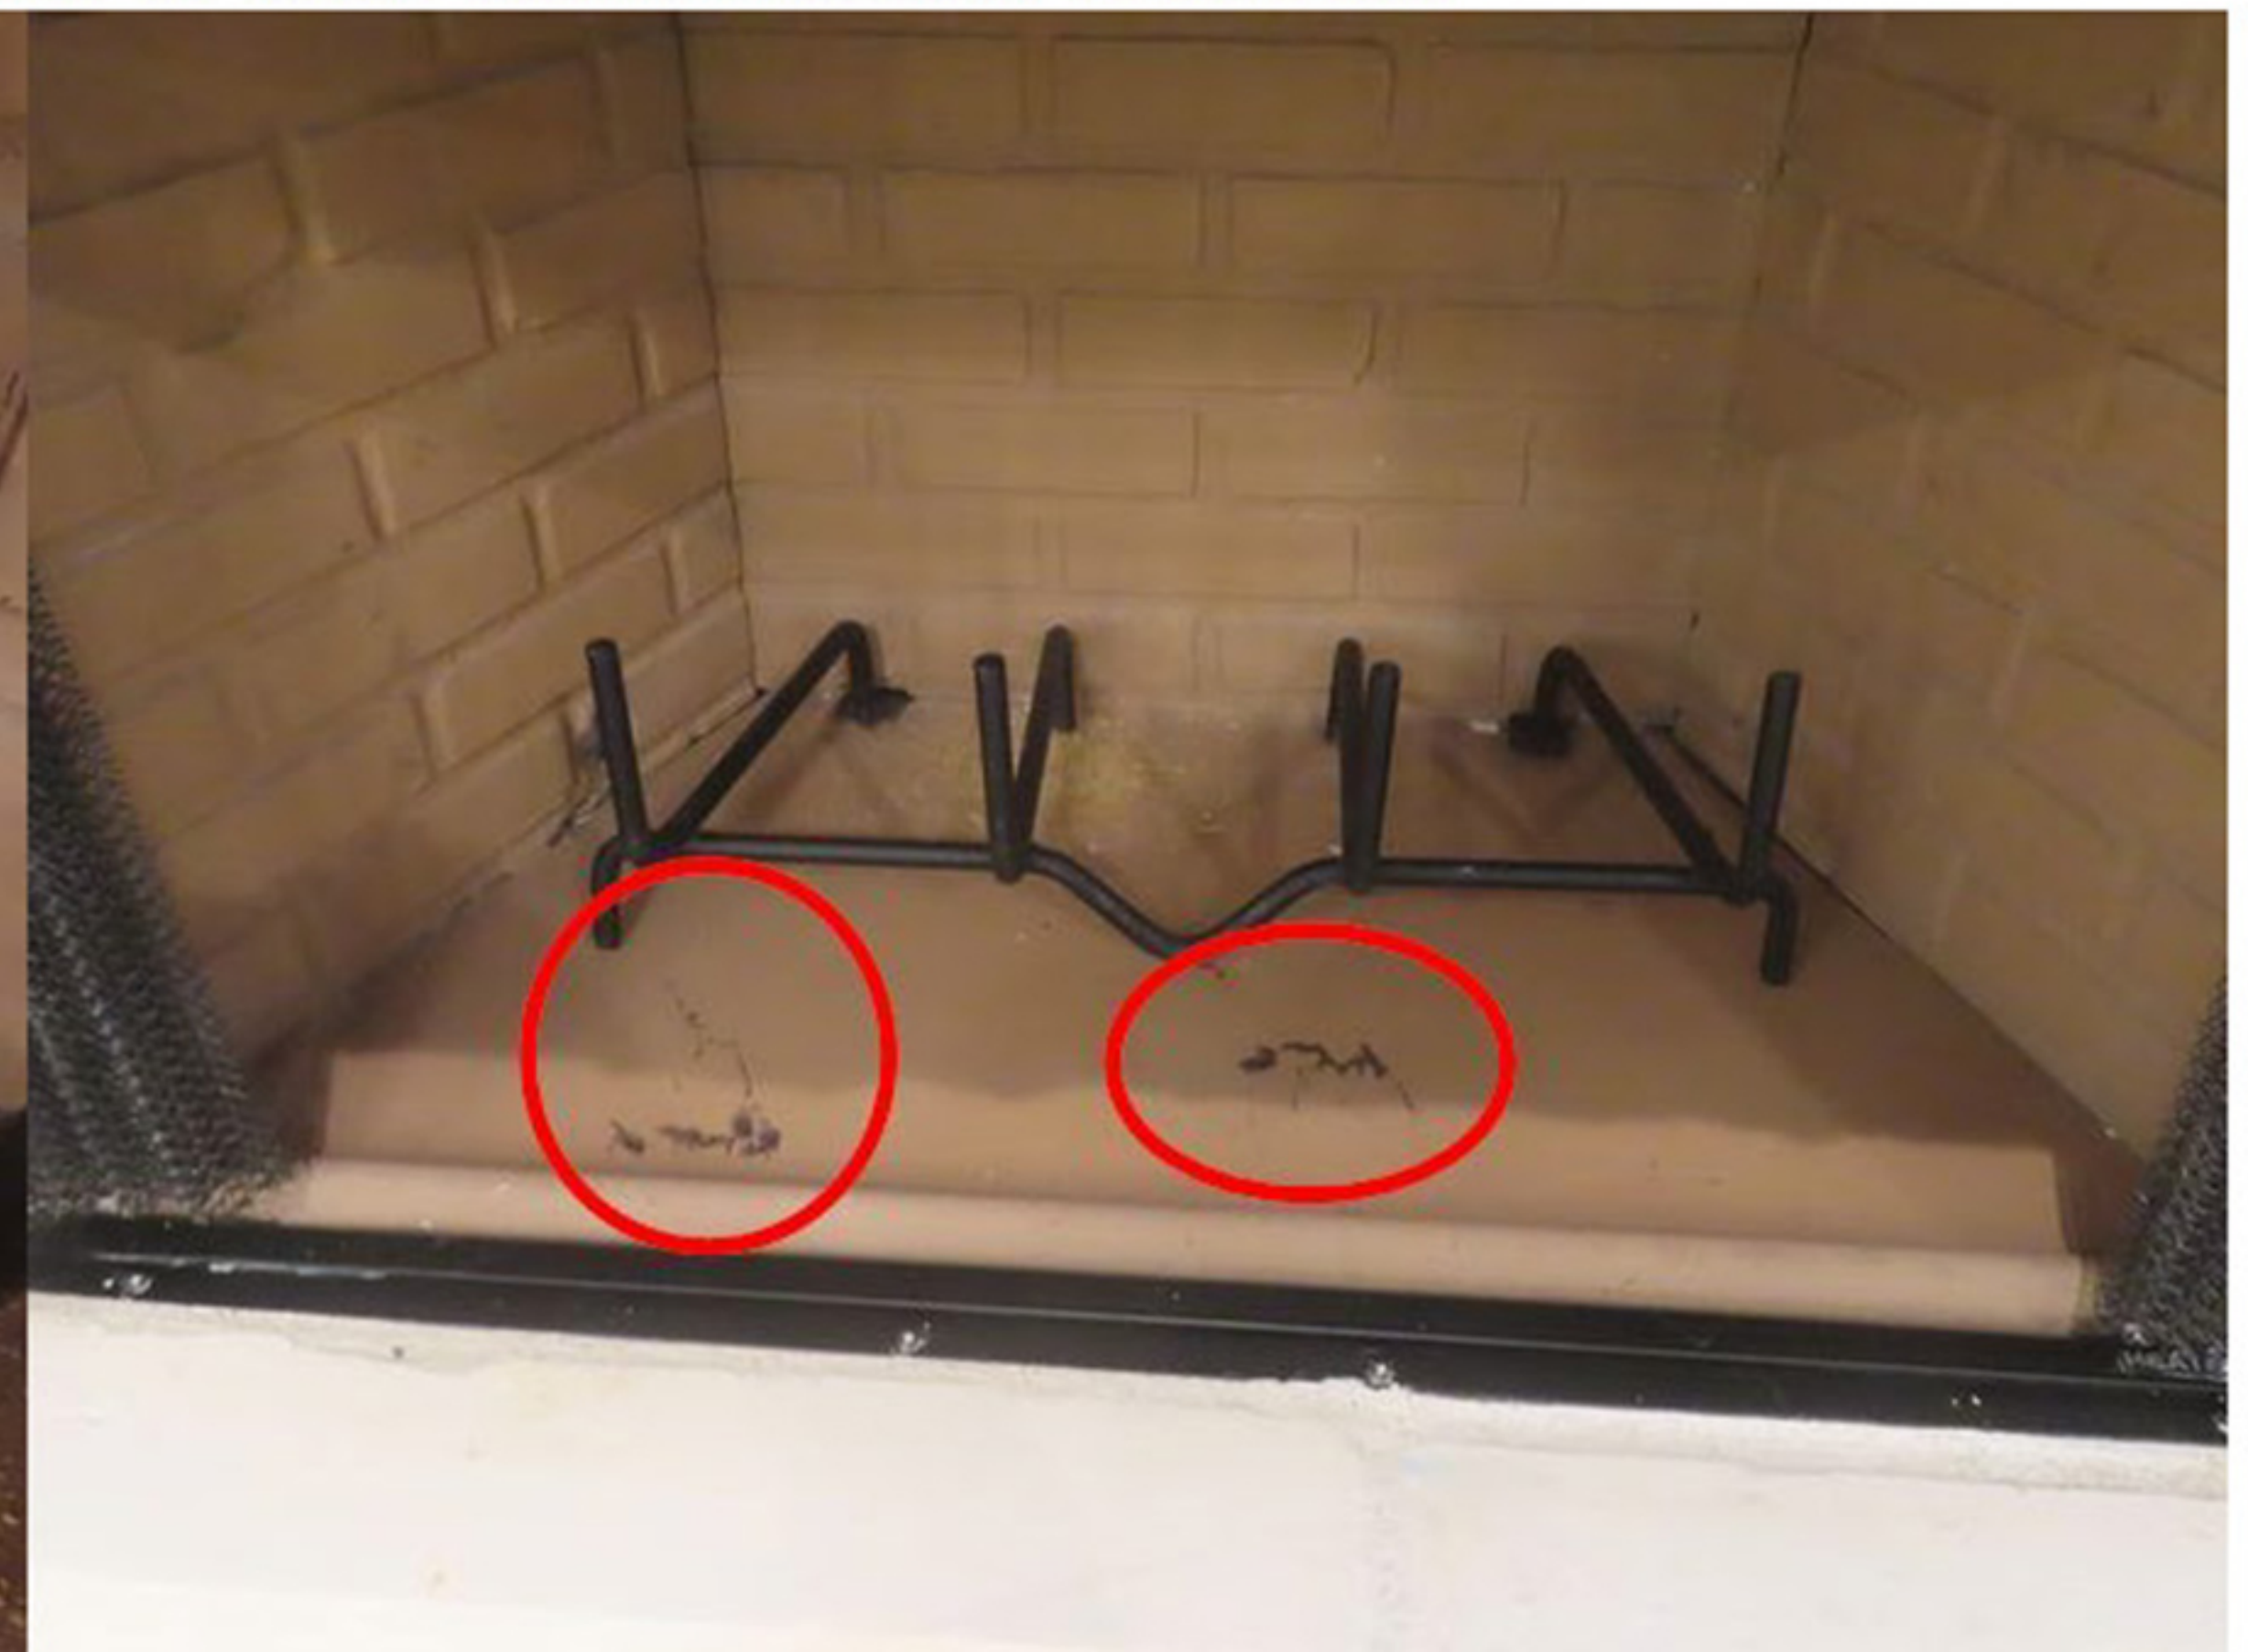
The left side of the firebrick liner was damaged during installation. A piece of it has chipped off the bottom, under the hole where a gas line can be installed. This side panel needs to be replaced.

Note: The bottom of the firebox has scuff marks on it. This is a cosmetic concern.
