PROFESSIONAL HOME
INSEPTION REPORT

Inspector: **Shane Zimmerman**

License#: **24563**

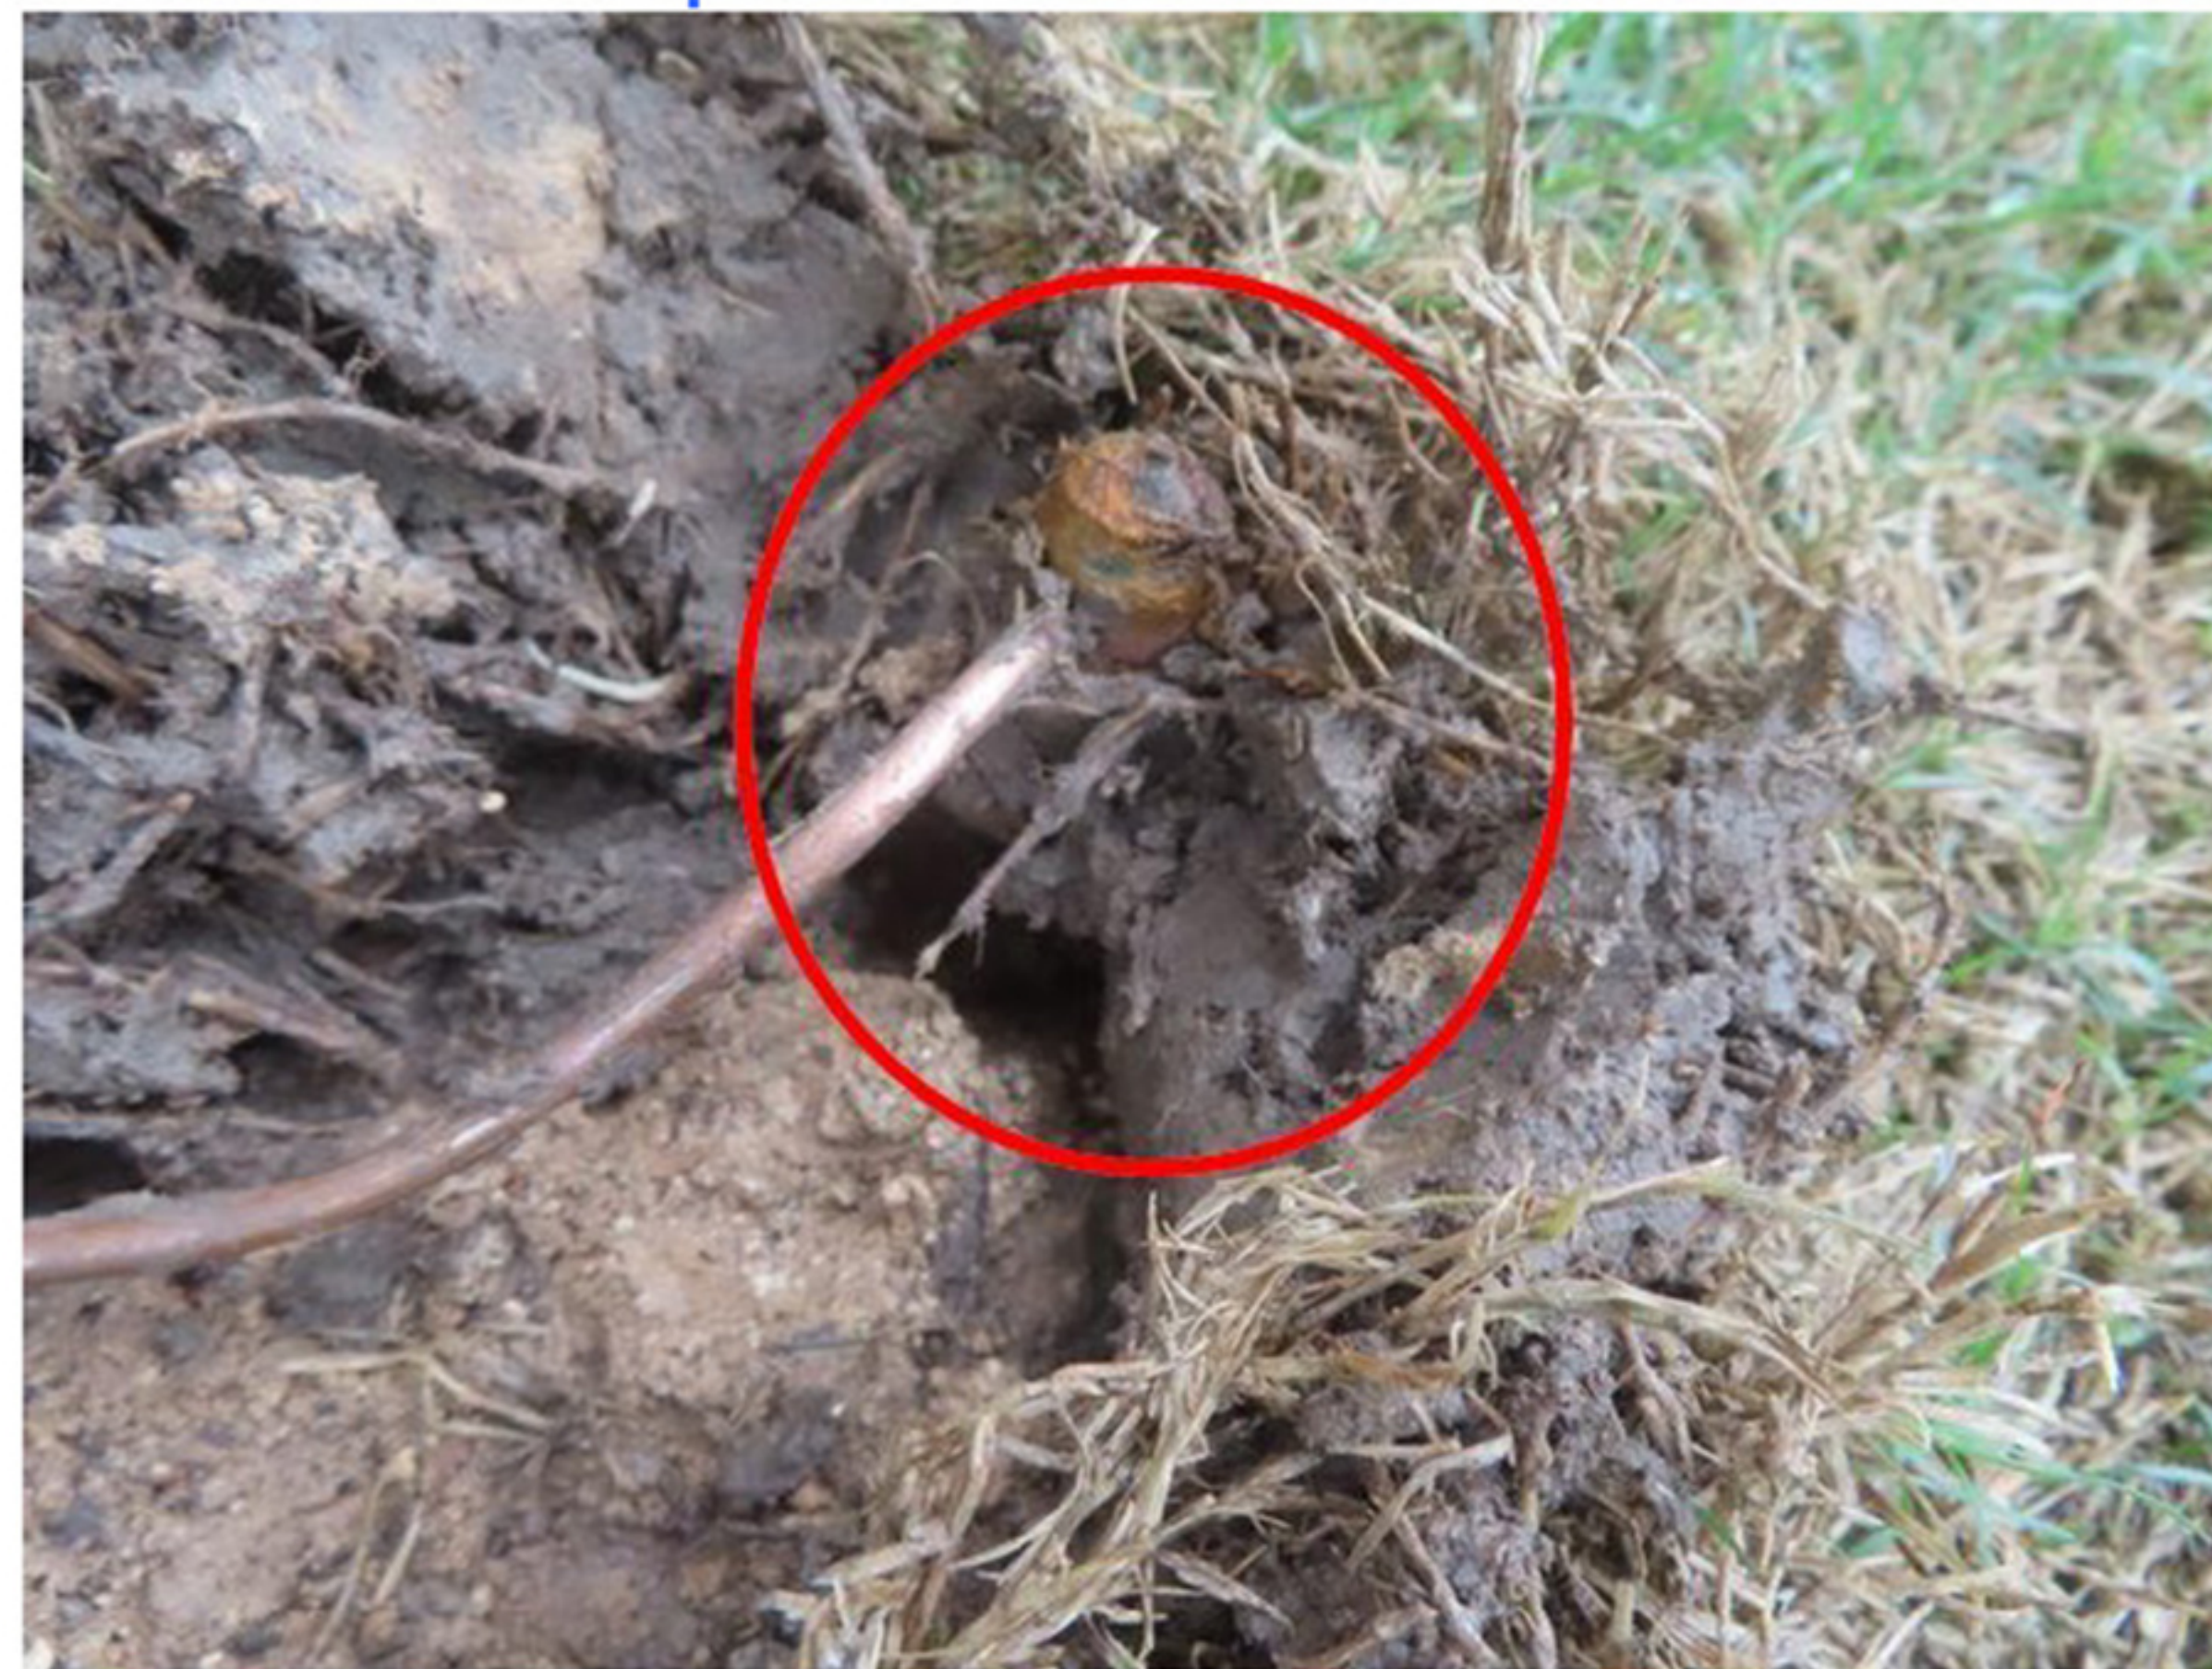
The grounding electrode is connected to the grounding rod improperly. Code requires the wire to be run under the acorn clam and be inserted from the bottom up, so it can't accidentally be pulled out from the top. This needs to be reinstalled the correct way.

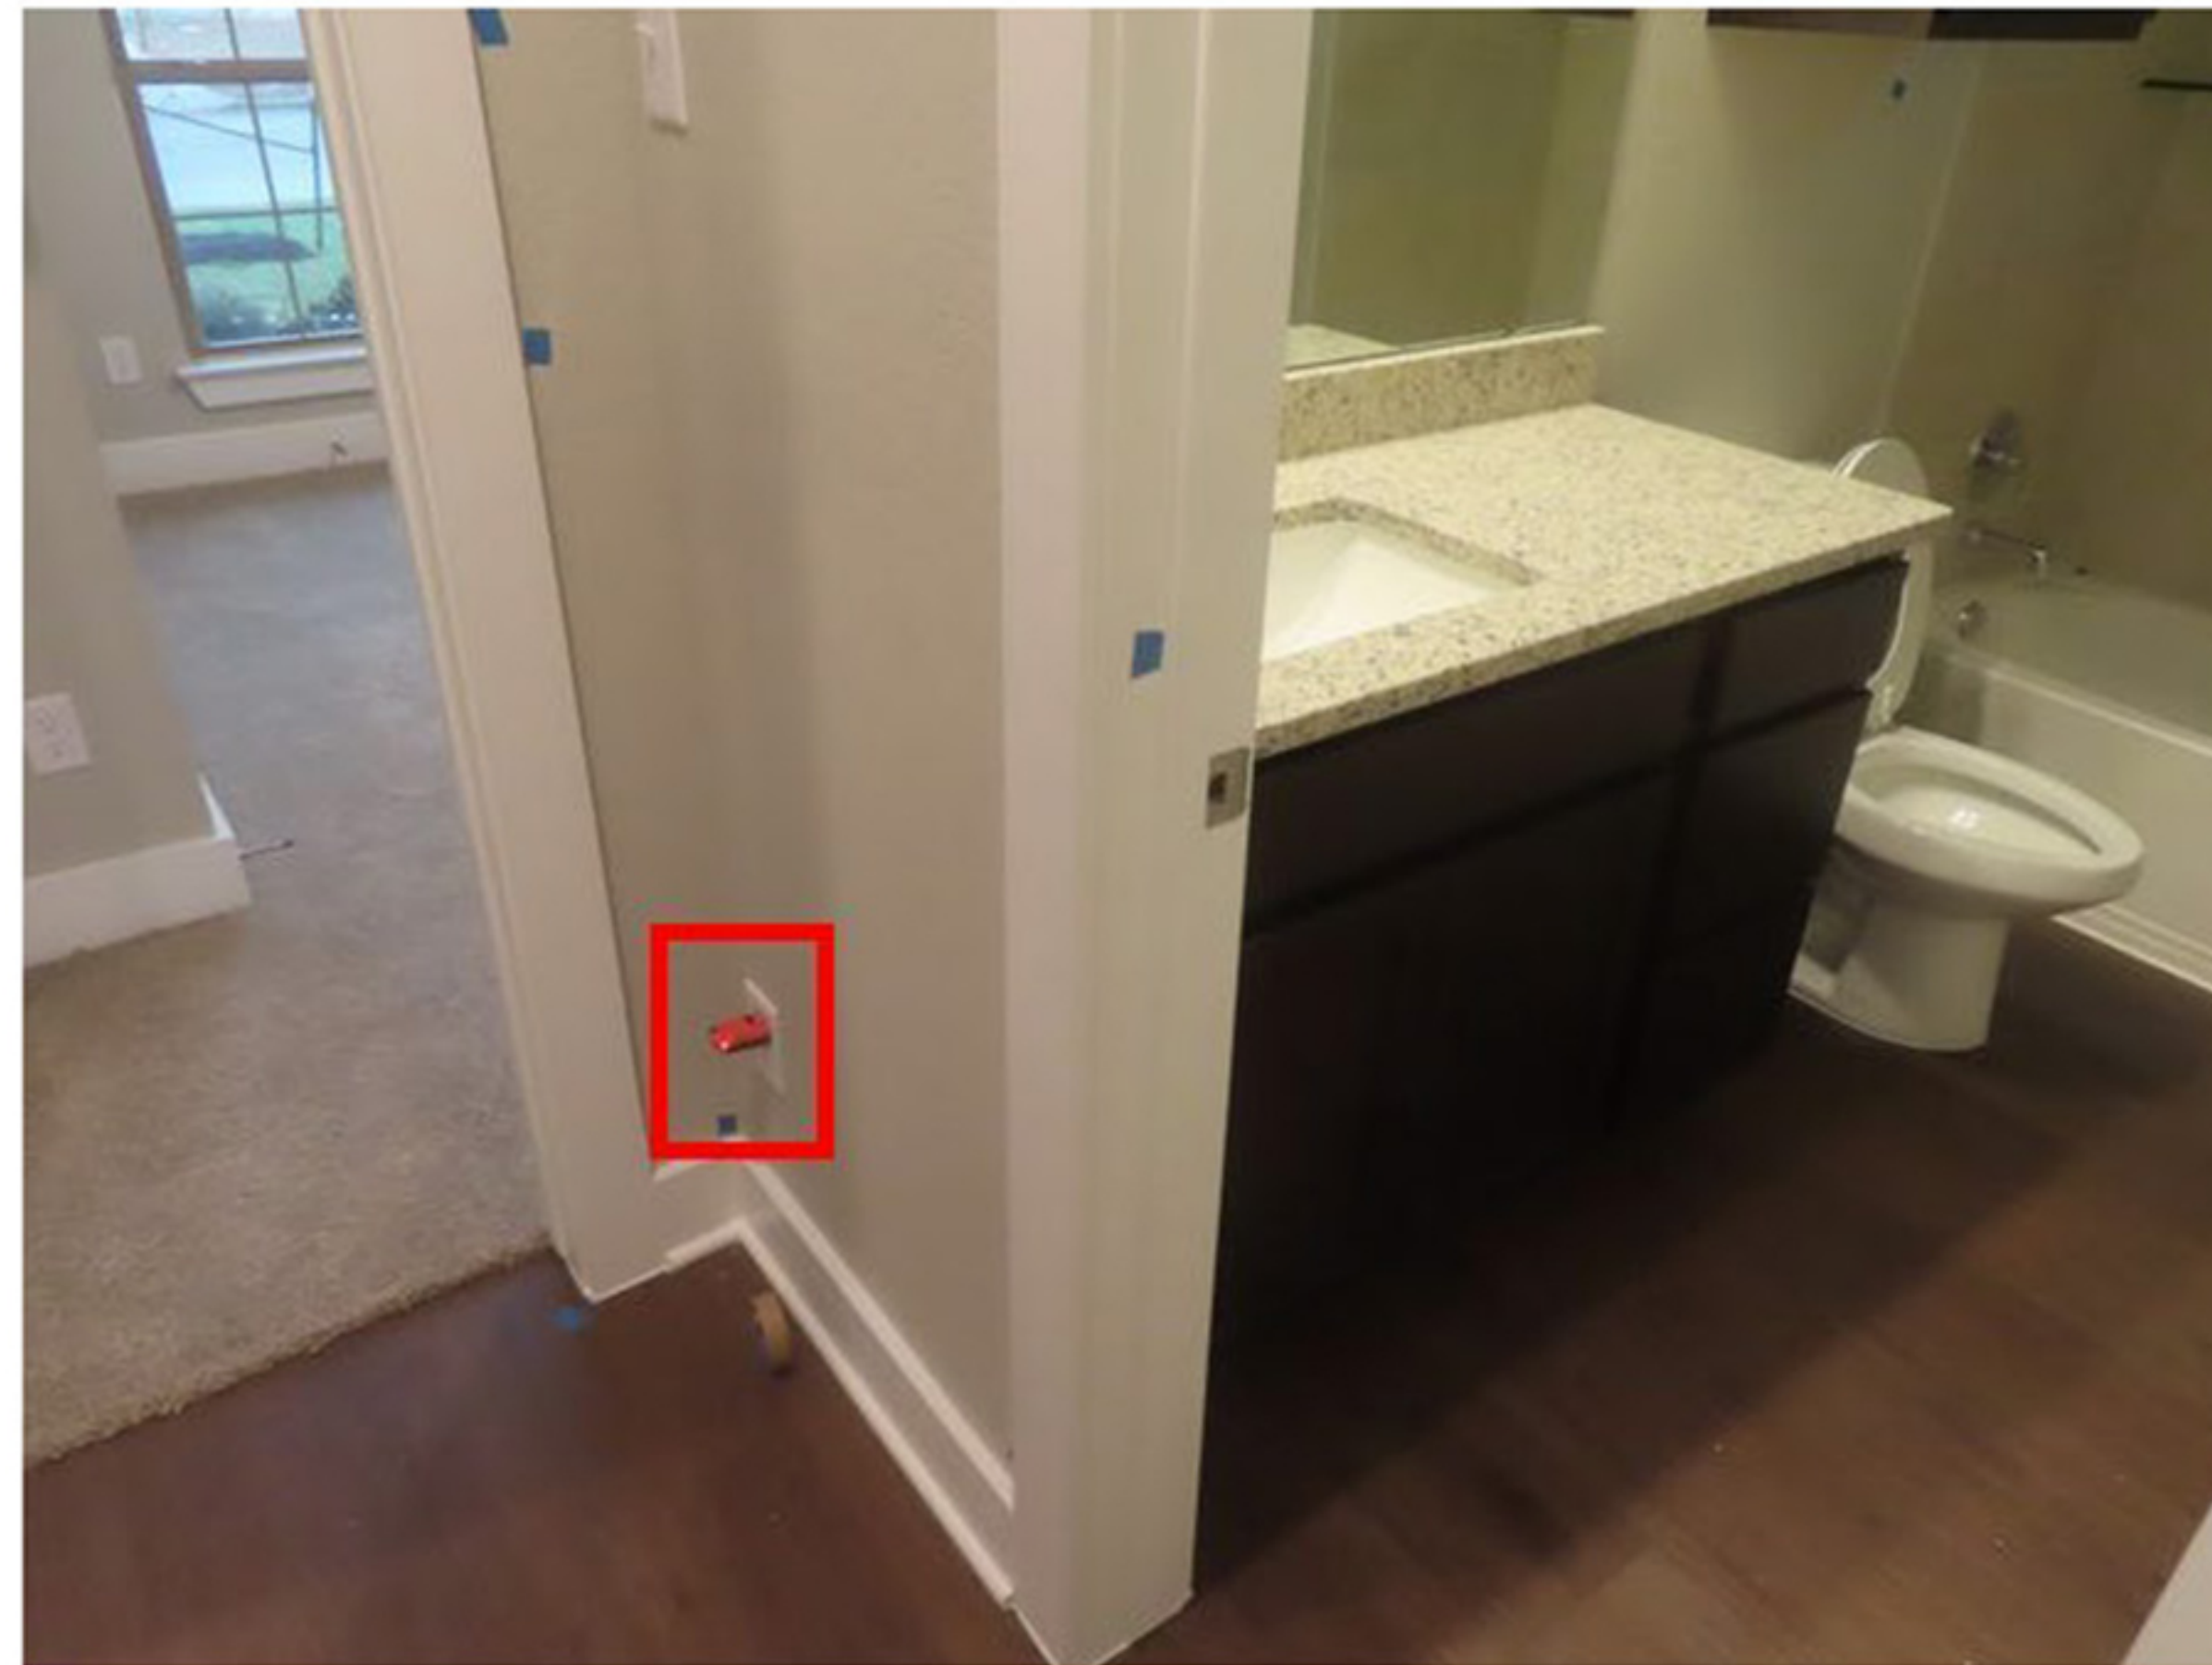
There is an electrical outlet receptacle in the hallway outside the downstairs bathroom that is within 6 feet of the sink. This outlet receptacle is missing the required ground-fault protection. It needs to be replaced with a GFCI outlet. This is a safety concern, because someone could be shocked without the circuit tripping due to a ground-fault. This needs to be addressed immediately.

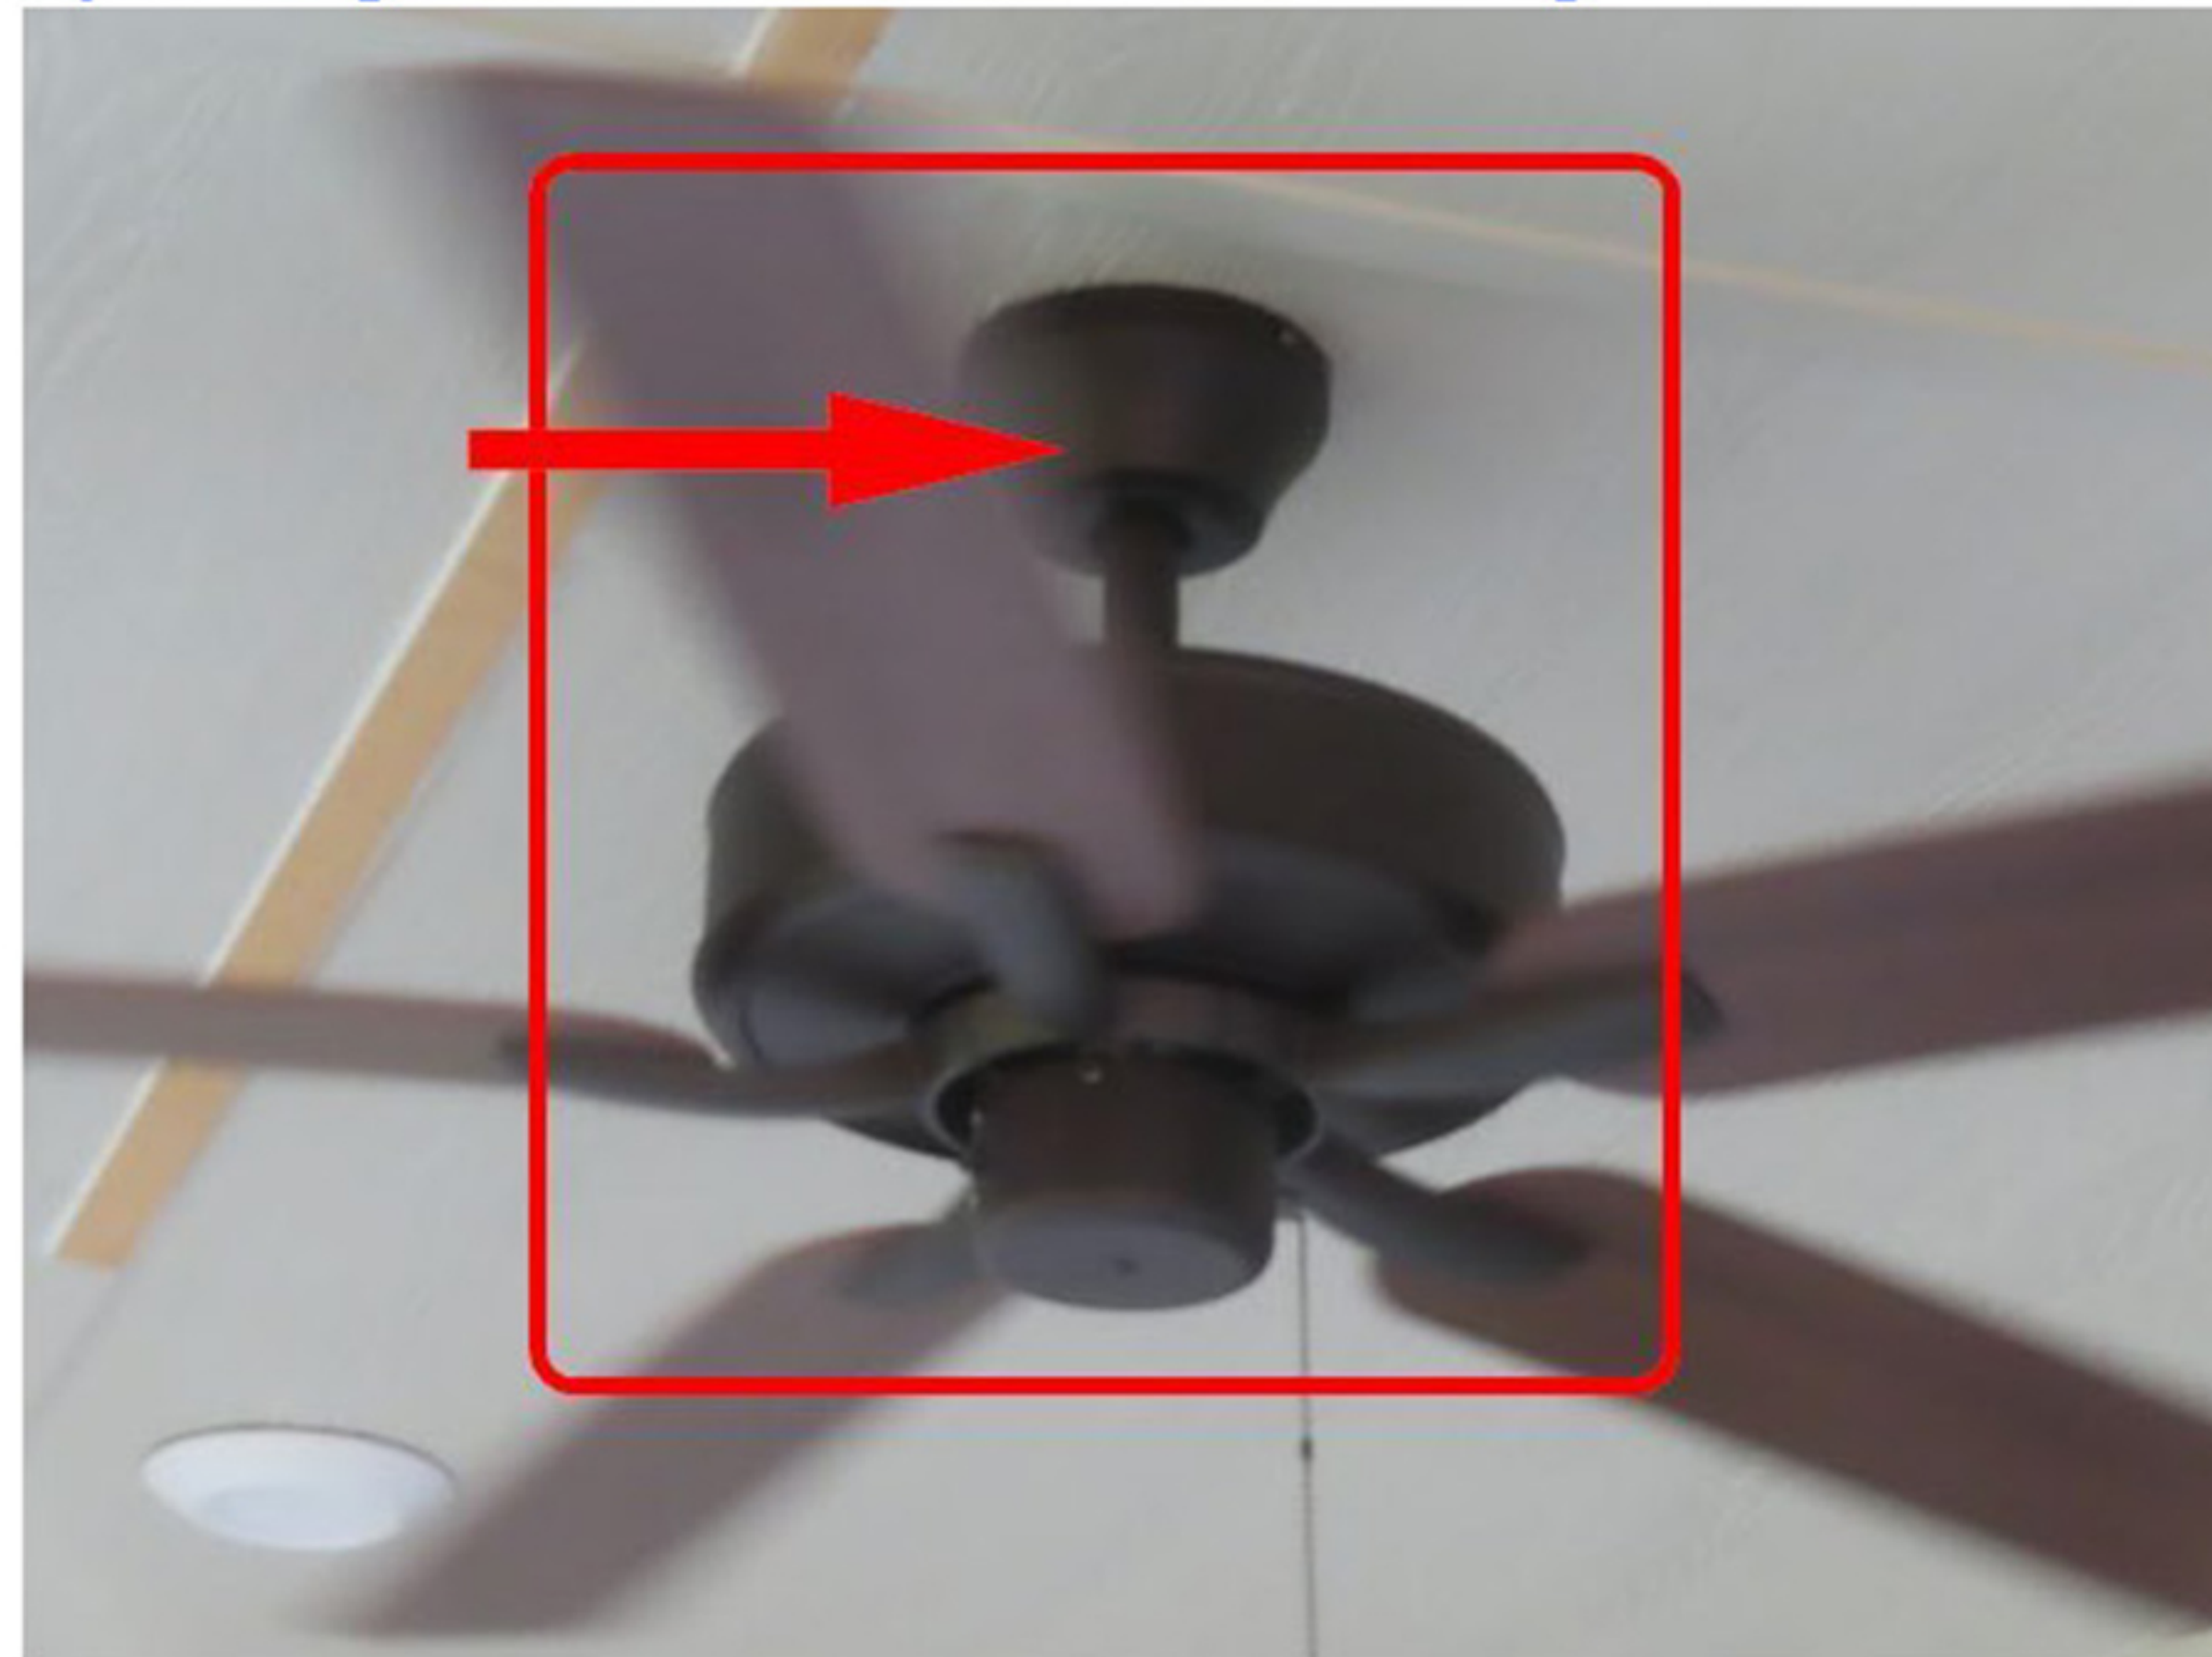
The right fan fixture on the rear porch was not mounted properly. It is shaking while the blades are spinning. The left fan is not moving at all while the blades are spinning.

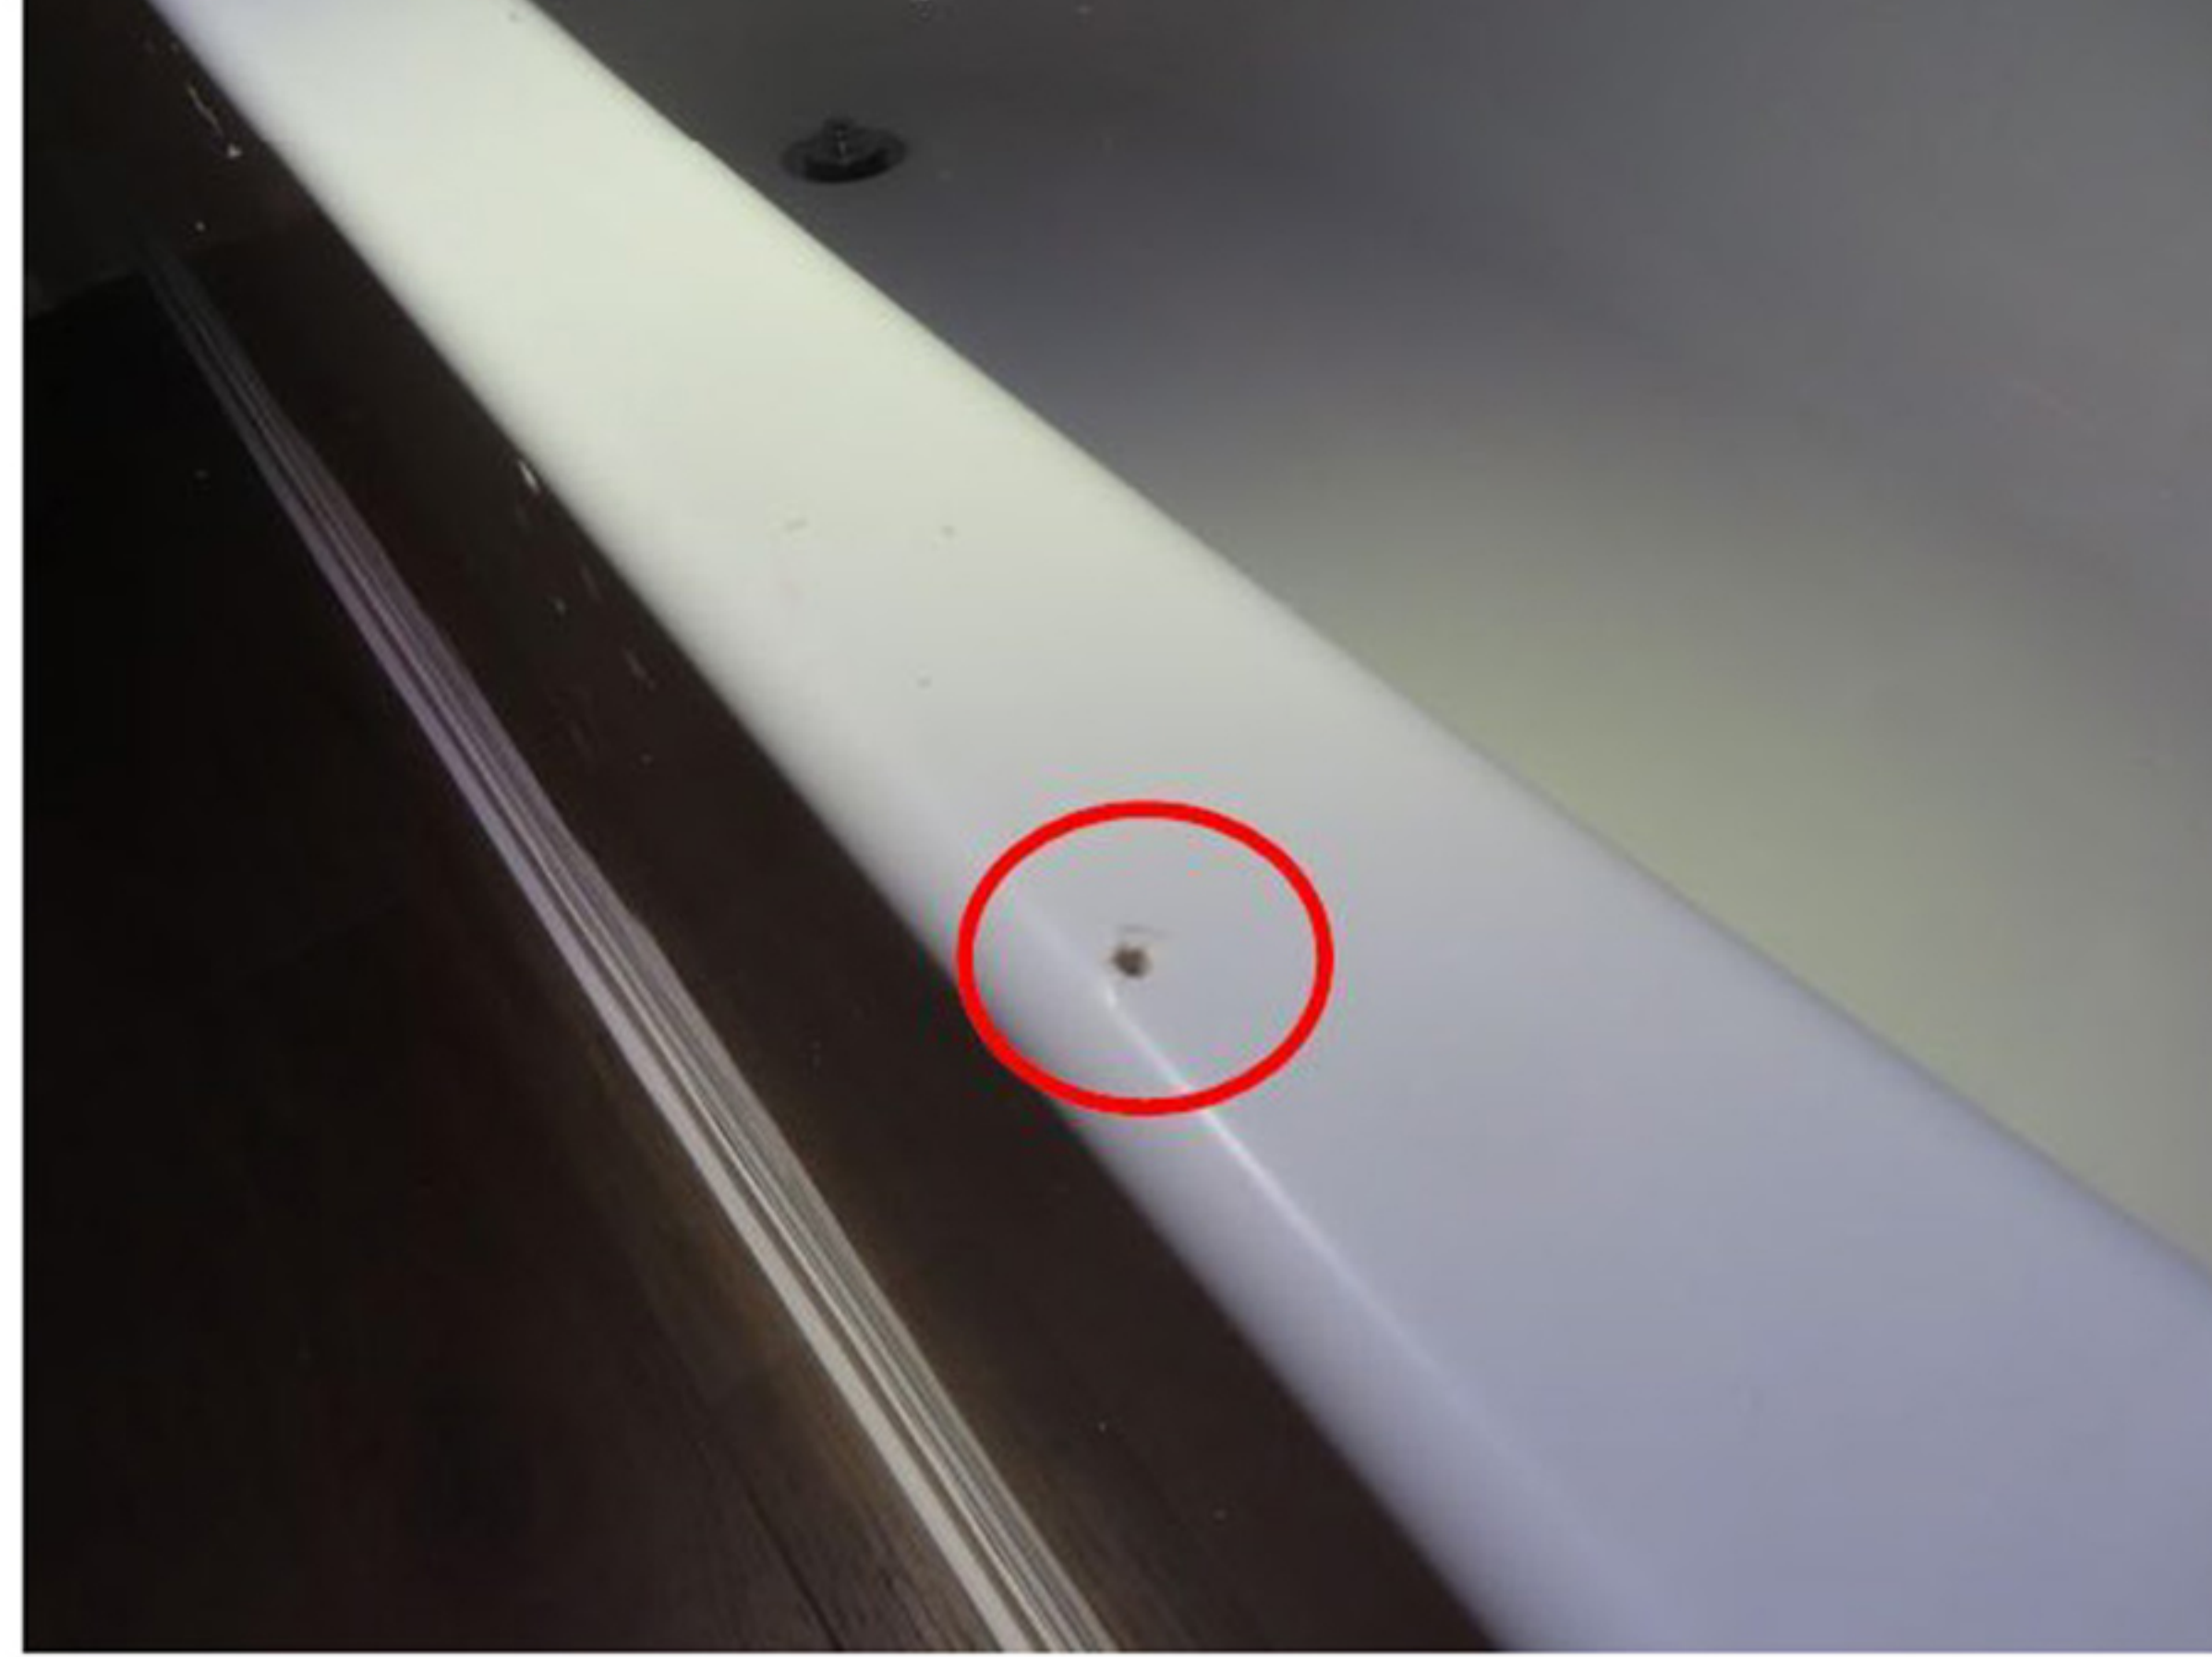
There is a chip in the downstairs hall bathroom's bathtub. This tub needs to be repaired/replaced.

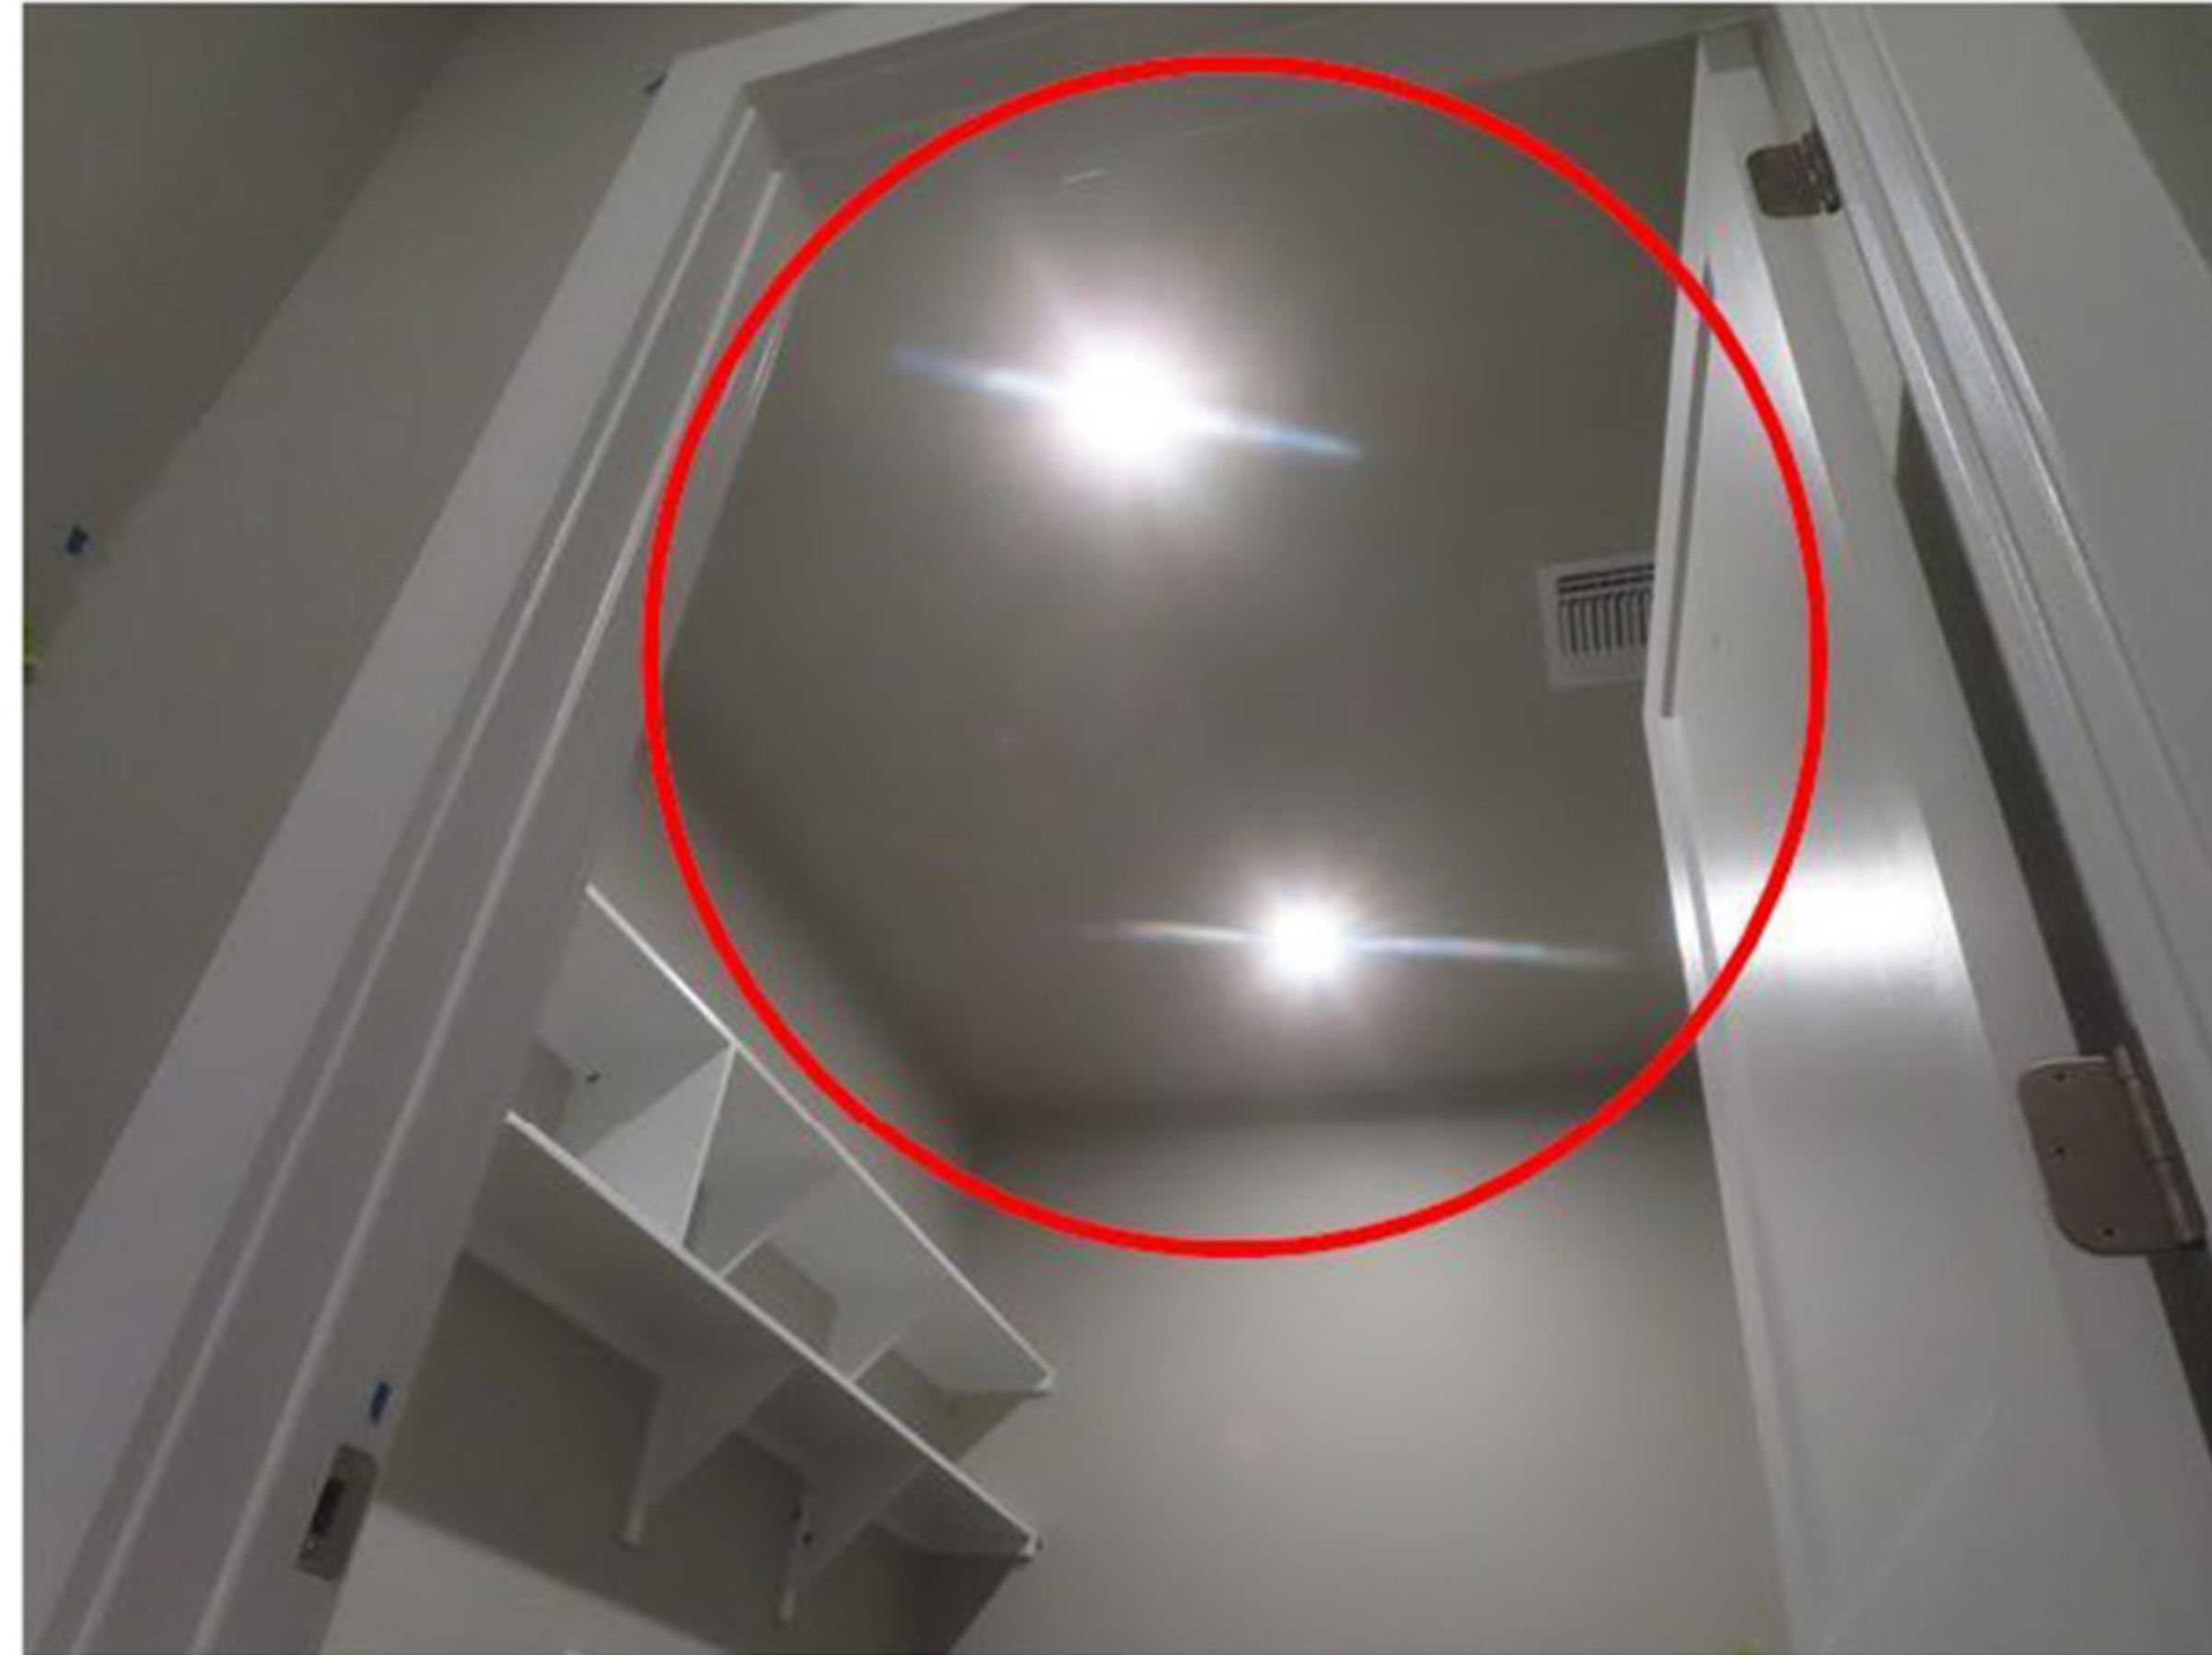
The required mechanical exhaust vent for the laundry room is missing. This is required, because it provides a way for any water vapors to be safely transmitted outside the house. A mechanical exhaust fan should be added to the laundry room. In some cities, local code supersedes the state code. If this is the case in Belton, I recommend the builder show the buyer that documentation.

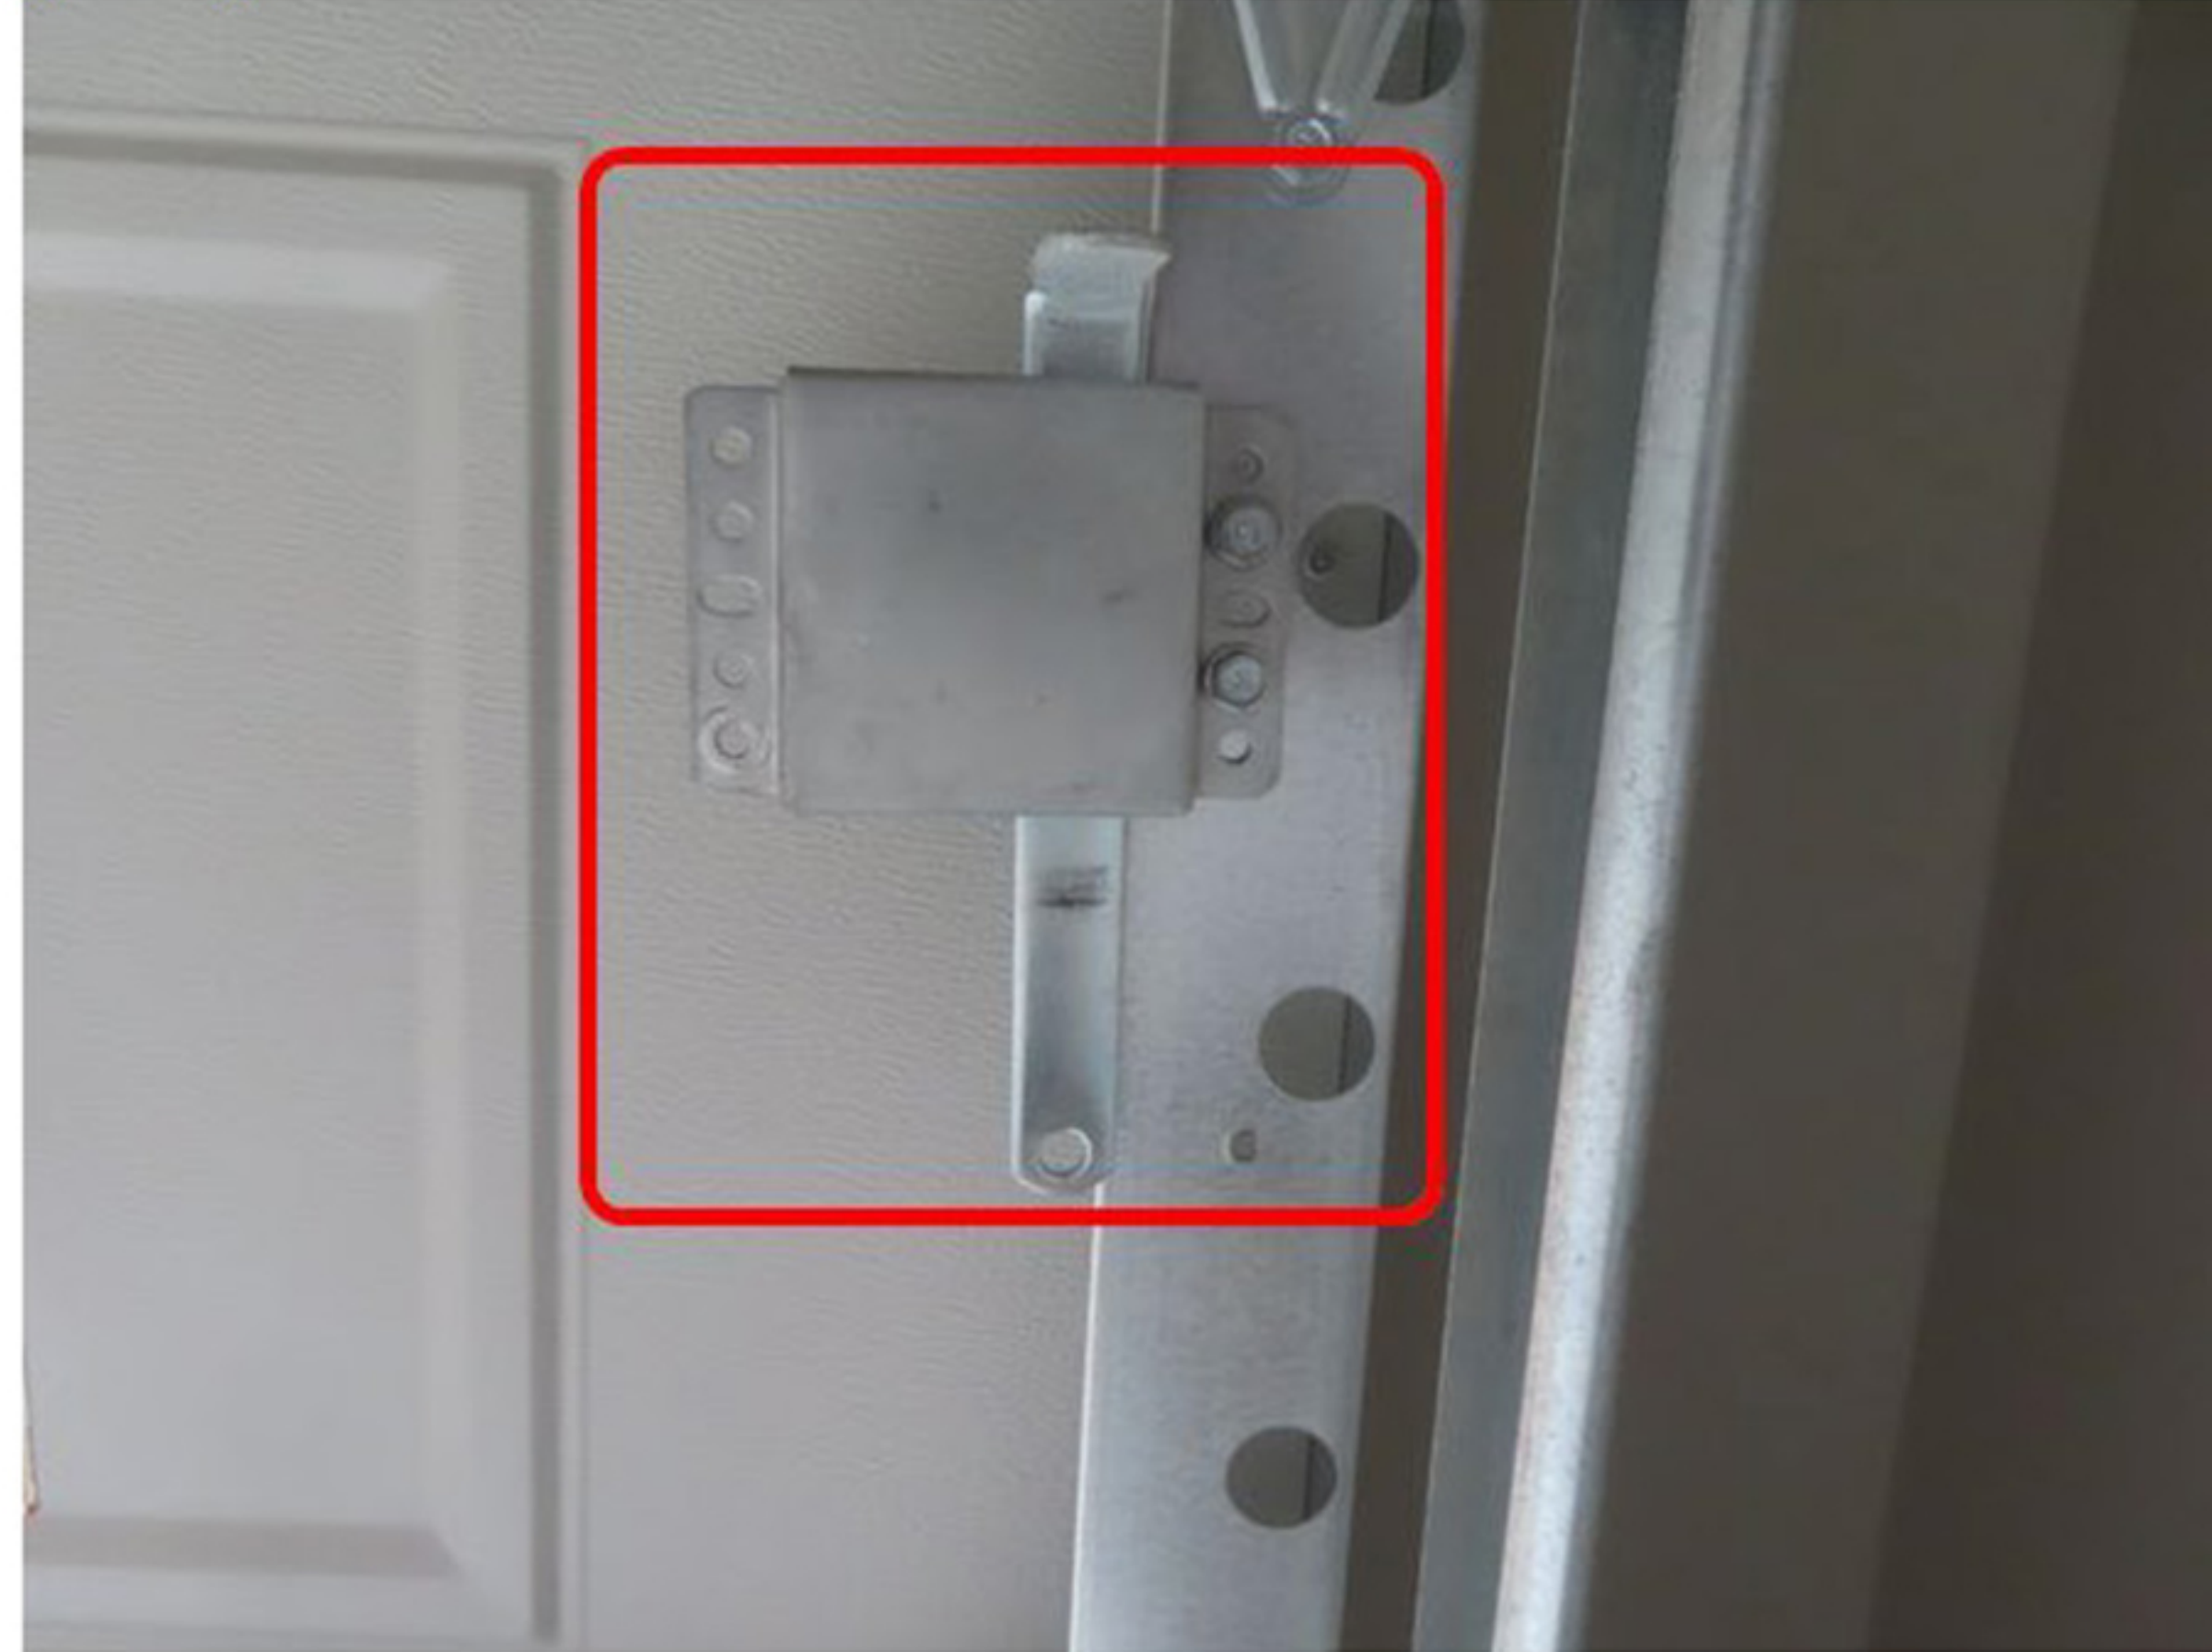
NOTE: The manual garage lock has been disabled, as code requires. However, this is usually done by inserting a bolt into the hole in the slide that will prevent it from operating. If this is ever going to be used, it will have to be removed and reinstalled in the correct, horizontal orientation.
