PROFESSIONAL HOME
INSEPTION REPORT

Inspector: **Shane Zimmerman**

License#: **24563**

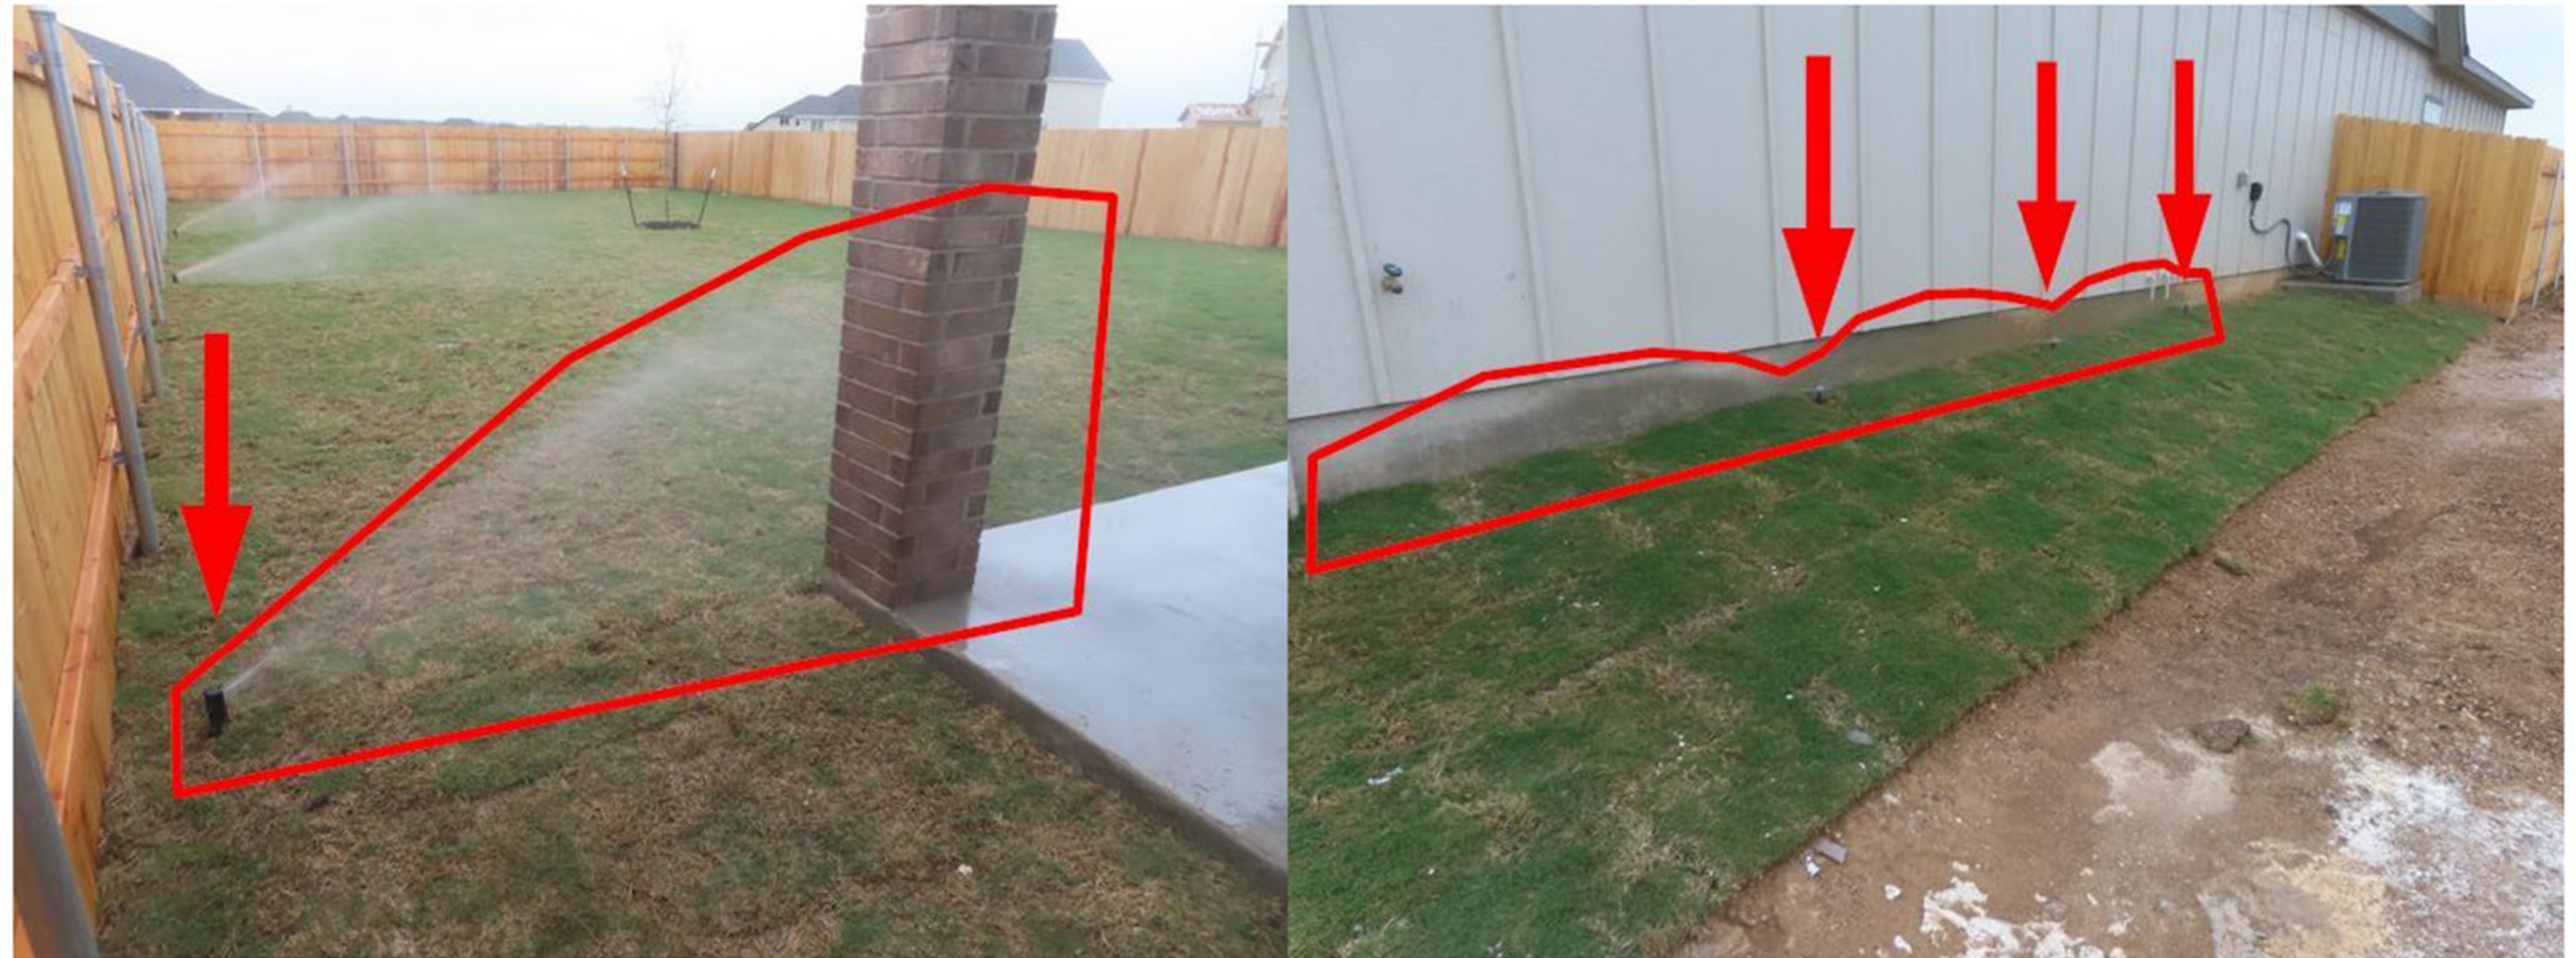
When brick siding, stone siding, or a concrete foundation are repeatedly sprayed with water, they can become over-saturated and form cracks. There are one or more heads in zones 4 & 7 which are partially directed towards the house. These heads need to be adjusted immediately, so they no longer spray the house.

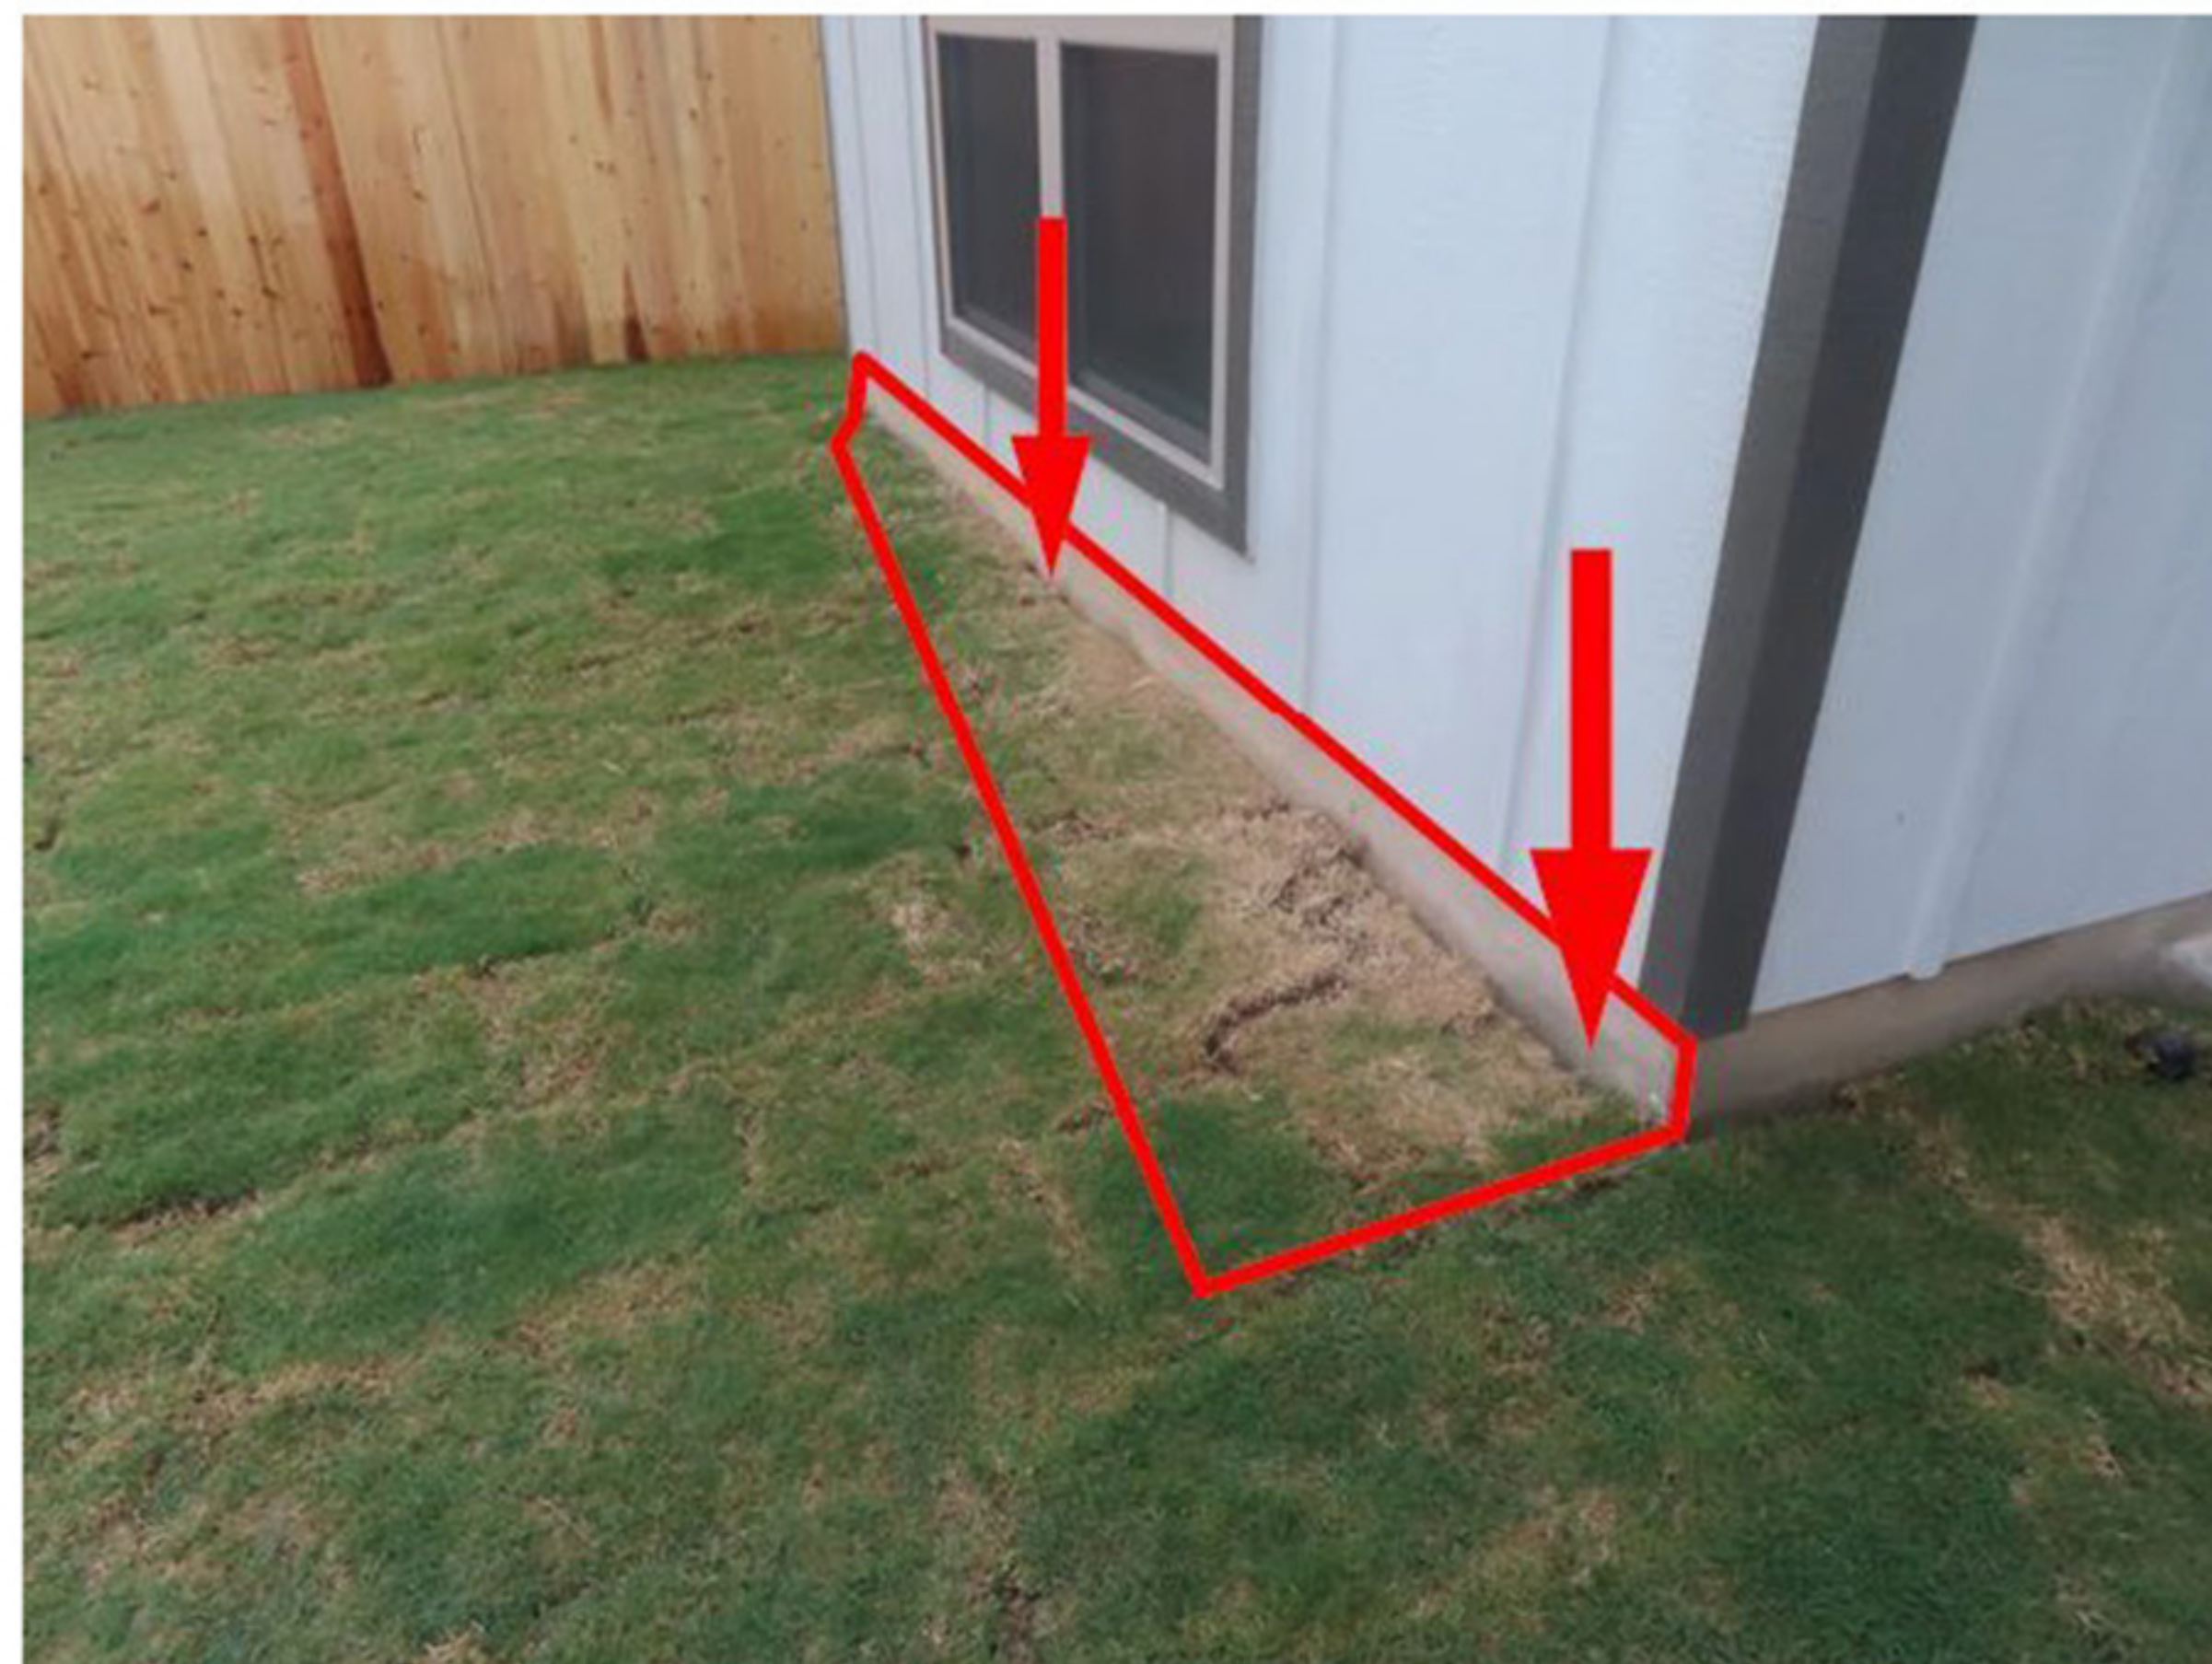
There is an area of the backyard that is not being sprayed by any of the heads in this system. This grass is already more brown than the surrounding grass and will die unless the irrigation system is changed. Now, because we don't want this area of the house and foundation to be over-saturated, simply adjusting the heads in this area will not suffice. A new head needs to be added. I recommend tying it into zone 6 and put it either directly under the center of the master bedroom window or at the rear corner of the master bedroom closest to the rear porch.
