PRE-DRYWALL  
INSEPTION REPORT

Inspector: **Shane Zimmerman**

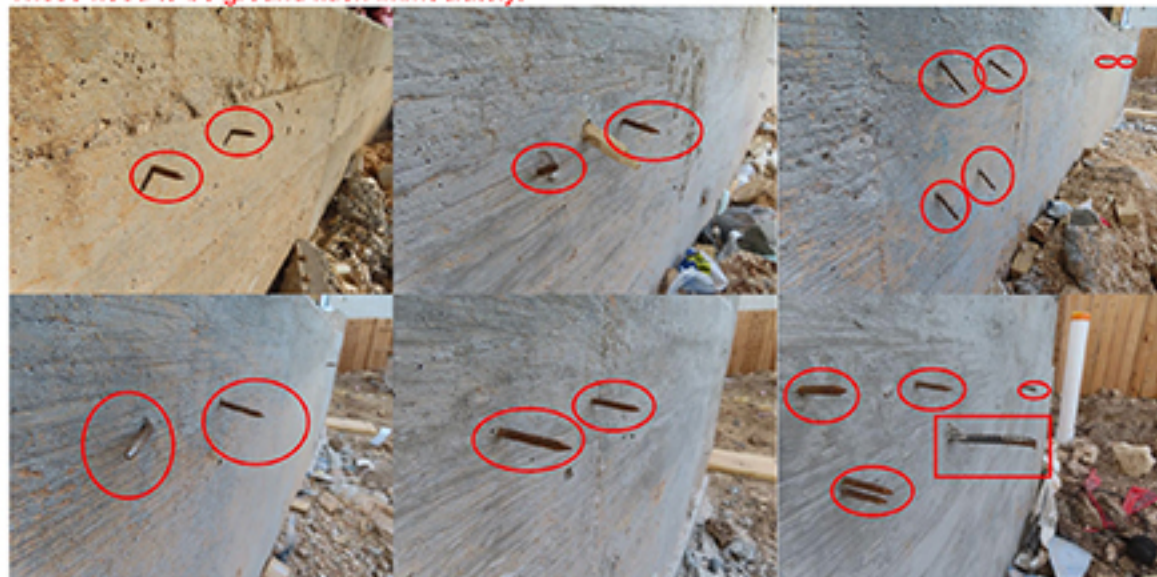
There are nails sticking out of the foundation throughout that need to be ground flush with the foundation. This is a safety concern, because someone walking near the foundation can accidentally rub against it or kick it and be seriously injured. These need to be ground flush immediately.

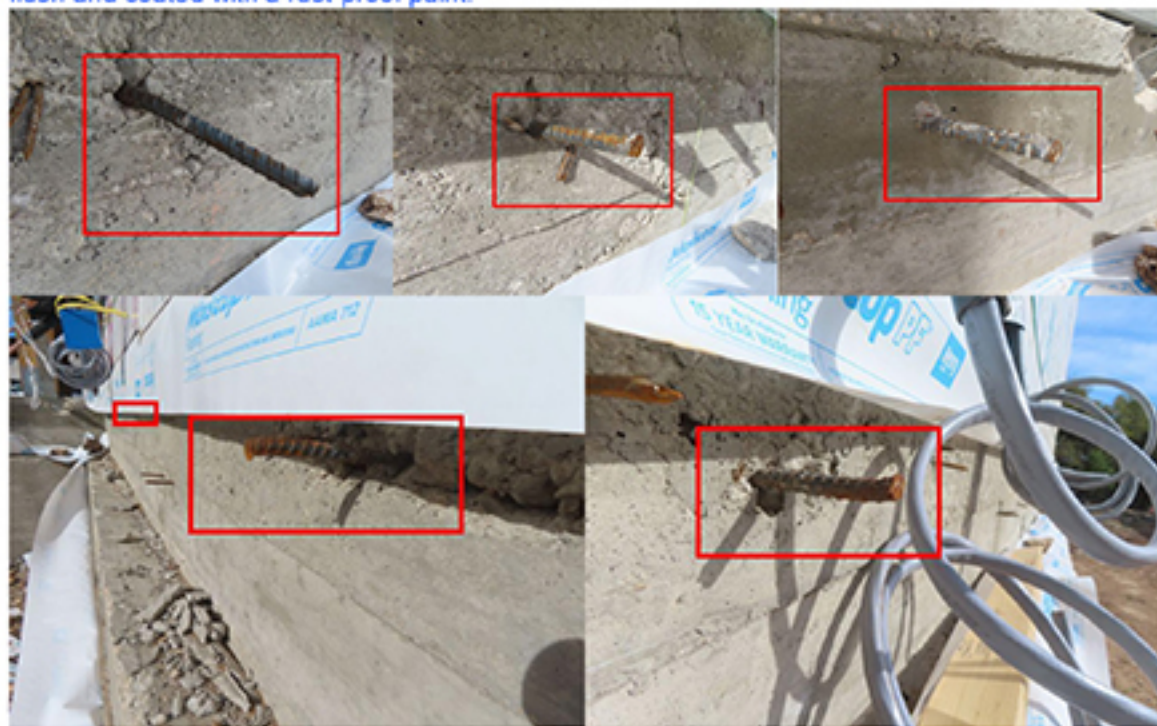
There is rebar sticking out of the foundation throughout. This rebar, if not tied into something else, needs to be ground flush and coated with a rust-proof paint.

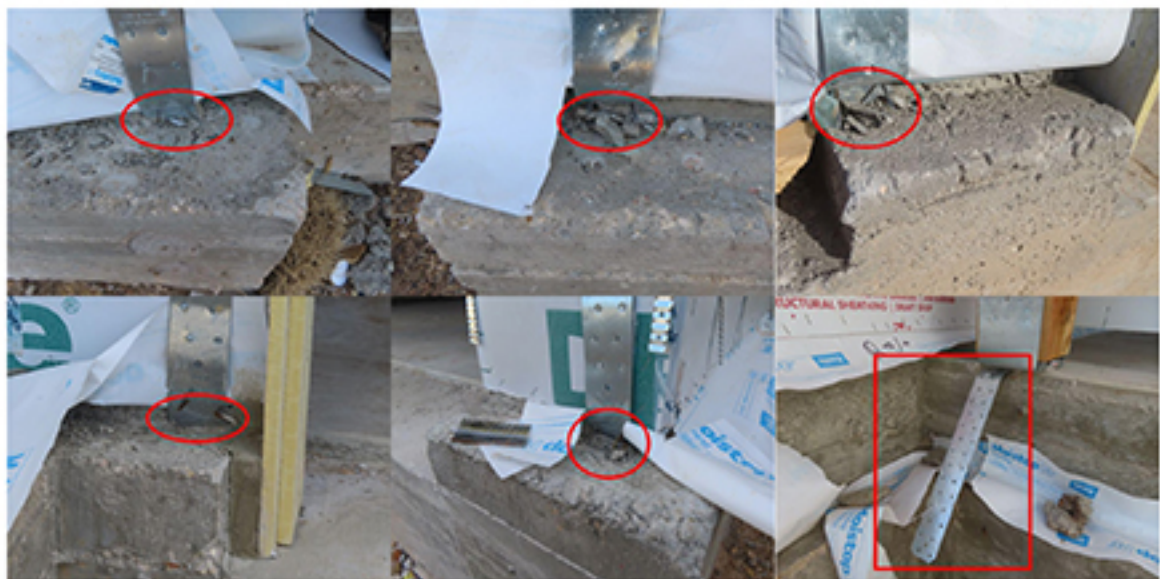
The bottom of the anchor strapping throughout has nails sticking out that will prevent the proper installation of the brick/stone siding. These nails need to be ground flush before proceeding with the siding. Also, the anchor strapping at the rear side of the breeze way needs to be removed. There is one at the base of both of the rear pillars serving the breeze way.

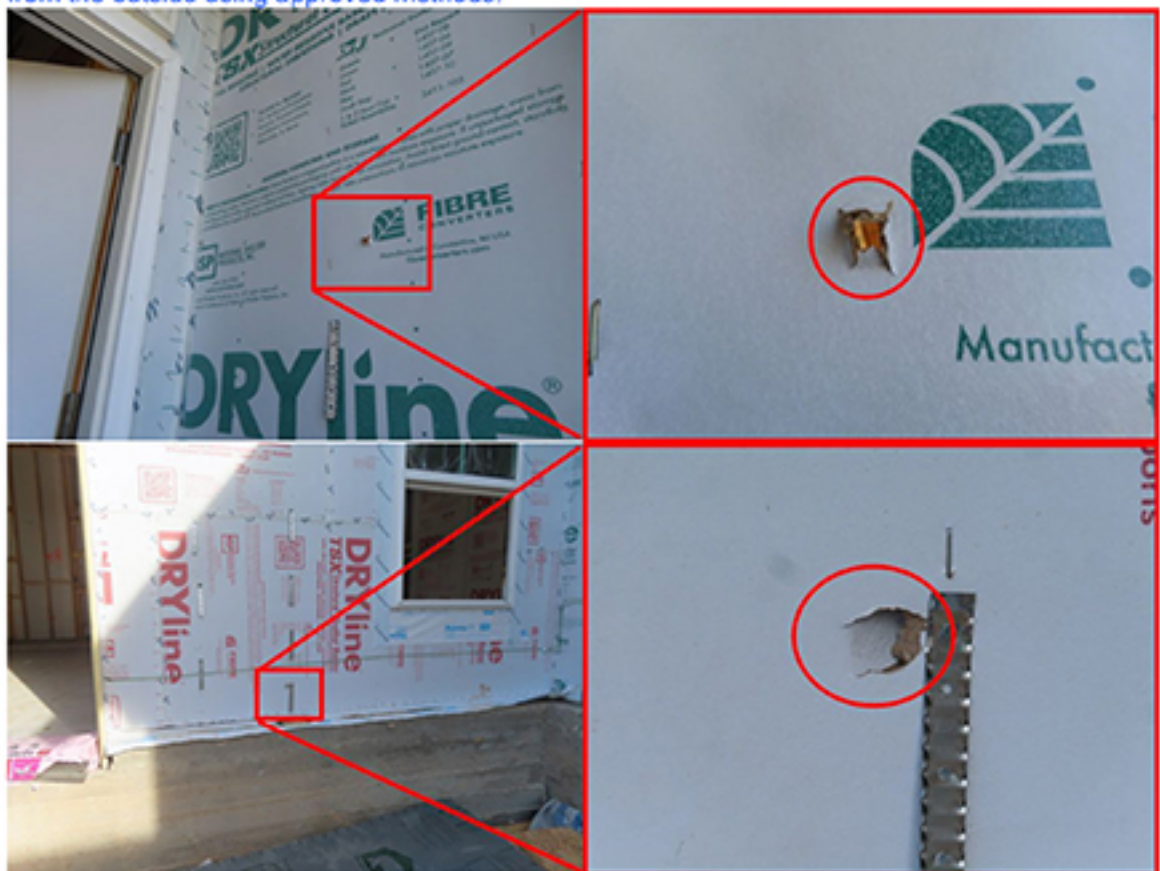
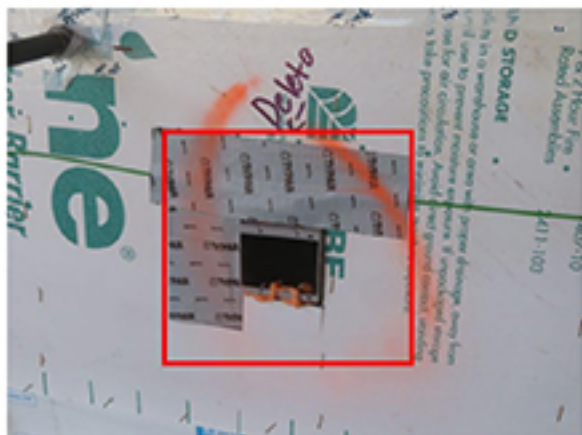
There is a hole in the vapor barrier on the right side of the front porch area. There is also a hole on the right wall of the far-left garage, near what appears to be the guest bedroom. Also, there is a box on the rear porch that is no longer going to be used, which leaves a large hole in the vapor barrier at this location. All of the holes in the vapor barrier need to be sealed from the outside using approved methods.

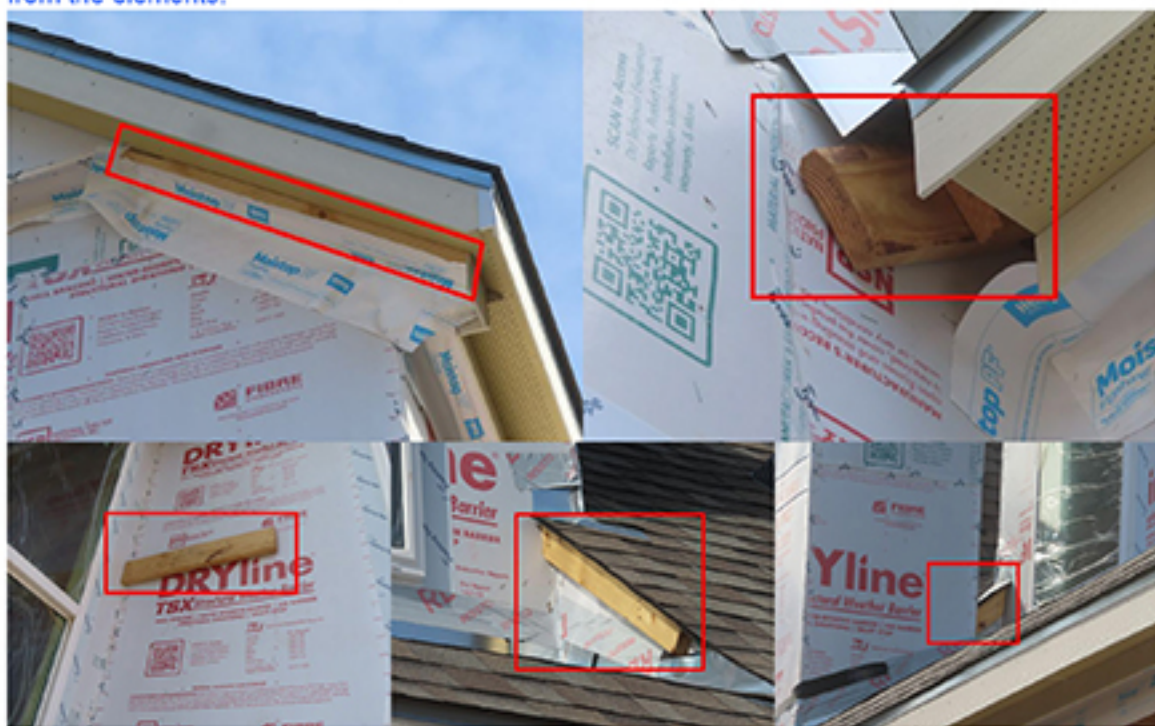
There is exposed wood outside the vapor barrier in 4 locations: above the far-left garage near the soffit, on the front of the house at the left corner above the two garage section of the house (near the soffit), on the rear of the house half-way up the wall, and above the rear porch (both sides) This exposed wood needs to be wrapped/taped to ensure it's protected from the elements.

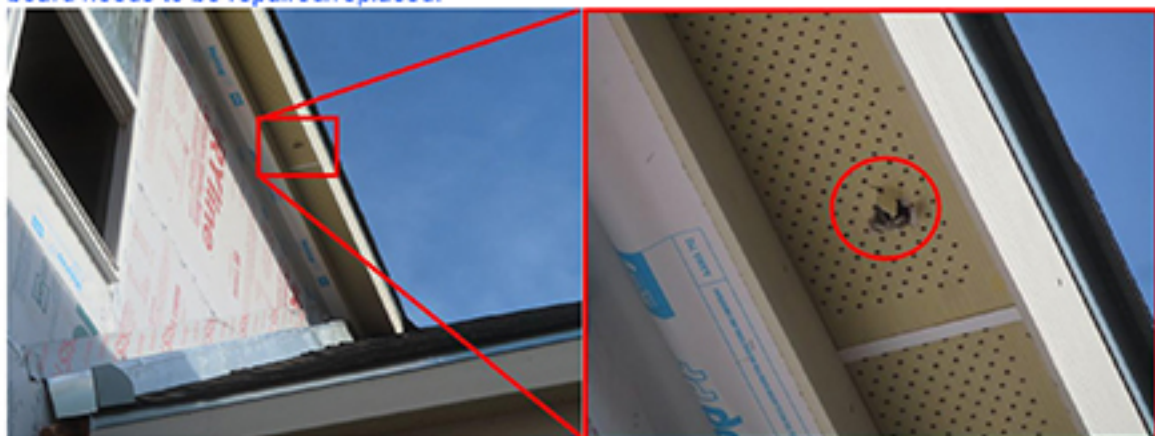
There is a hole in the soffit on the right side of the upstairs soffit. This is close to the rear upstairs bedroom. This soffit board needs to be repaired/replaced.

possibly missing lintel above front porch entryway.

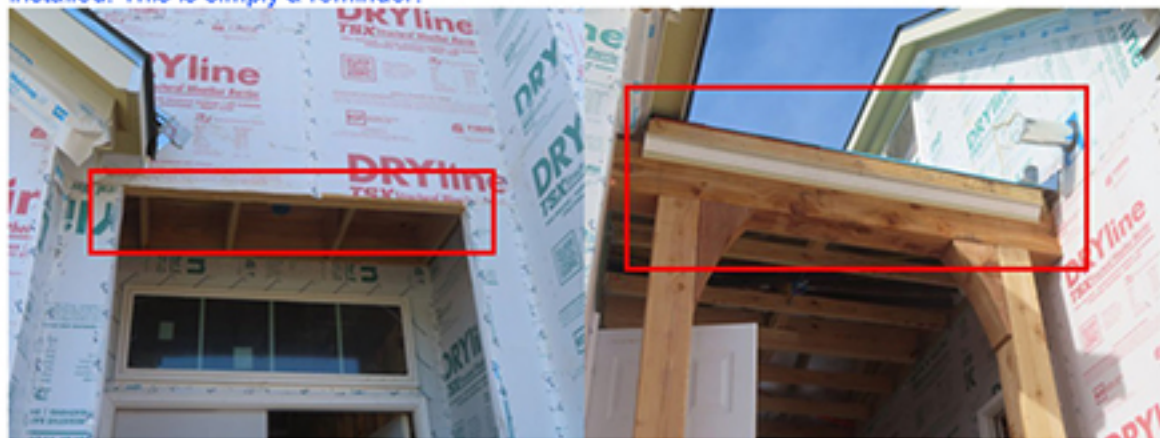
Missing fascia board on rear of breeze way. The builder was most likely planning on putting this in after the metal roof was installed. This is simply a reminder.

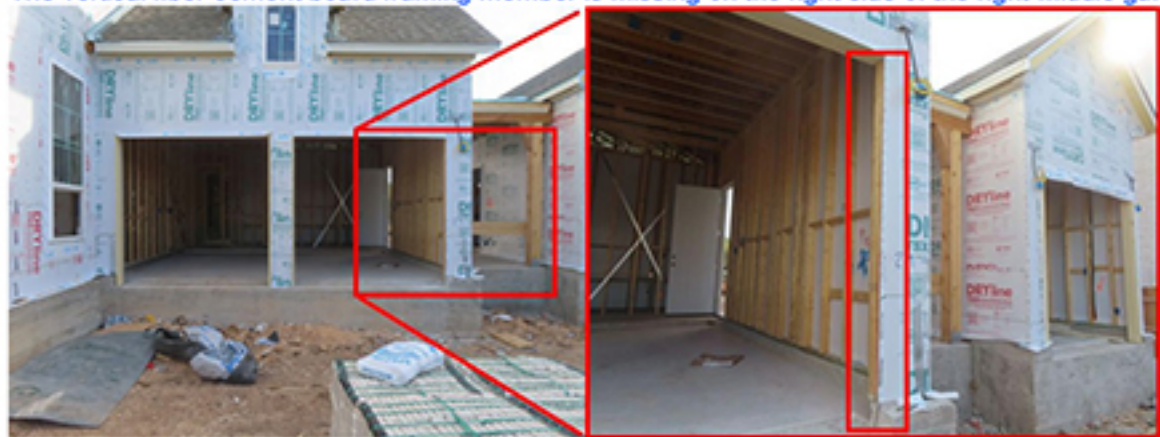
The vertical fiber-cement board framing member is missing on the right side of the right-middle garage car doorframe.

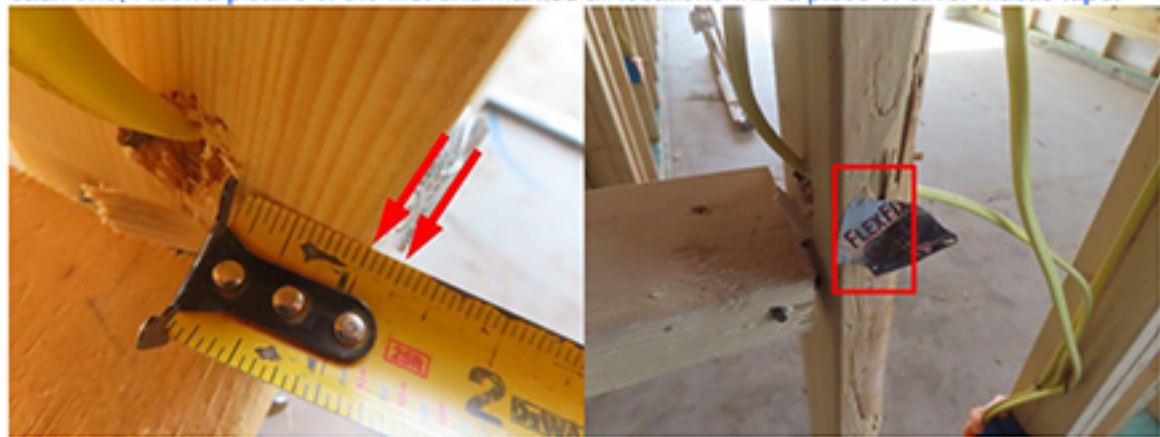
There were about 30 nail plates that were missing from the studs throughout the house. Rather than taking a picture of each one, I took a picture of the first and marked all locations with a piece of silver mastic tape.

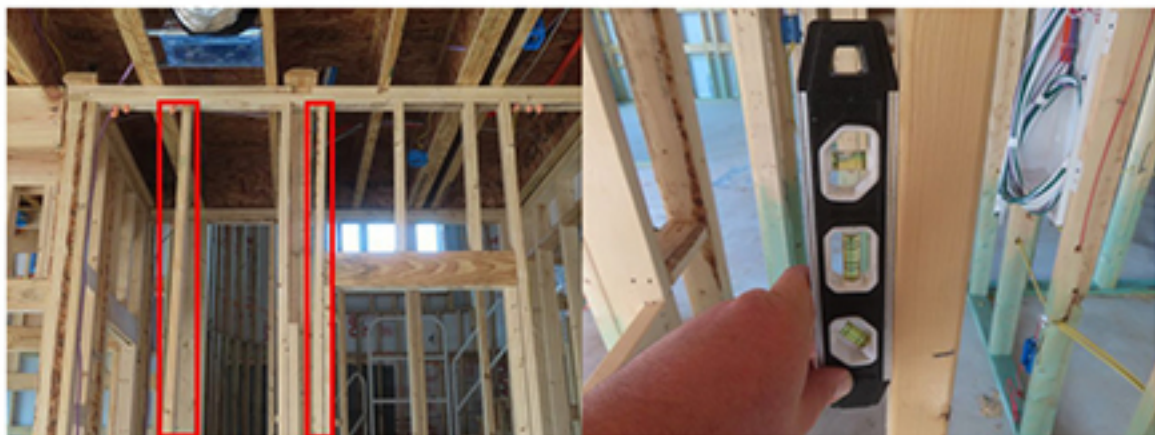
There are two studs on the left wall of the guest bedroom that are not upright. They are not level, being off several inches at the top from where they start at the bottom. The two boards are shown in the first image. The second image simply shows that they are not level.

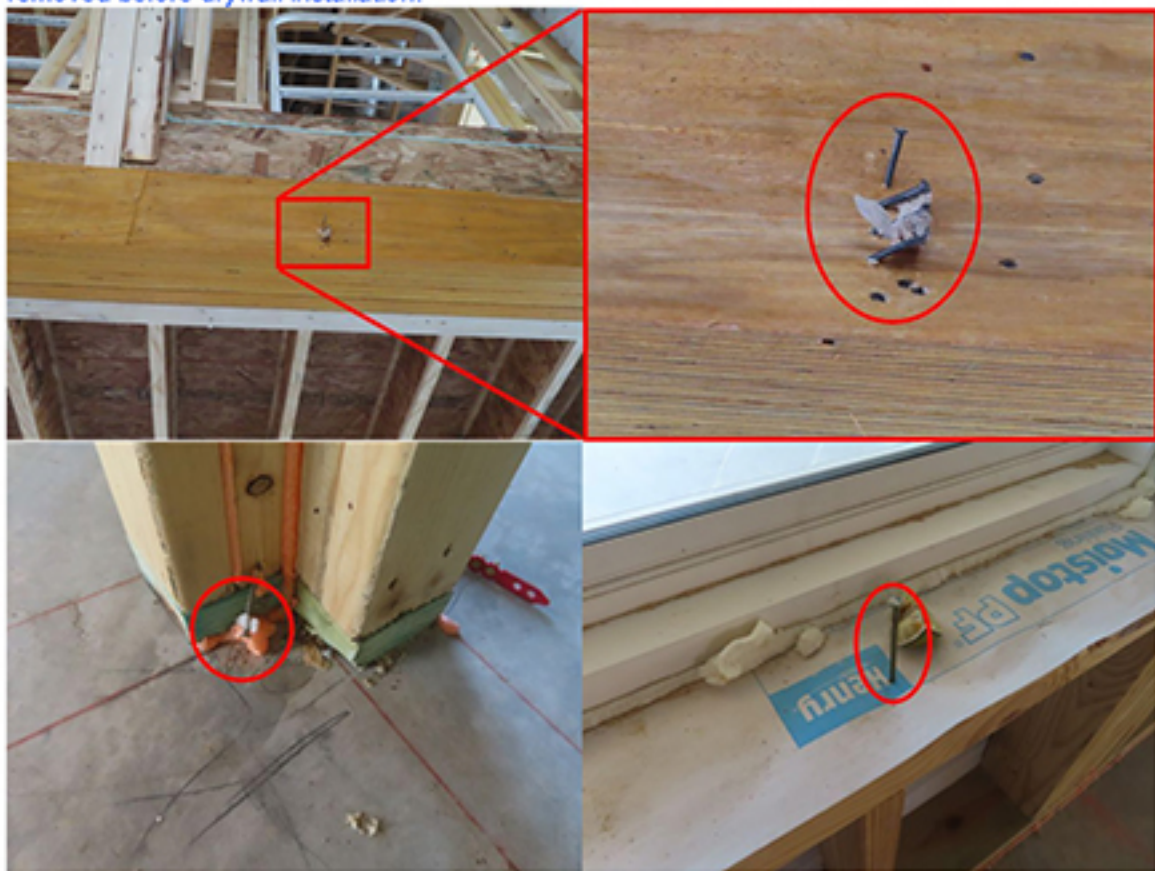
There are nails sticking out of the beam in the living room. There is a nail sticking out of the bottom plate near the laundry room doorframe. There is a nail sticking out of the middle-right window sill in the living room. These nails need to be removed before drywall installation.

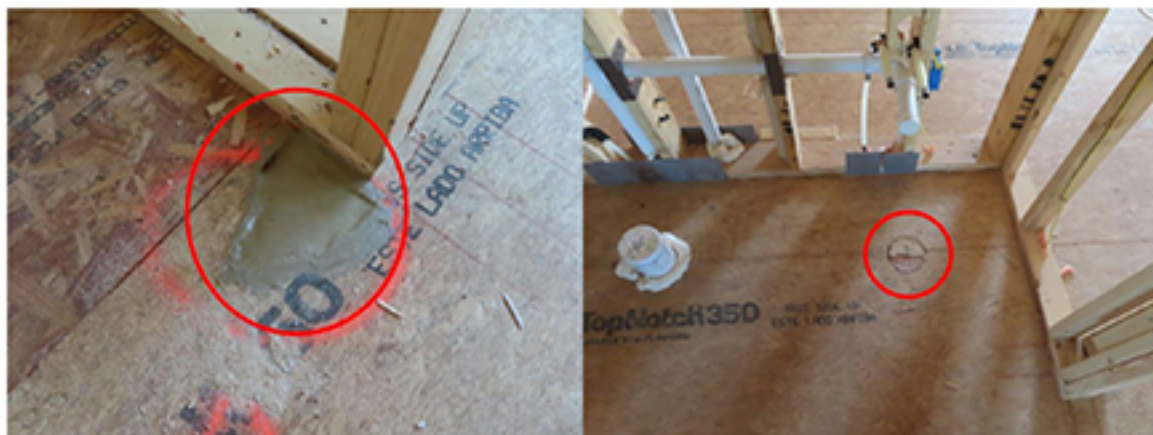
While I was on the second floor, I noticed a hole in the game room floor that has been filled, but it is still not solid. This needs to be properly repaired to ensure nobody falls through the floor in the future.

The hole for the toilet plumbing in the upstairs half-bath was cut in the wrong location. This hole needs to be sealed to ensure proper fire-stopping.

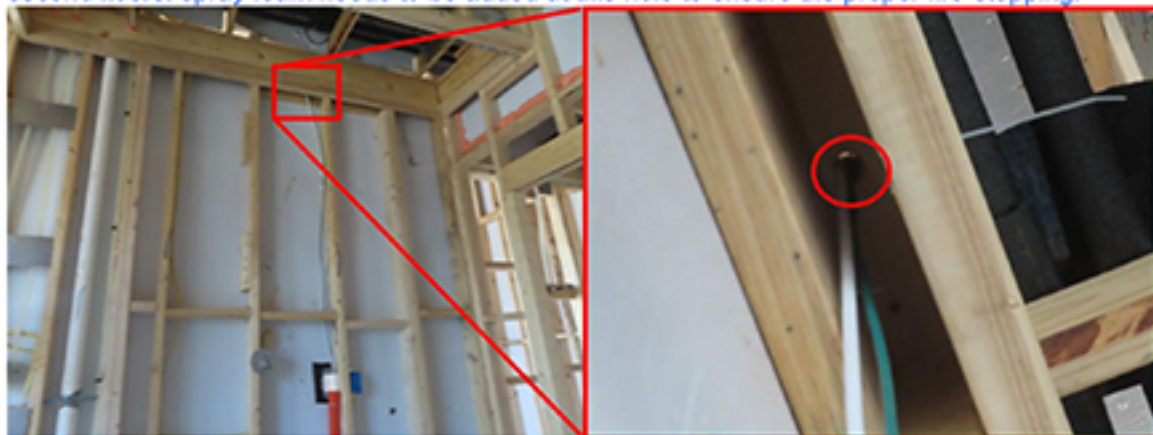
There are white and green wires in the master bathroom that are missing the required fire-stopping between the first and second floors. spray foam needs to be added at this hole to ensure the proper fire-stopping.

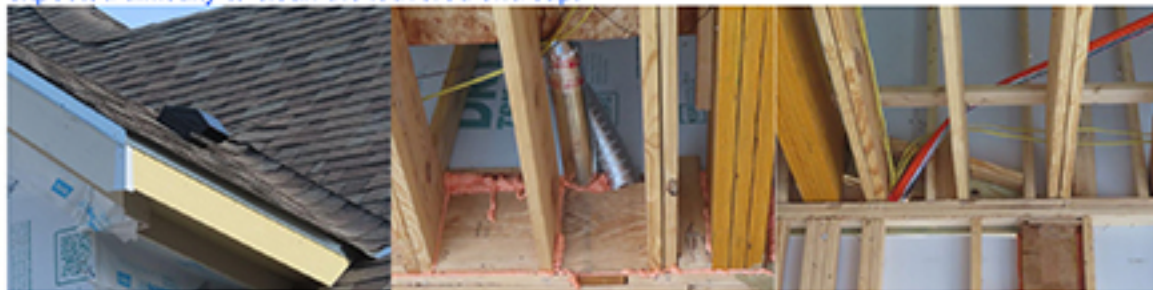
NOTE: This is not a deficiency. The dryer exhaust vent is currently terminated on the roof on the right side of a dormer above the two garage section of the house. This would be extremely difficult to clean out. I recommend not routing the ducting up and out through the roof. Rather than that, I recommend extending the ducting strait from one side of the garage to the other, and have it terminate on the wall, above the breeze way. This is only recommended, due to the expected difficulty to clean the louvered end cap.

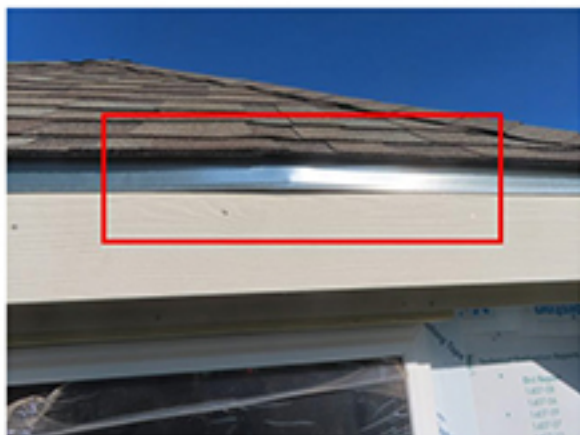
The drip ledge on above the breeze way is damaged and needs to be replaced.

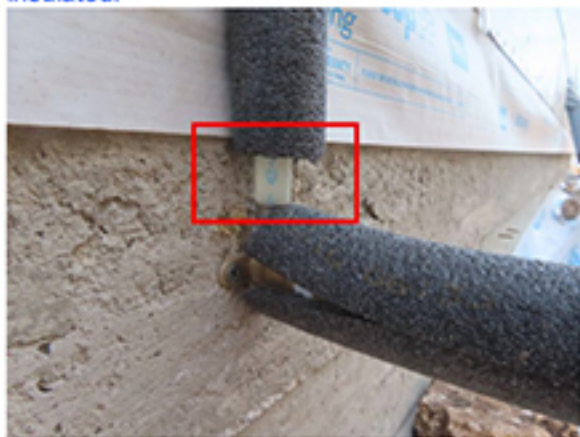
The PEX tubing on the far-right side of the house is missing a small section of insulation. This is required to be fully insulated.

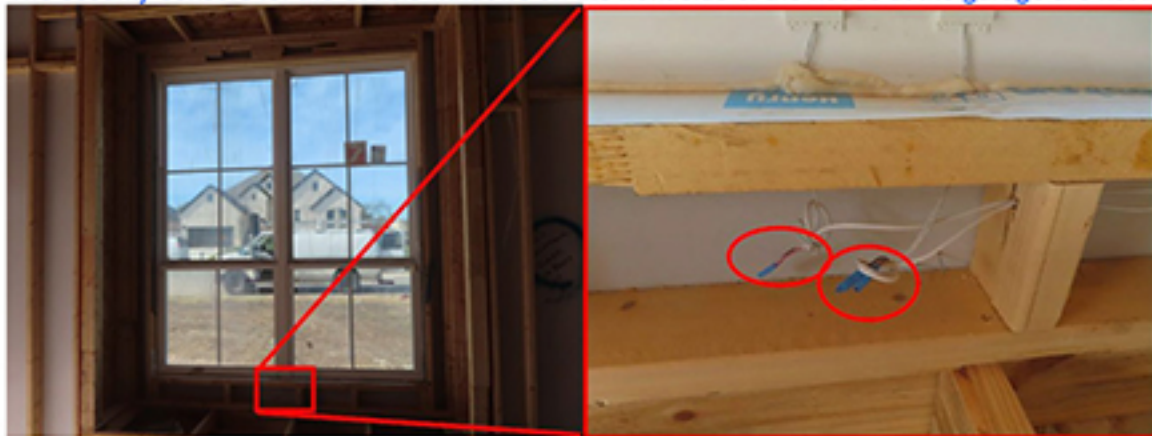
The security sensors for the double windows on the front side of the house at the garage are not installed.

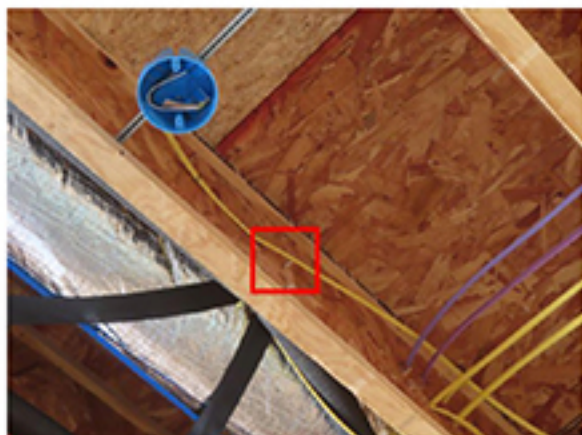
There is an electrical wire running to the light in the mud room that has been pushed to the side with a nail going through the i-beam. It's unclear if this nail has damaged the sheathing at this location. The wire needs to be inspected close-up. If the sheathing has been damaged, but the wires inside are not harmed, this wire can be wrapped with electrical tape.

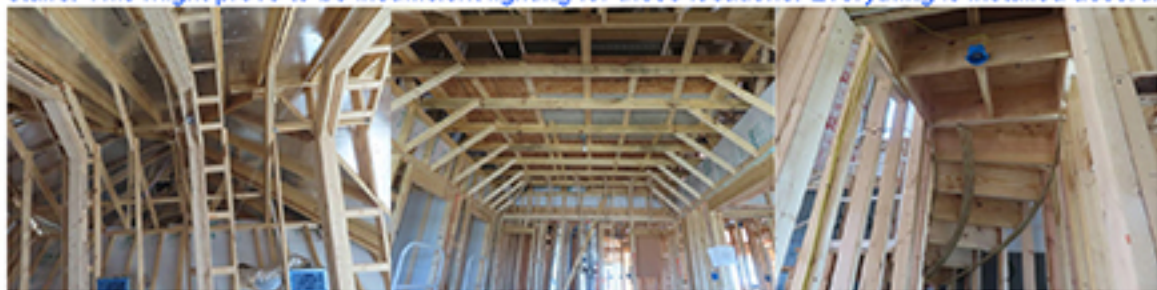
NOTE: This is not a deficiency. There is only one light in the master bedroom, the game room, and the closet under the stairs. This might prove to be insufficient lighting for these locations. Everything is installed according to code.

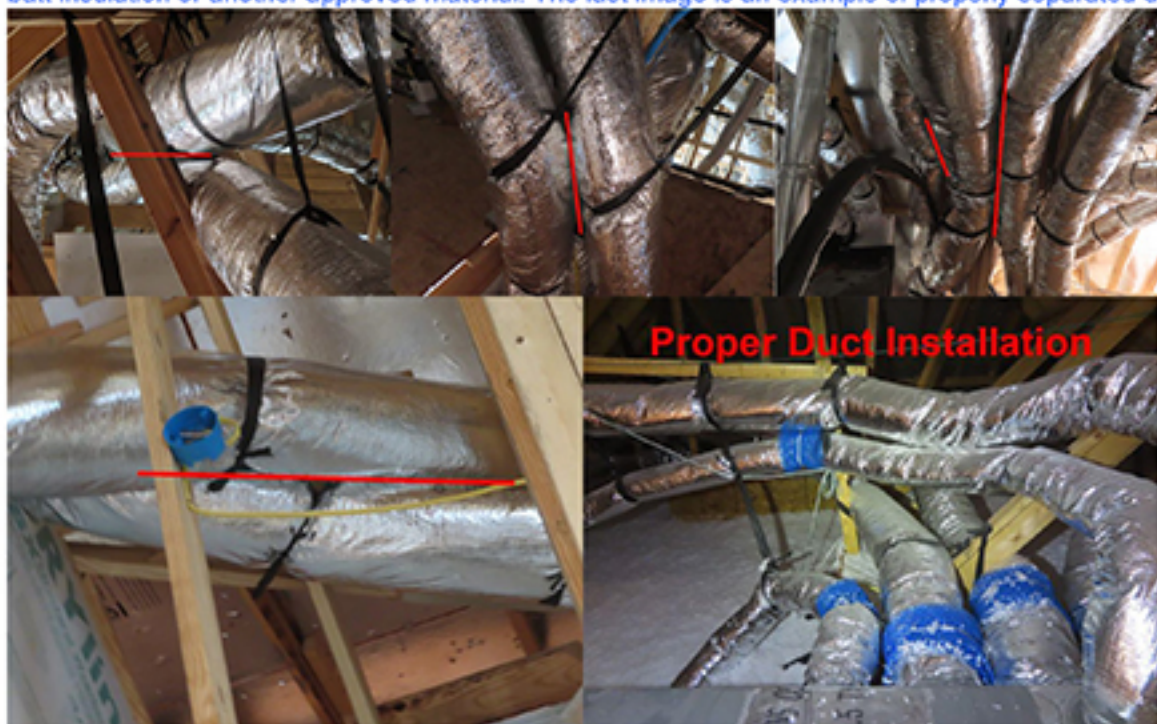
The ducting in the attic is required to be separated, so it cannot touch each other. This is either done with a piece of roll-batt insulation or another approved material. The last image is an example of properly separated ductwork.

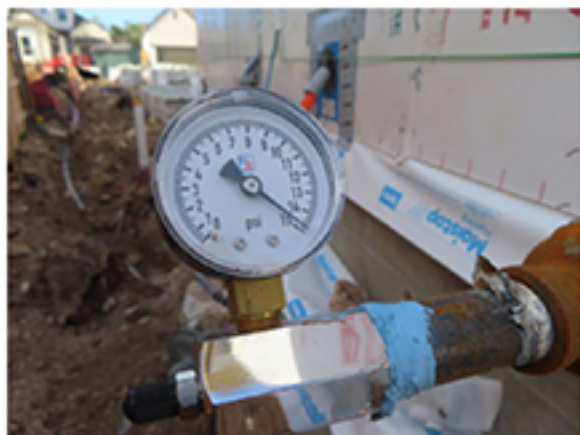
The gas line appears to be holding pressure. All of the lines appear to be installed correctly with proper shut-off valves and drip legs. There do not appear to be any deficiencies with the gas lines.

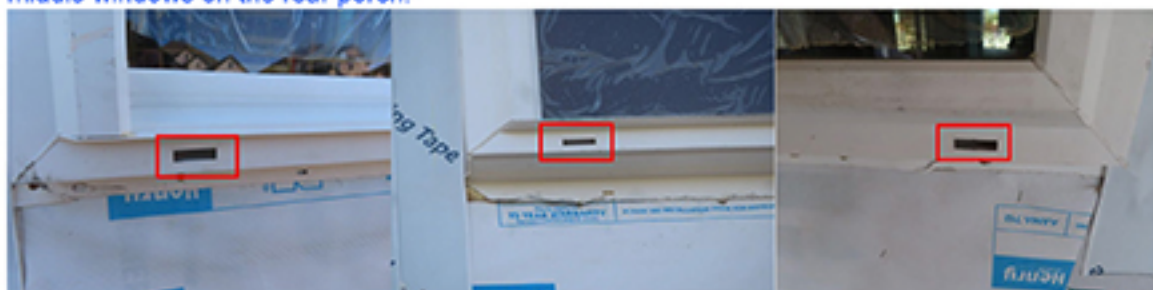
There are three windows on the house which appear to be missing the weep hole cover. The first is located on the front side of the house on the left bay window. The second is located the middle game-room window. The third is one of the middle windows on the rear porch.

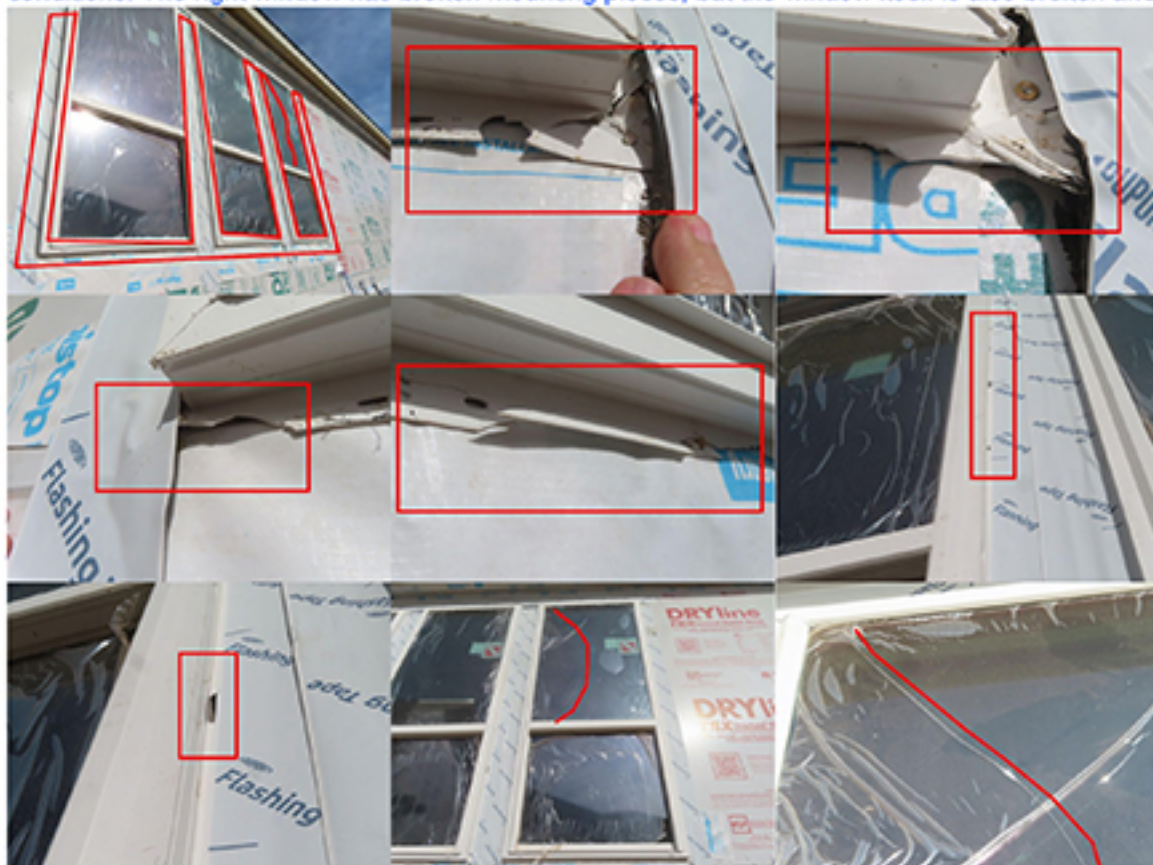
The three kitchen windows on the right side of the house are damaged and need to be replaced. The left and middle windows have broken mounting plastic pieces. Not only is the bottom broken, but the sides are broken, and I observed holes in the window that the tape/flashing on the sides are not covering. These windows will leak under these current conditions. The right window has broken mounting pieces, but the window itself is also broken and needs to be replaced.

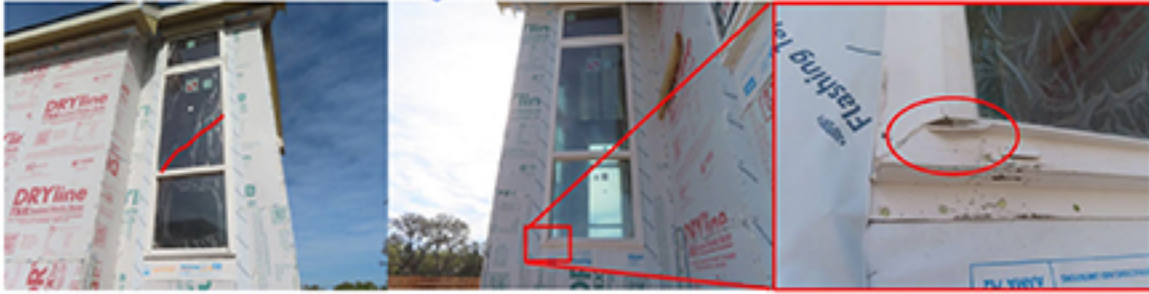
The master bedroom window on the right side of the house is broken. The glass is cracked. The master bedroom window on the left side of the house is damaged at the bottom of the window. These windows need to be replaced.

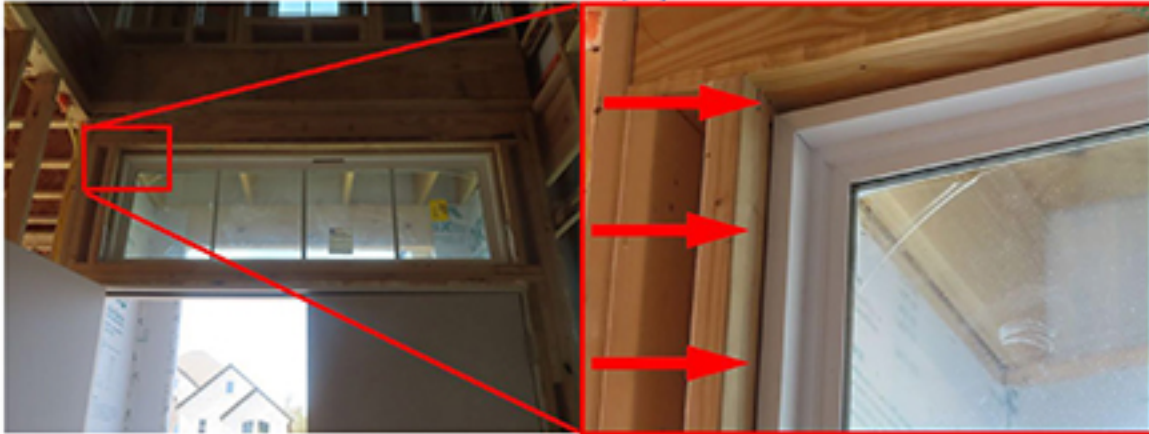
The window above the front door is not sealed with spray foam insulation.

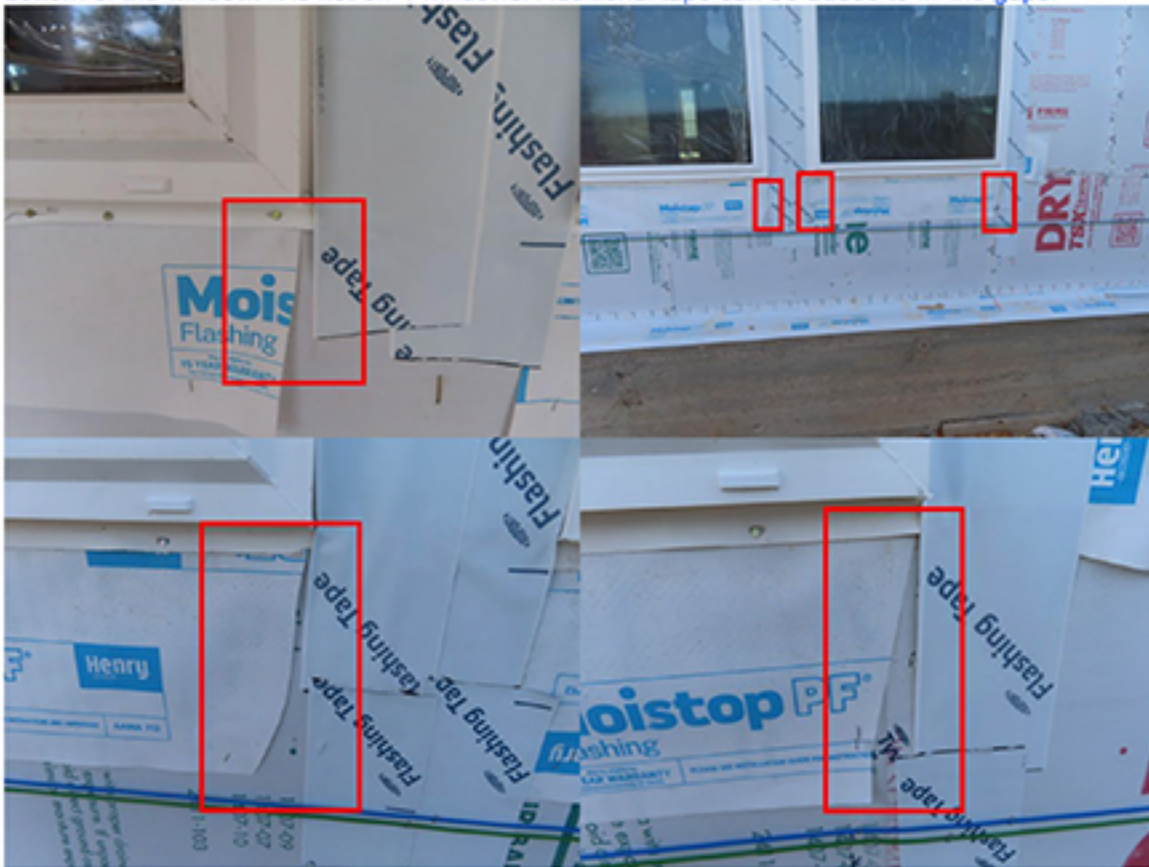
There are windows on the left wall and at the rear porch that are not properly sealed. The jamb flashing is required to overlap the sill flashing, which means the tape on the sides is supposed to overlap the vapor barrier coming out of the bottom of the window. It is not on 4 windows. Additional tape can be added to fill the gaps.
