**FOUNDATION
INSEPTION REPORT**

Type of Foundation(s): Post-Tensioned Slab-on-Grade

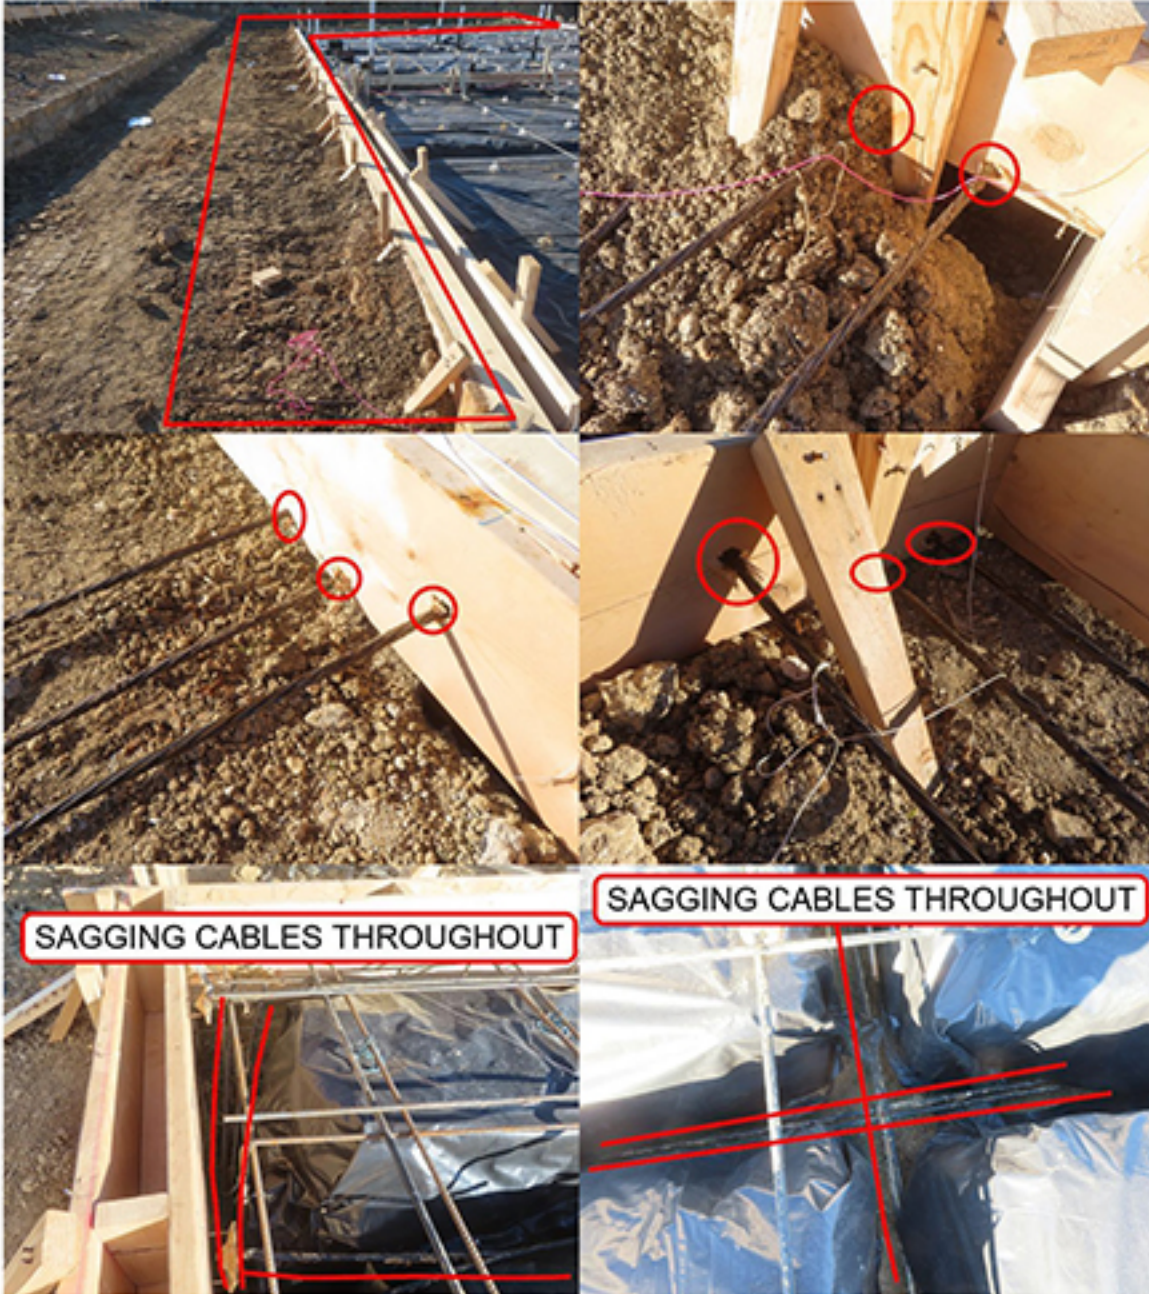
The tension cables are not clamped on the ends sticking out of the foundation on the left and rear sides of the house. This is causing the cables to sag in the foundation. The cables need to be partially pre-tightened, so they will not sag when the concrete is poured, and clamped in place. Then, after the concrete is poured, the clamps can be removed, and the cables will be fully tightened.

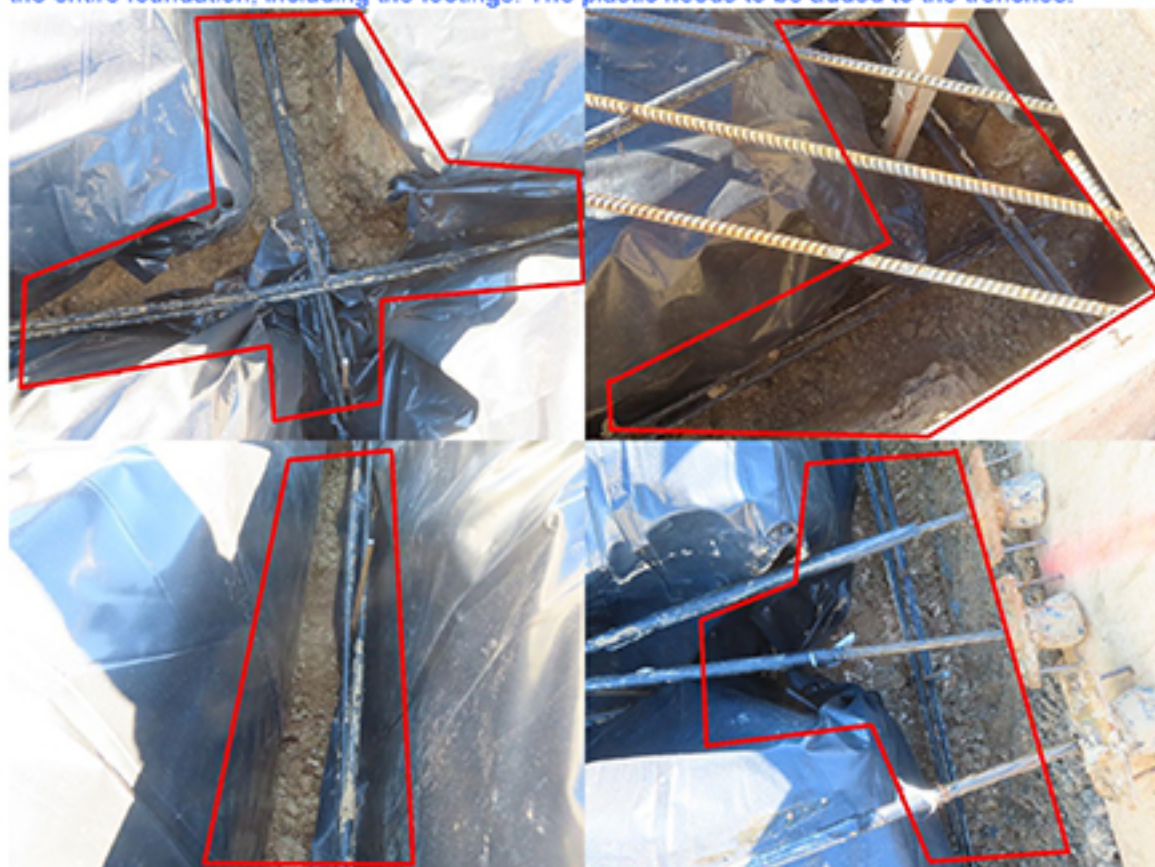
The required vapor barrier is missing from the bottom of the footings. Code requires a vapor barrier to be continuous under the entire foundation, including the footings. The plastic needs to be added to the trenches.

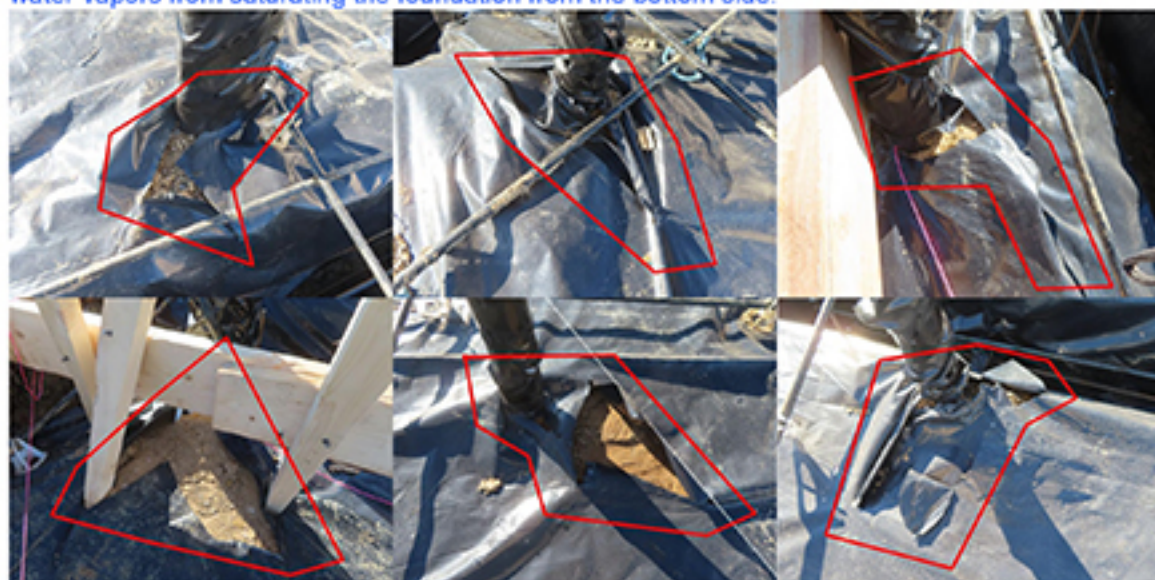
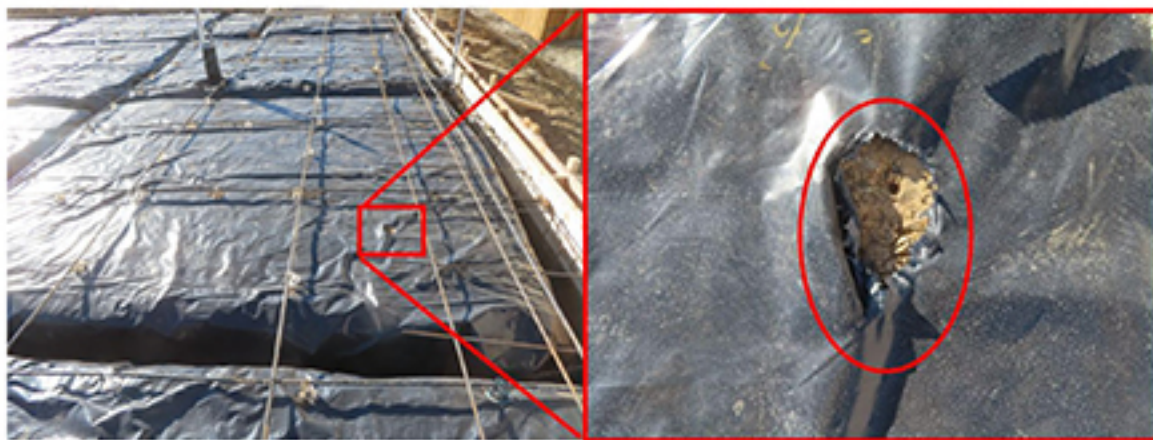
There are holes in the vapor barrier that need to be taped. These holes are primarily located around the pipe penetrations, but I also found one on the third-back far-right raised section of the house. These holes need to be taped to prevent any water vapors from saturating the foundation from the bottom side.

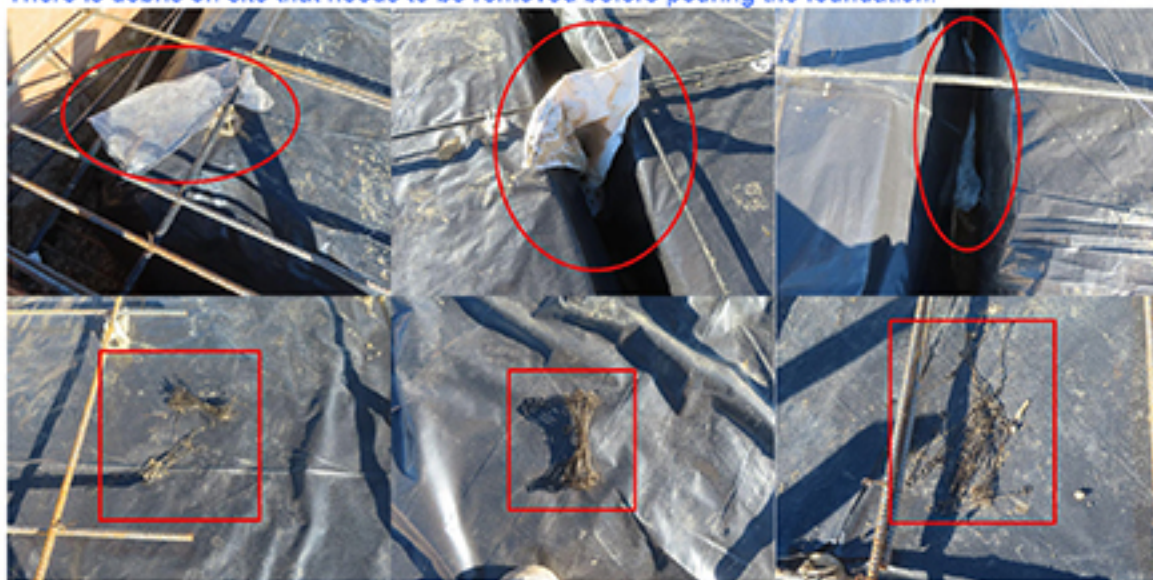
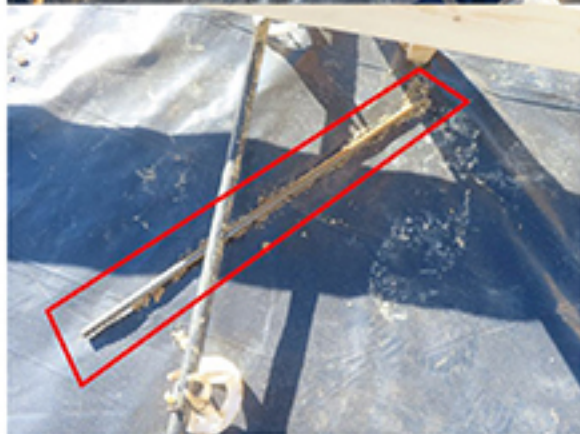
There is debris on site that needs to be removed before pouring the foundation.
