PROFESSIONAL HOME
INSEPTION REPORT

Inspector: **Shane Zimmerman**

License#: **24563**

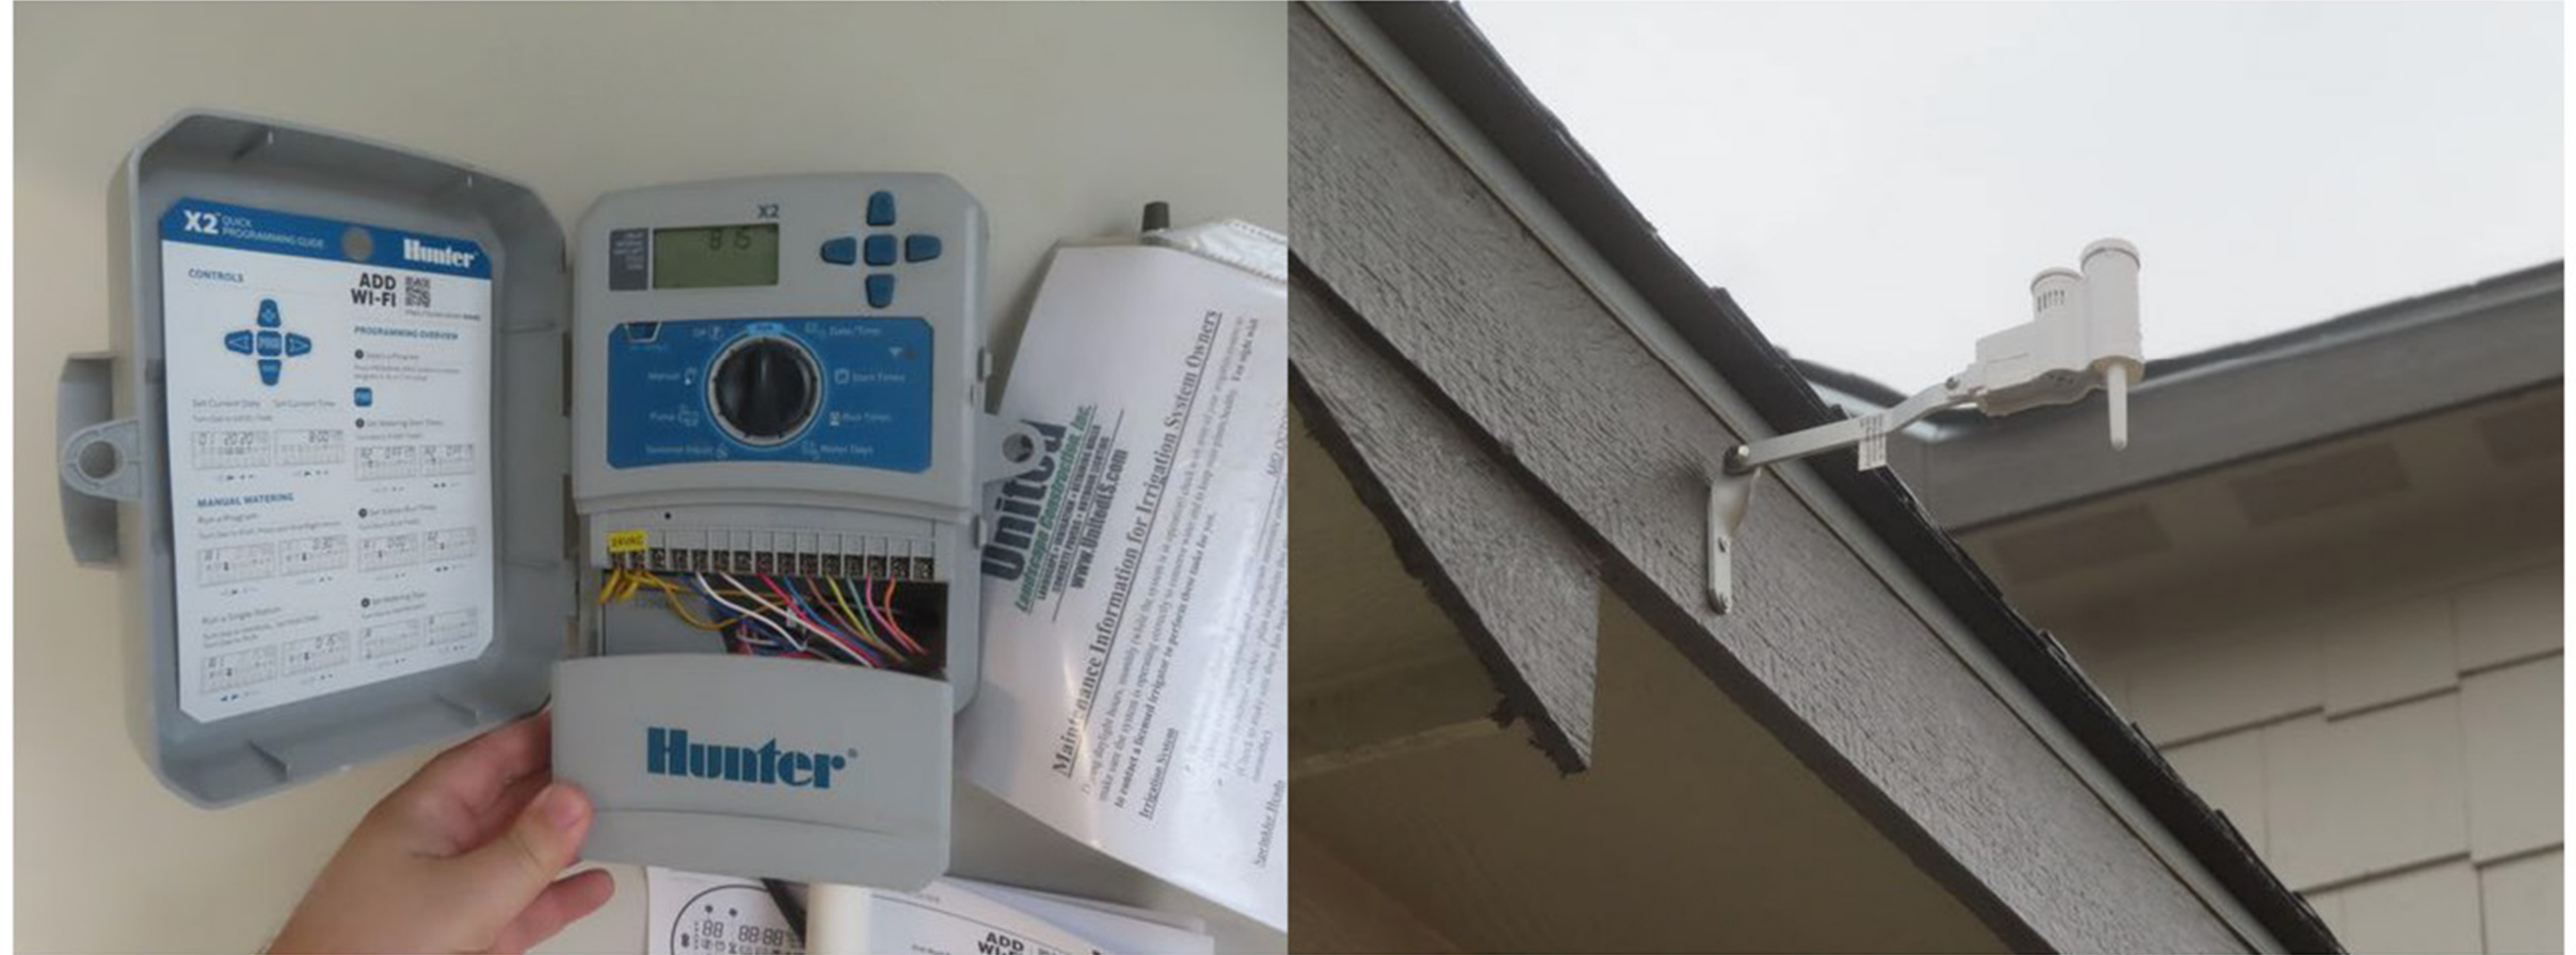
The irrigation system is controlled by a Hunter control unit located in the garage and appears to be functioning properly. It is also controlled by a rain sensor that is installed on the fascia board on the right side of the garage. This rain sensor appears to be functioning properly. There are no deficiencies in either of the following images.

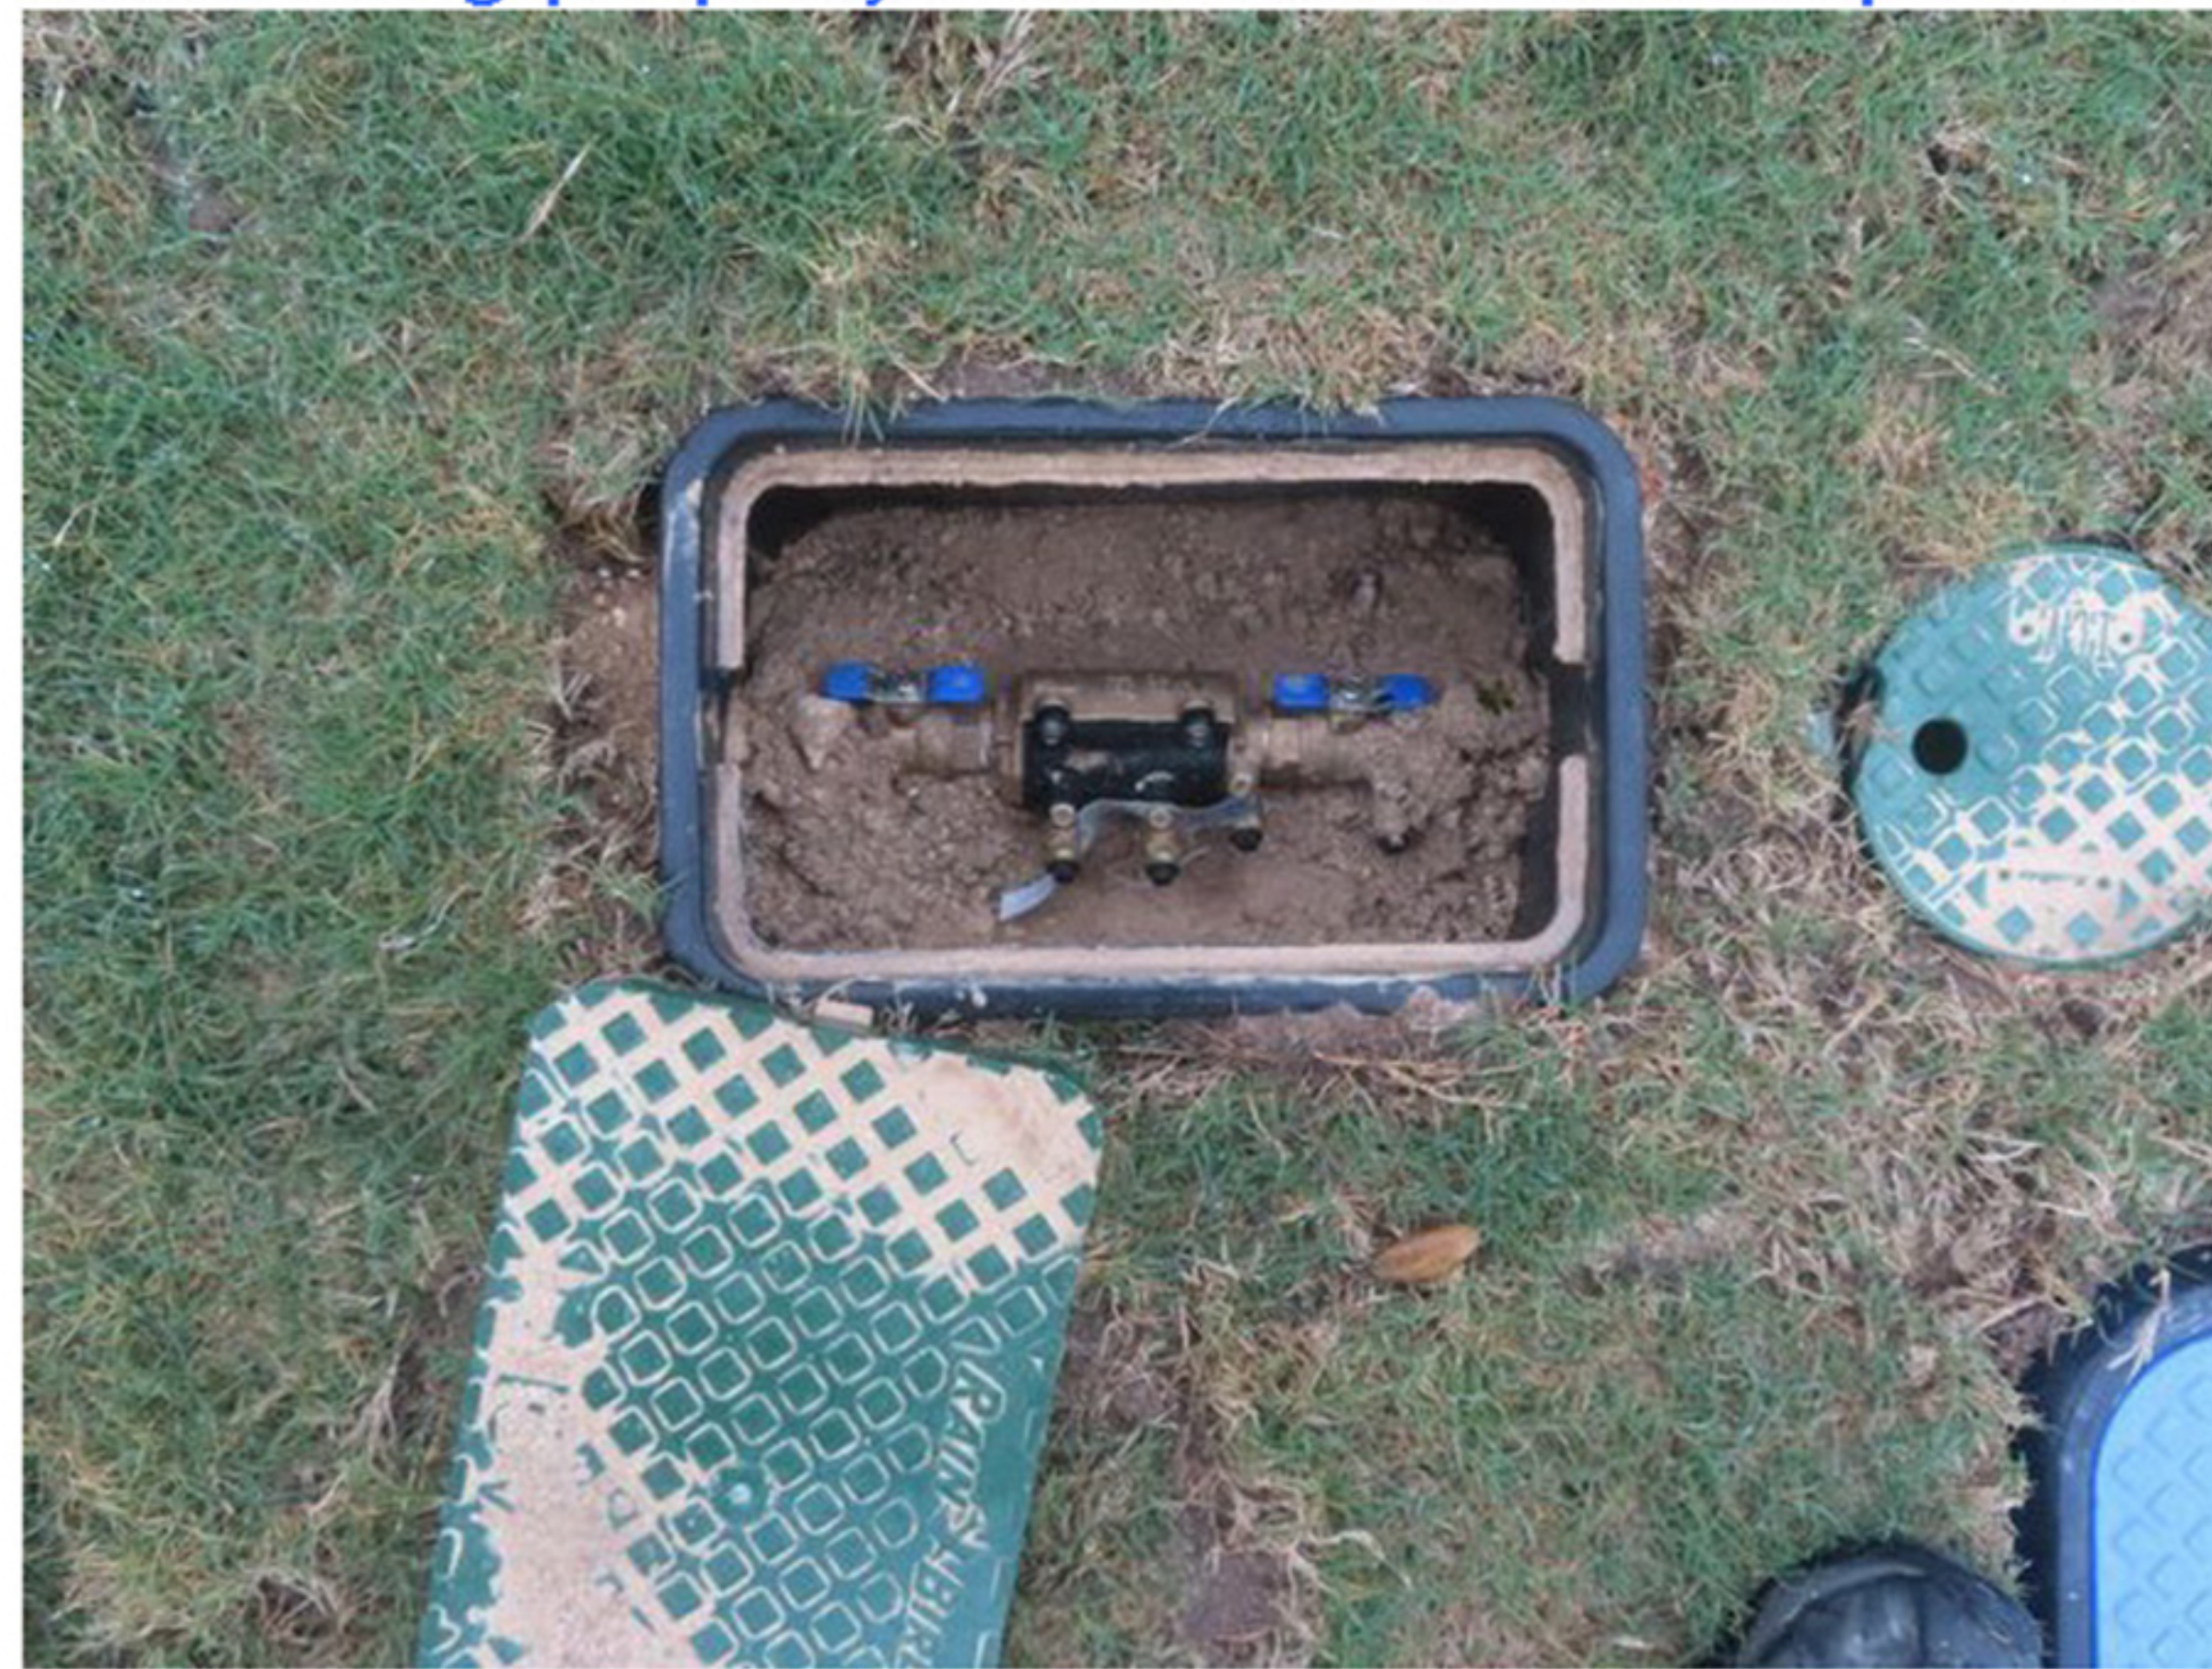
The system is protected by a back-flow preventer located in the front-right yard, near the water meter. It appears to be installed at the appropriate height for the heads in this system and functioning properly at the time of the inspection. There are no deficiencies in the following image.
